## A pragmatic, performance-based approach to levee safety assessments

Journal of Flood Risk Management

## Abstract

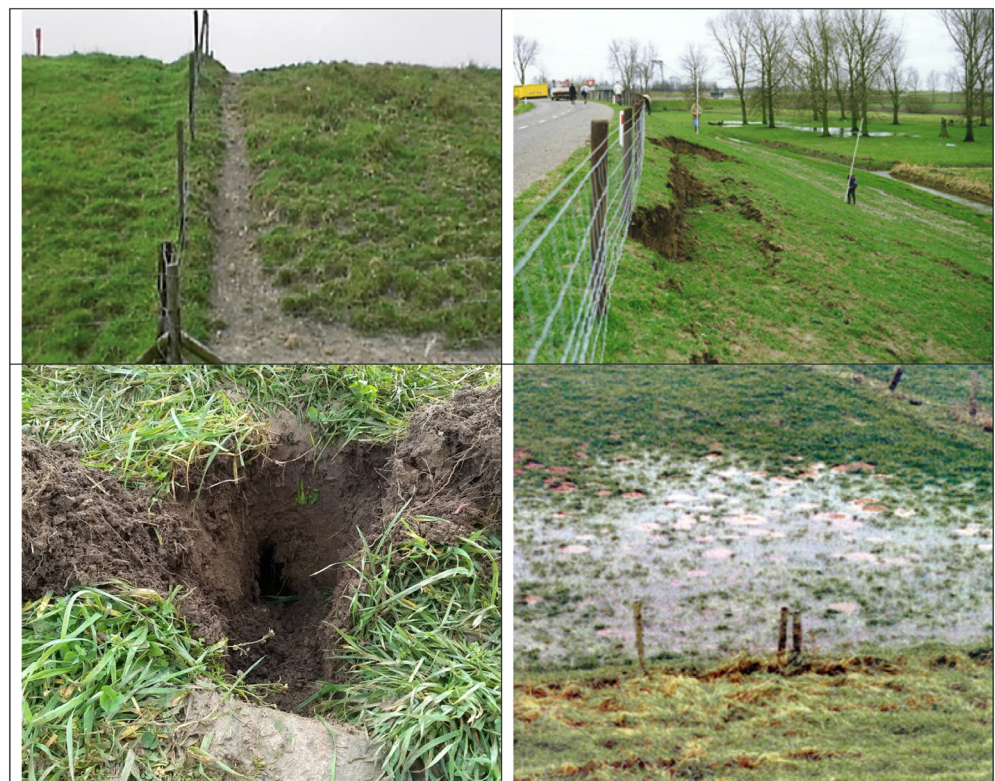
**FIGURE 3** Examples of performance indicators. Local subsidence due to trampling by livestock (upper left; picture from STOWA, 2018), severe subsidence (upper right; picture from STOWA, 2018), animal burrowing (lower left; picture taken by S.J.H. Rikkert, 2020), and wet spots at the levee toe (lower right; picture from STOWA, 2018)

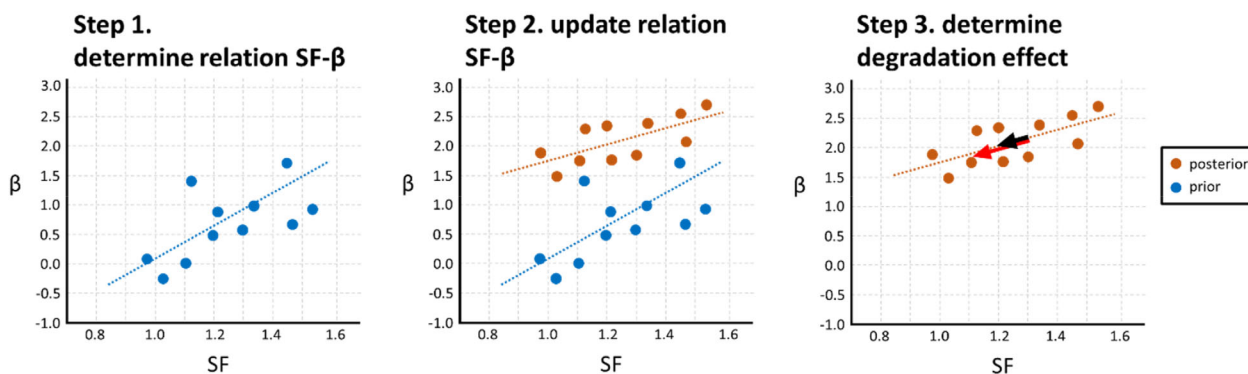
**FIGURE 5** The approach explained through three steps. Step 1: Relation between safety factor SF and reliability index  $\beta$  for one levee type, based on probabilistic stability assessments. Step 2: Updating the prior relation between safety factor SF and reliability index  $\beta$  for one levee type, based on observations of survived hydraulic loads, with the prior relation in blue and the relation after updating in orange. Step 3: The arrows indicates how different degrees of degradation (black: light degradation; red: severe degradation) affect the stability factor, and hence the reliability index, of one levee type is influenced by levee degradation. The arrows are indicative, and effects on the stability factor depend on levee characteristics and degradation type

2. Observations of performance of the levee under various loading conditions can be included, using the approach described in Section 2.2.1 on reliability updating. The initial relation found in step 1 can be improved, by fitting a line through the points after reliability updating, as is shown in (see step 2 in Figure 5).

3. The final step is to correct the posterior failure probability by including results of levee inspections in the form of levee performance indicators, in addition to the survived loads from the previous step. These levee performance indicators contain information about the actual condition of the levee, and they influence the stability factor, and hence the probability of failure. Ideally, the same approach as in step 2 would be used here: including the effects of a certain performance observation, based on Bayes theorem. However, in this study a more pragmatic approach was used to limit the processing time of the study. Besides, discretization of the load and resistance in reliability updating makes it difficult to take into account gradual degradation. Therefore, we assumed that the effect of an observation (e.g., animal burrows) on the stability factor can be expressed as a reduction factor that is dependent of the levee type, the performance indicator and the level of severeness (see step 3 in Figure 5).

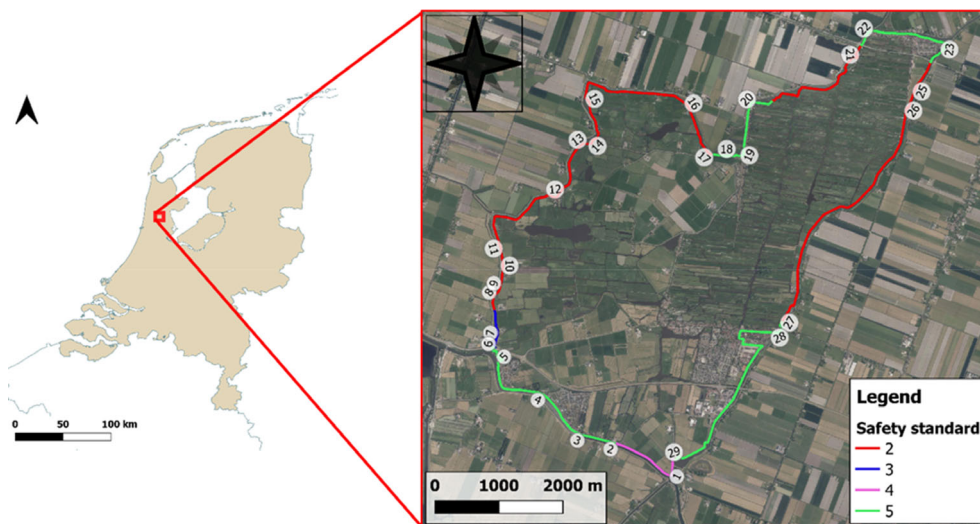
**FIGURE 6** Left: Map of the Netherlands, with the location of the Eilandspolder. Right: Overview of levees protecting the Eilandspolder, the distinction into separate, numbered, levee sections, and their assigned flood protection standard

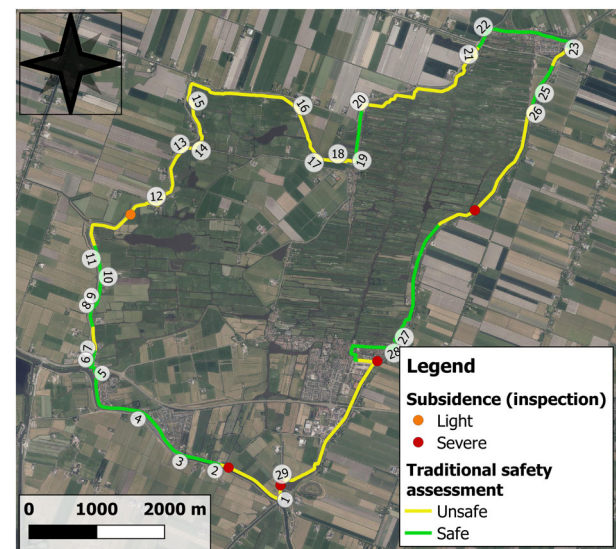
**FIGURE 9** Map showing the subsidence observations from the levee inspection. Light subsidence is observed in section 4.5, and severe subsidence is observed in section 1 (on 2 locations), 8.2, and 9.2

Figure 9 shows the severity of levee subsidence per location, observed during levee inspections over a course of about 2 years (2016–2018). The figure only includes observations of levees that were unsafe according to the semi-probabilistic safety assessment. A distinction is made based on the degree of severity of subsidence:
