Main house fragment 1:50

Farm house fragment 1:50

Horse stable fragment 1:50

Ankerschuur fragment 1:50

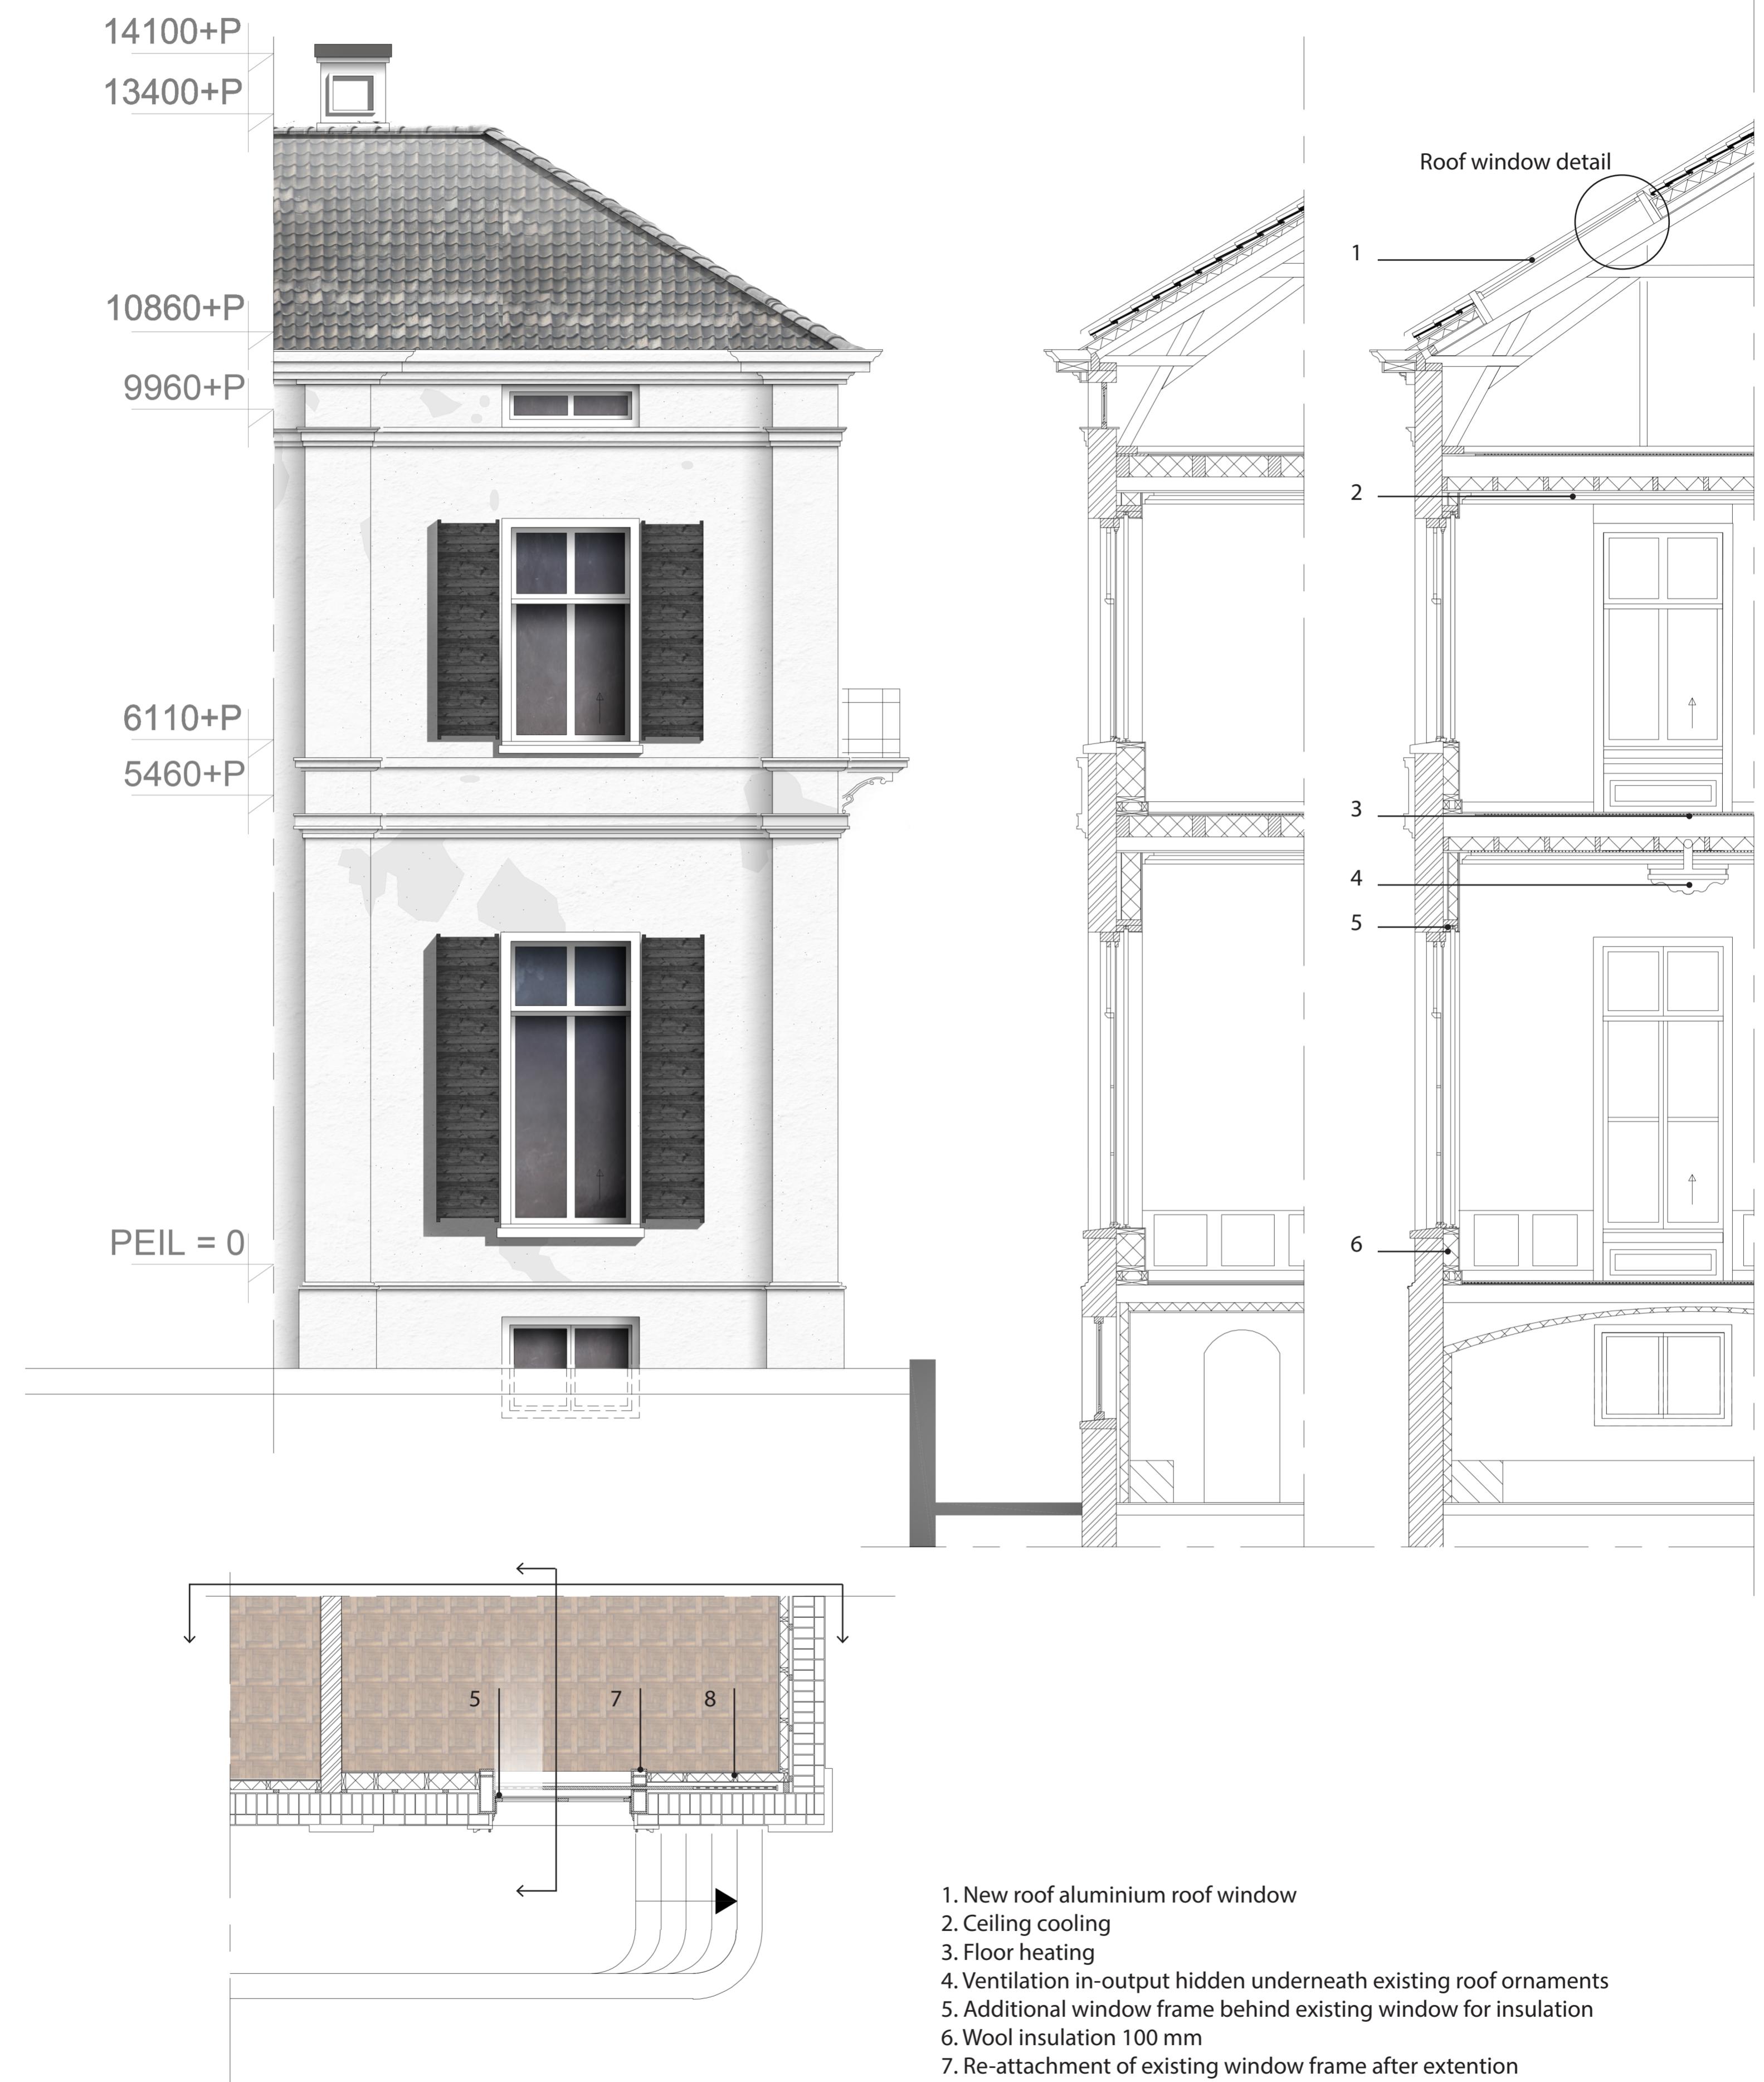
1. New roof aluminium roof window
2. Ceiling cooling
3. Floor heating
4. Ventilation in-output hidden underneath existing roof ornaments
5. Additional window frame behind existing window for insulation
6. Wool insulation 100 mm
7. Re-attachment of existing window frame after extention
8. Additional framework for insulation

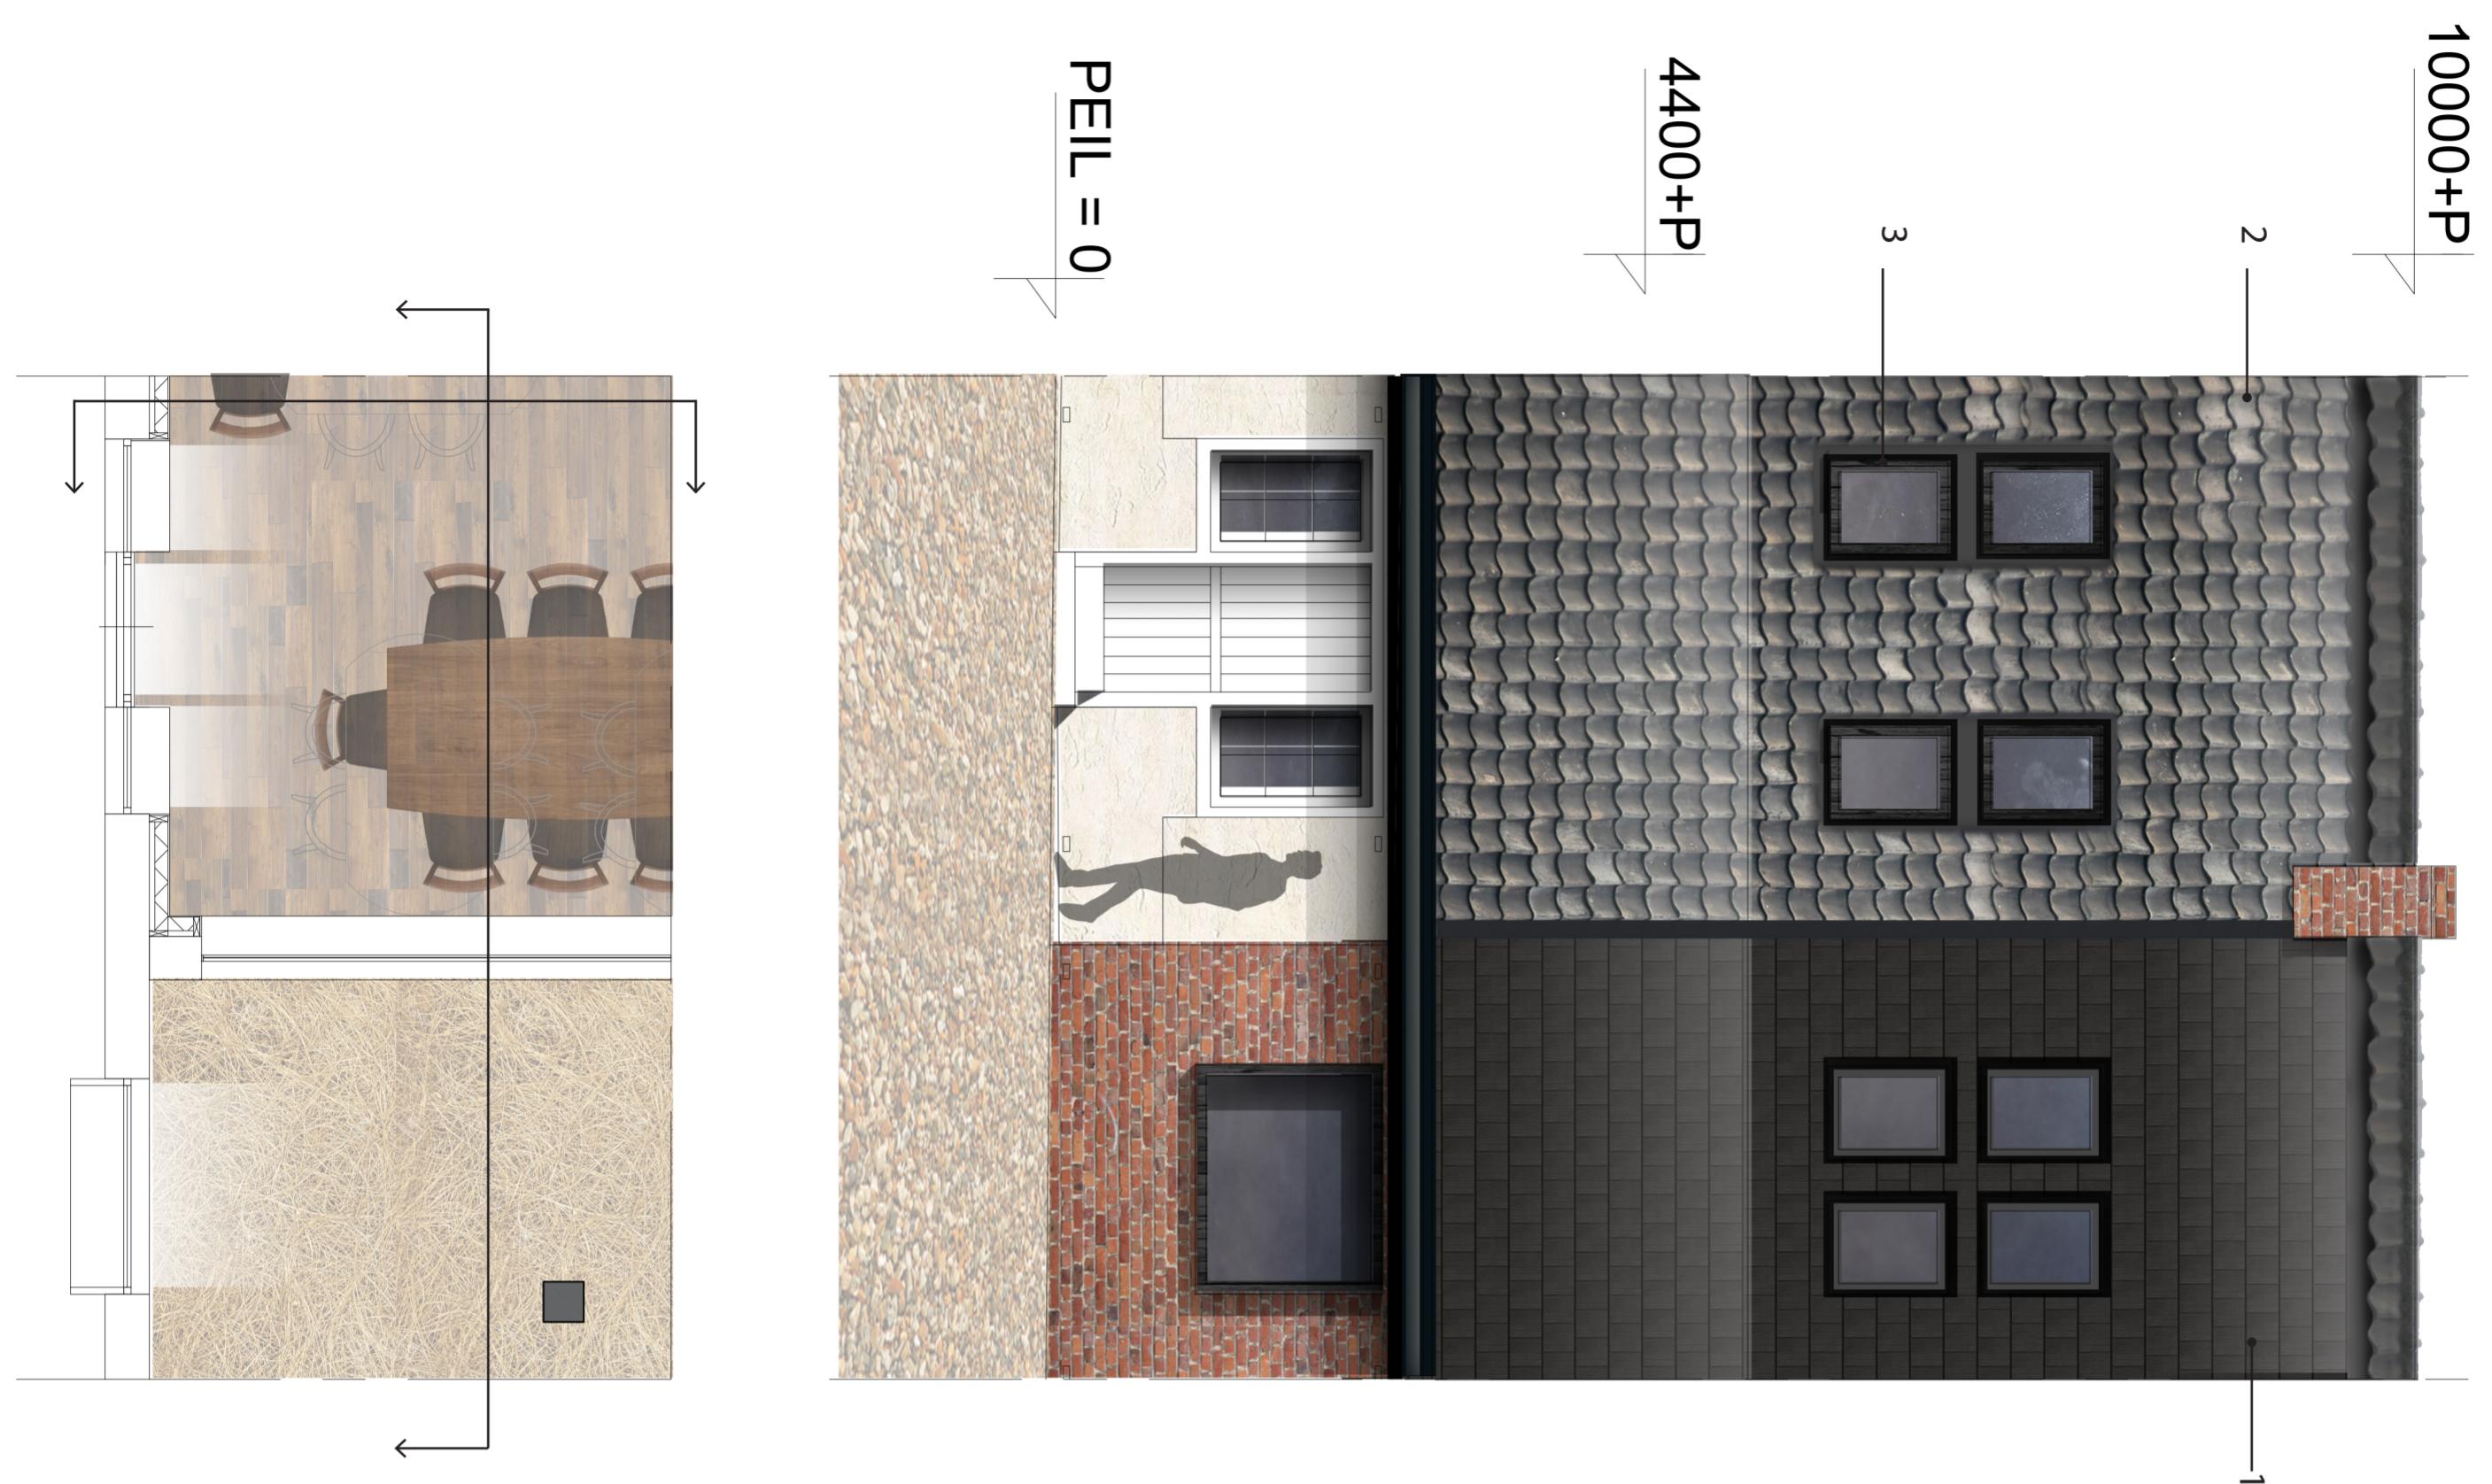
1. PV panels
2. Original roof tiles
3. New roof window
4. Existing separation wall
5. New opening in separation wall and window frame
6. Existing visible roof structure
7. Existing floor beams
8. Floor heating
9. Wool insulation 100 mm

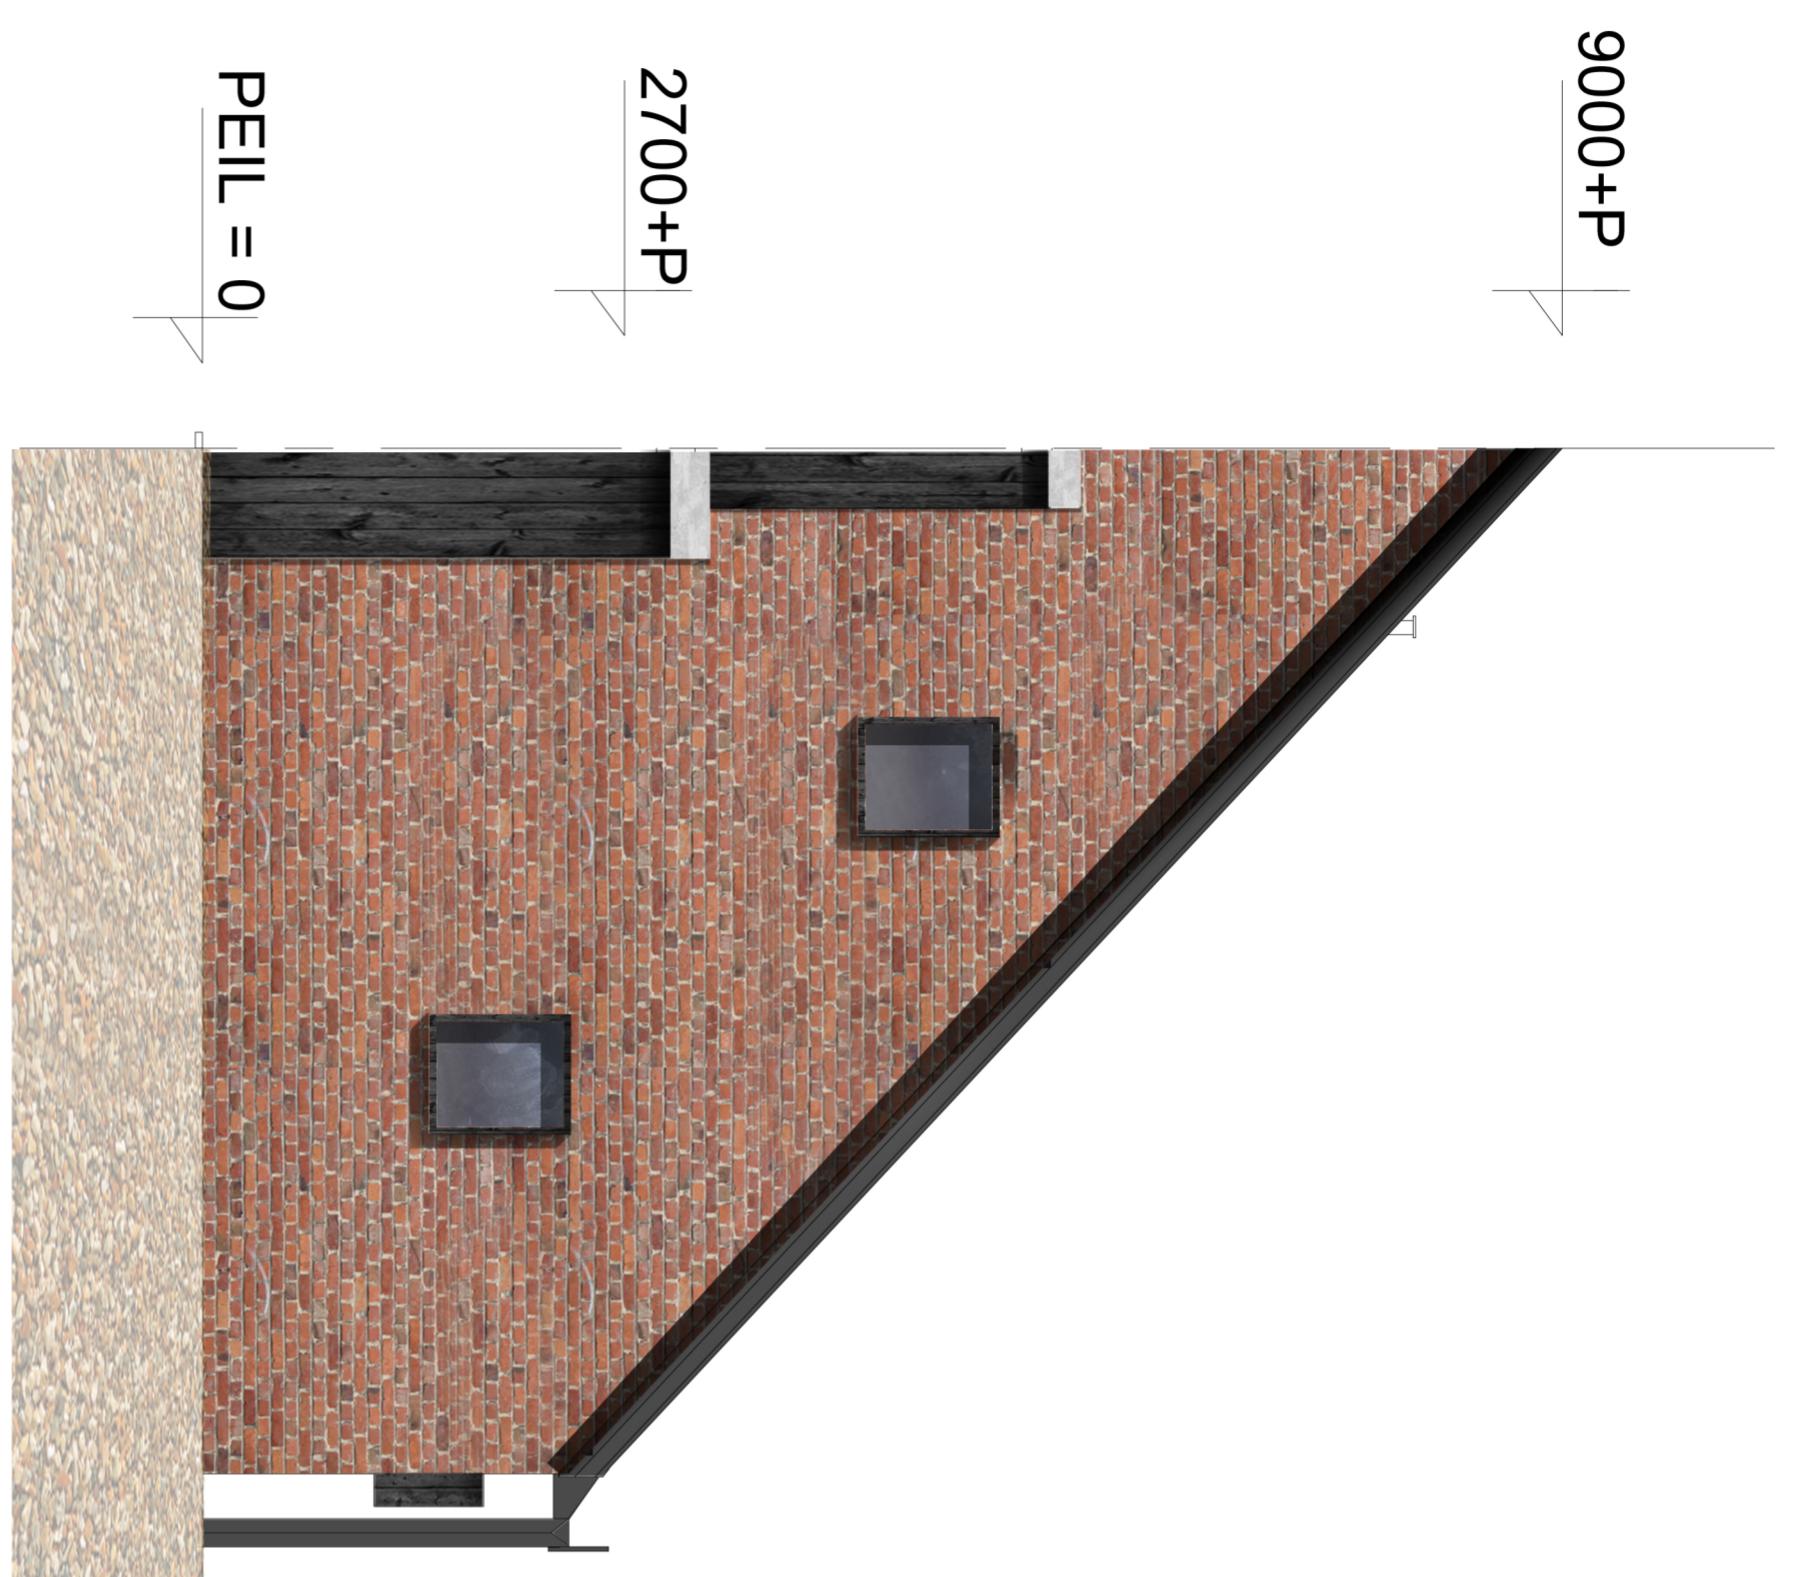
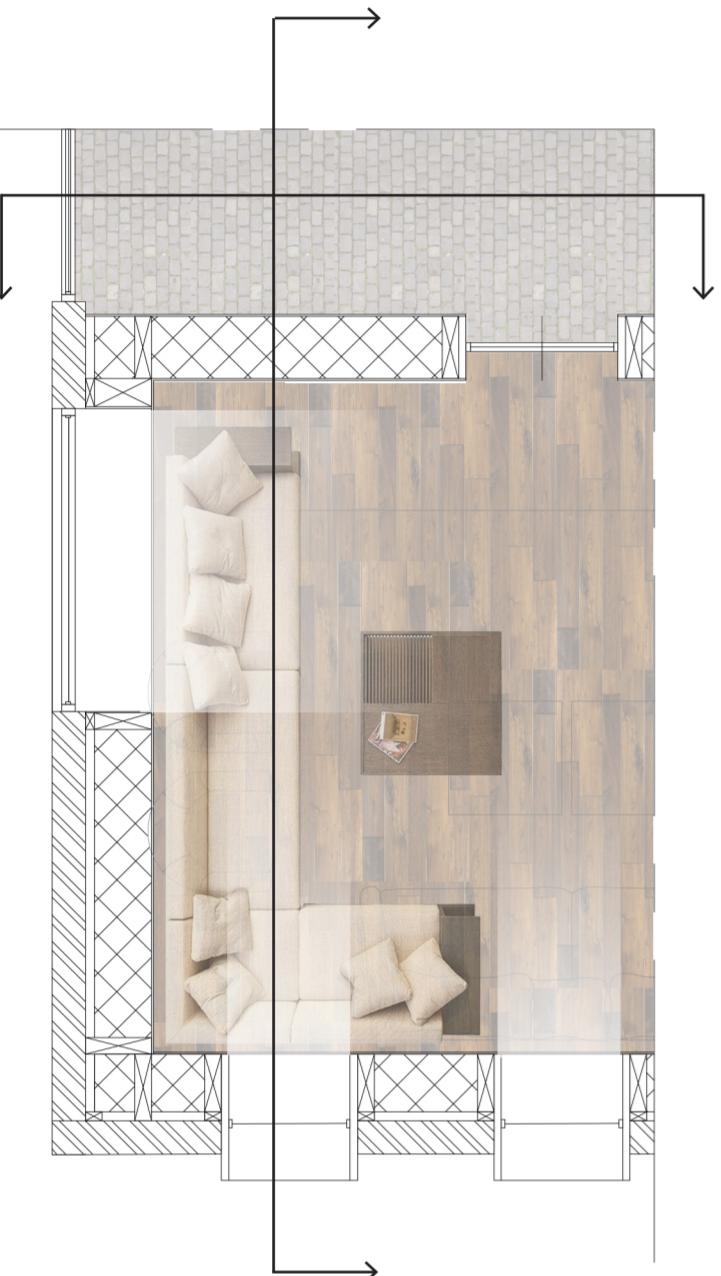
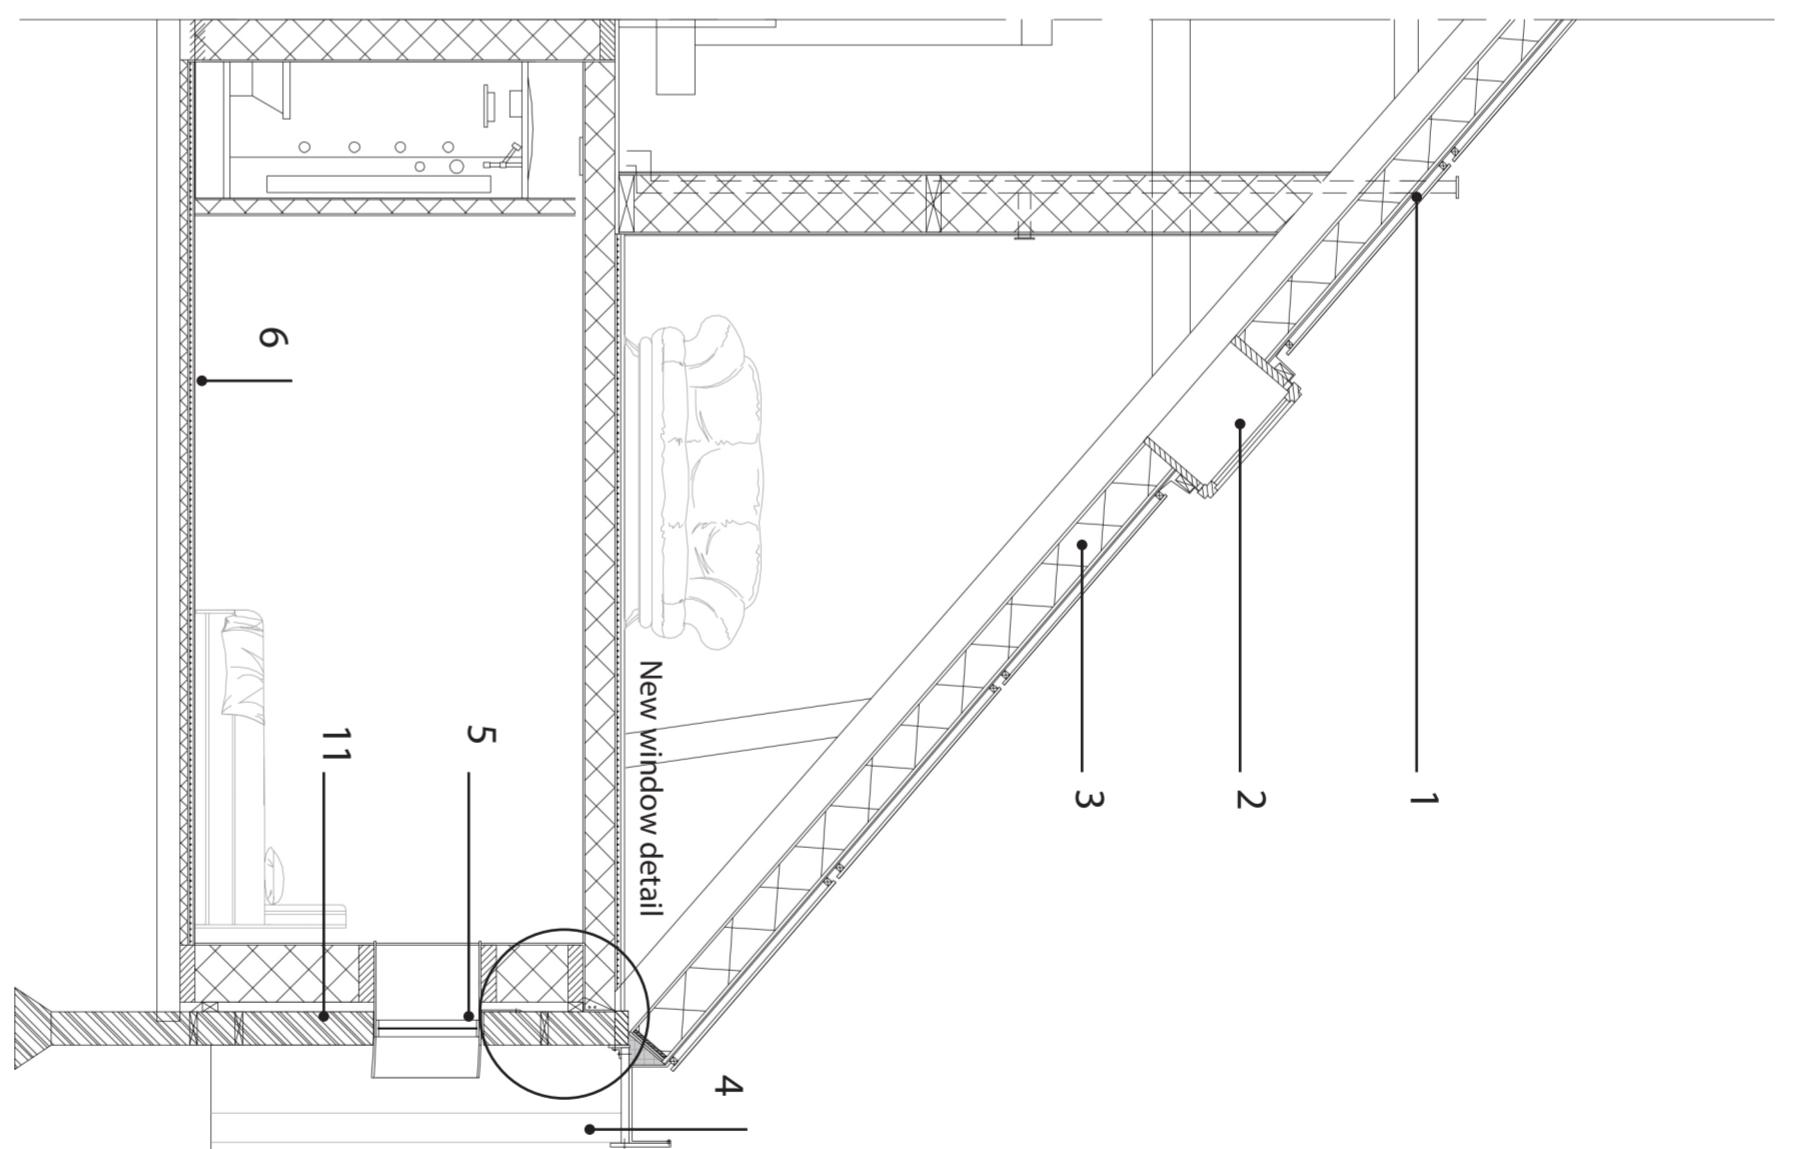
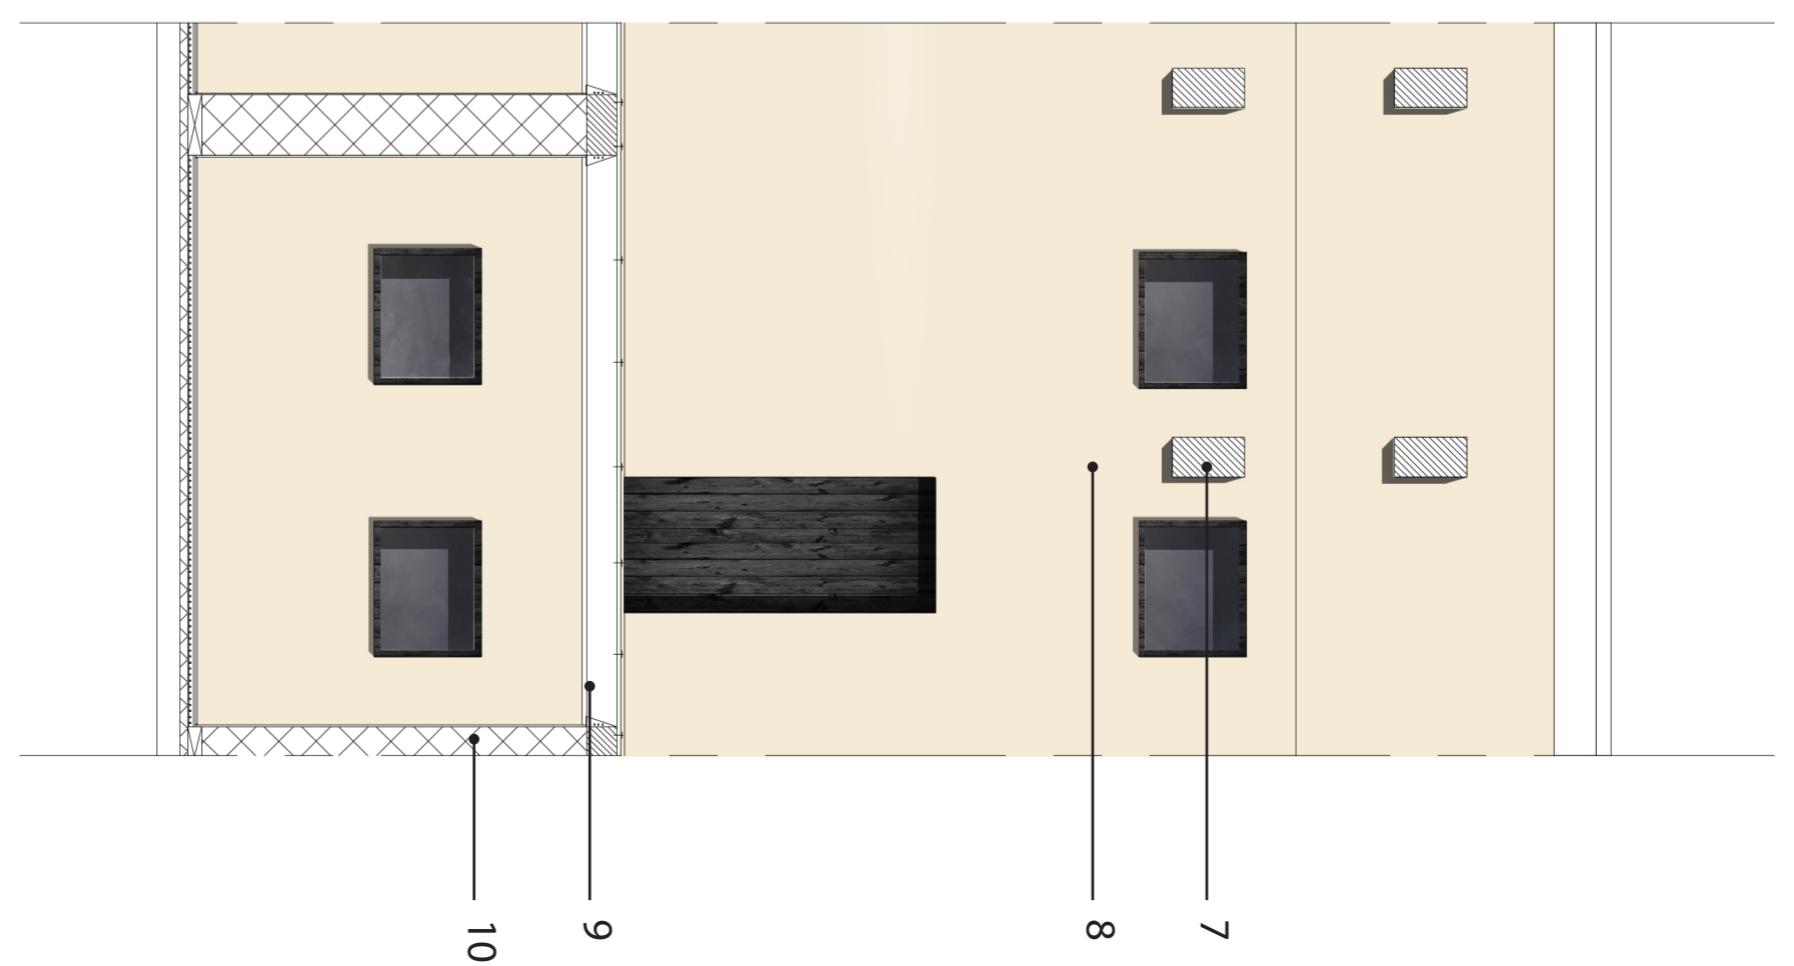
1. New ventialion
2. New roof window
3. PV panels
4. New, deeper gutter
5. New window frame in existing wall opening
6. Floor heating
7. Existing visible roof structure
8. Loam finish
9. Additional wooden structure (box in box principle)
10. Straw insulation 400mm
11. Existing exterior wall

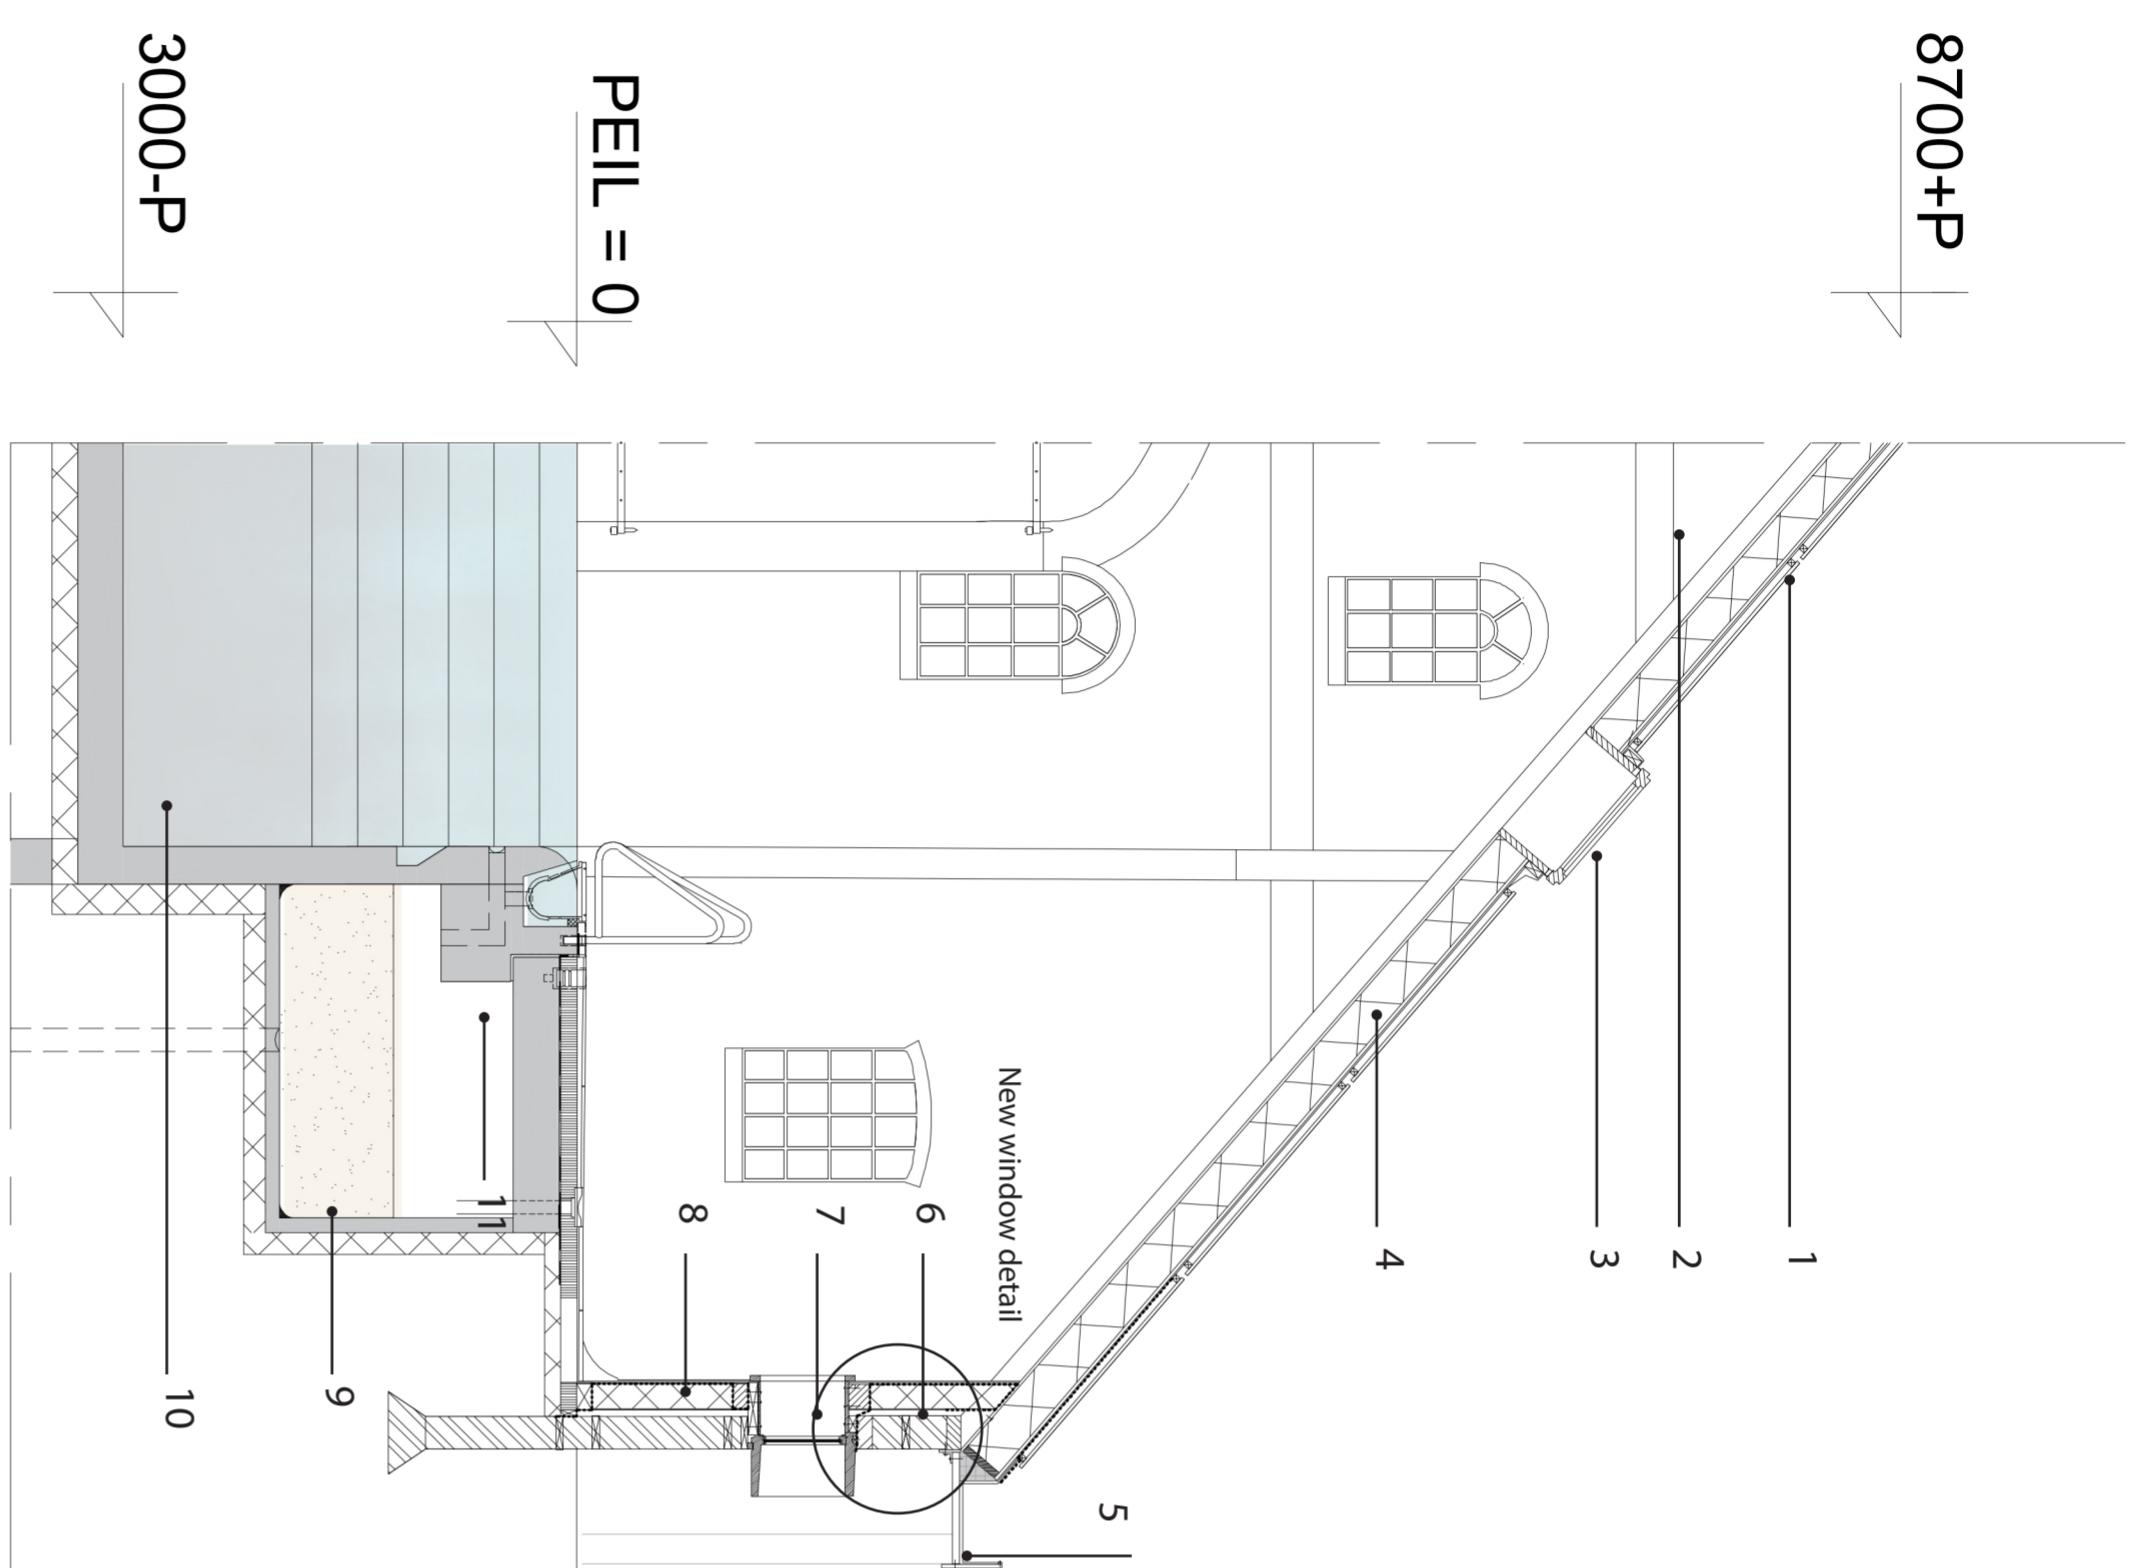
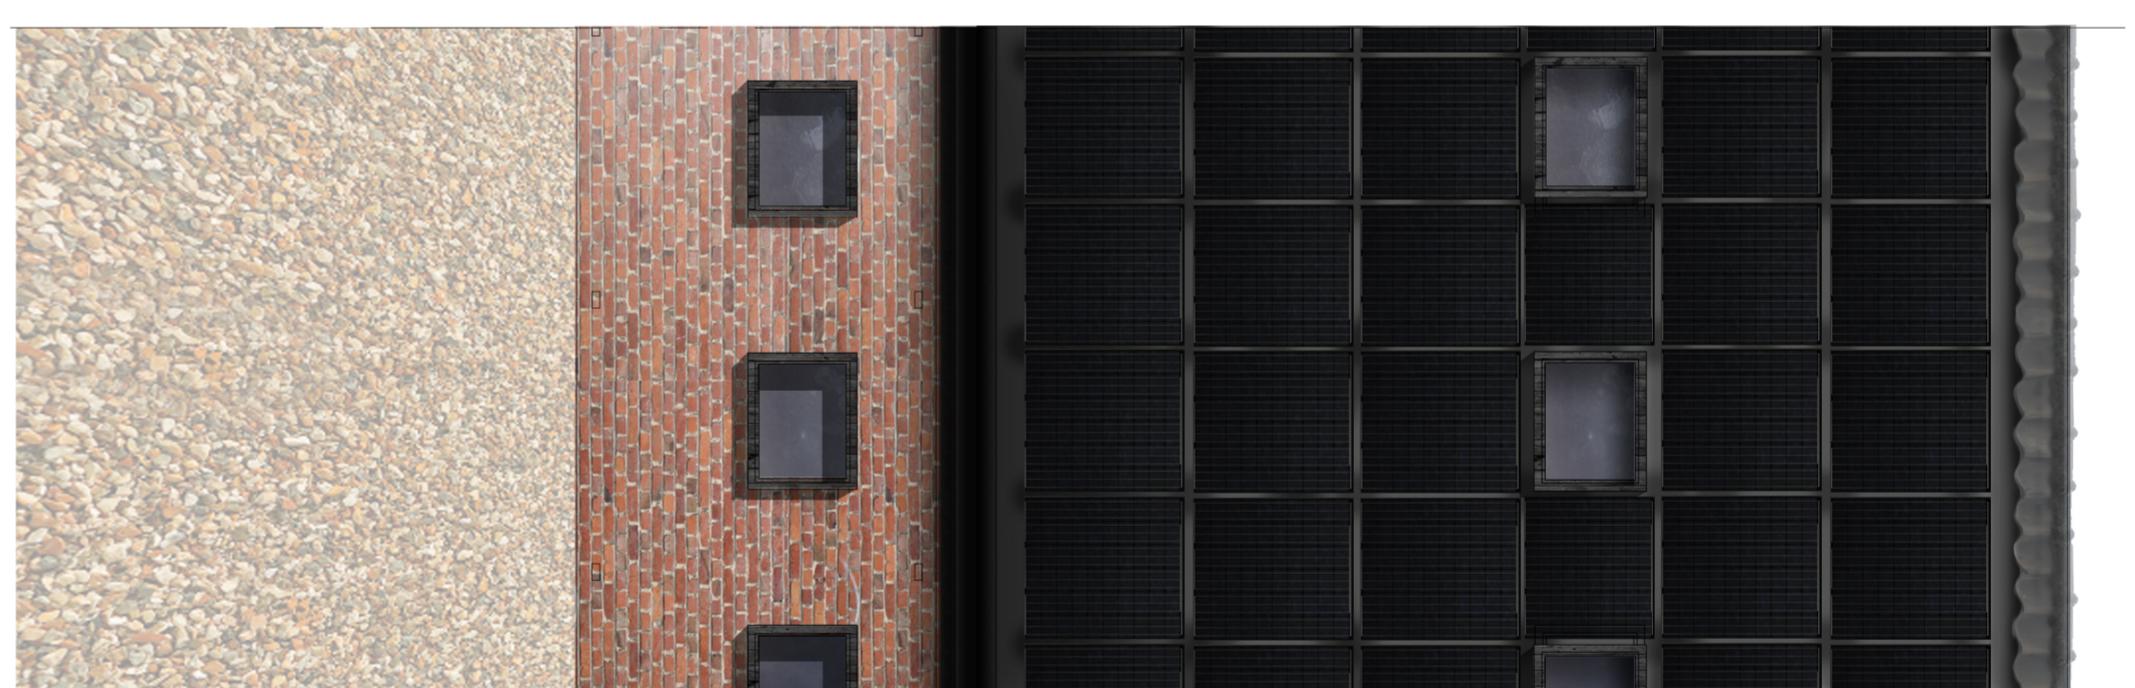
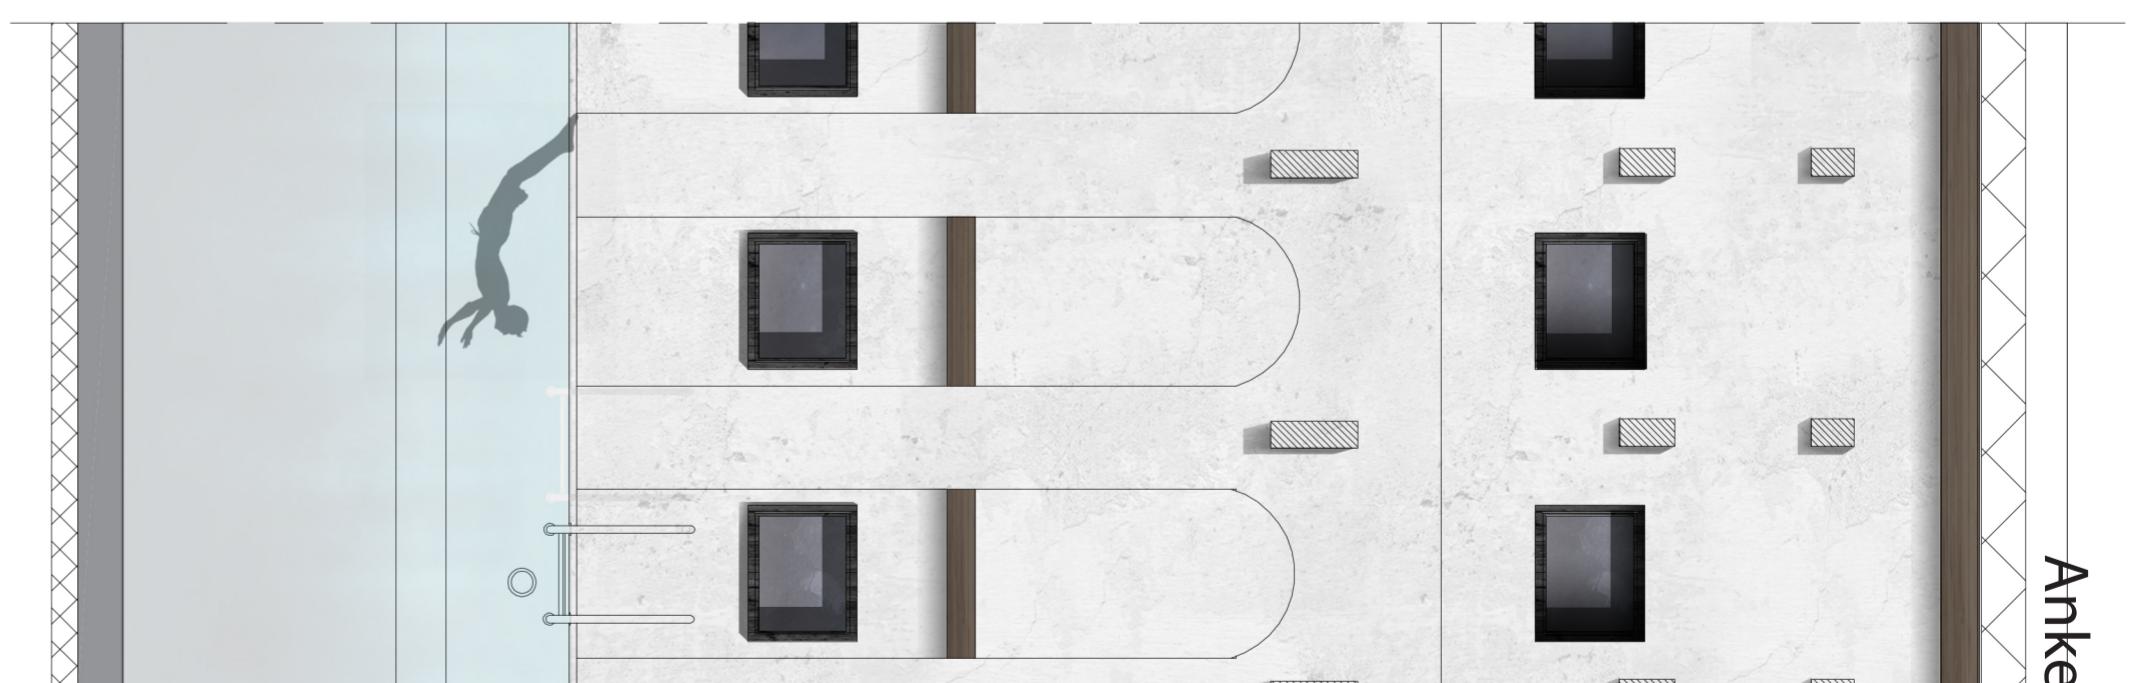
1. PV pannels
2. Existing visible roof structure
3. New roof window
4. New, deeper gutter
5. New window frame in existing wall opening
6. Existing exterior wall
7. Existing visible roof structure
8. Wool insulation 100 mm
9. Biofilter
10. Swimming pool
11. Skimmer
