Comfort at hospital reception desks

40th AIVC Conference, 8th TightVent Conference, 6th venticool Conference

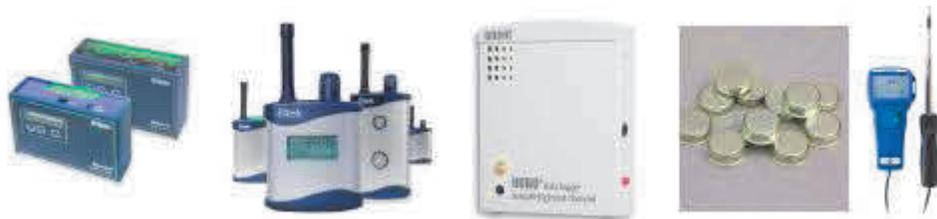
Figure 1: Equipment Eltek Squirrels, Hobo Dataloggers, I-buttons and air velocity meter, images from the producers.

Eltek Squirrels, HOBO dataloggers, I-buttons and EXTECH air velocity meters were used to measure the temperature, the relative humidity the air velocity and the CO₂ concentration, see figure 1. The researcher's nose was used to track and identify any interesting smells at the reception desk and in the surrounding areas. The outdoor temperatures of the nearest airport were taken from the KNMI website. The perceptions of the people from the reception desk were investigated using a questionnaire and additional small talk. The questionnaire consisted of questions about personal characteristics and thermal comfort.

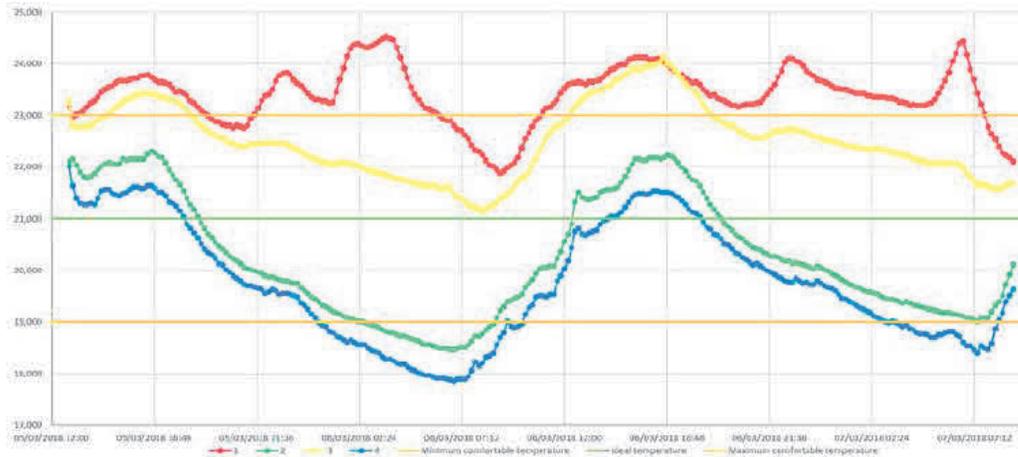
Figure 3: Temperature measurements (red and yellow line) at the reception desk in hospital 1.

The temperature at the reception desk was generally between 21 and 23 °C, see measurements 1 and 3 in figure 3. This means that the temperature should in general be comfortable. The personnel of the reception desk had a personal heating system. The air velocities were

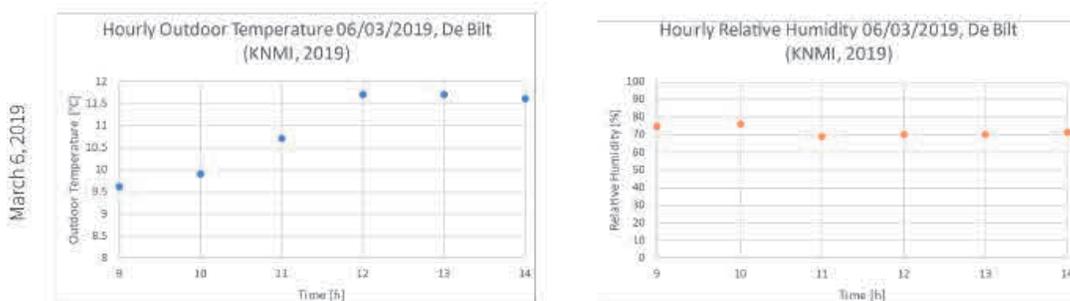
Figure 4: Outside temperatures (KNMI, closest weather station) of hospital 2.

Hospital 2: The measurements were taken on the 6th of May 2019 between 9.00 and 14:30. The outdoor temperature was between 9.5 and 12 °C with a North wind speed of 11 km/h, see figure 4. The temperature at the reception was between 22.5 and 23.5 °C measured with Eltek, I-button and Hobo’s, see figure 6. The CO₂ concentration was below 800 ppm.

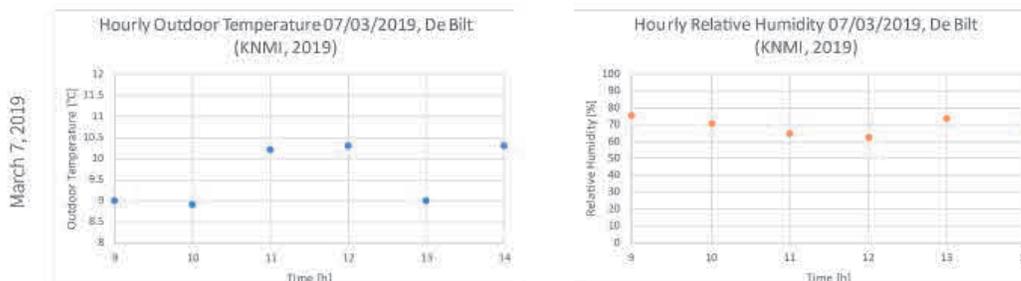
Figure 5: Outside temperatures (KNMI, closest weather station) of hospital 3.

Hospital 3: The measurements were taken on the 7th of May 2019 between 9.00 and 14:30. The outdoor temperature was between 9.5 and 10.5 °C with a North East wind speed of 18 km/h, see figure 5. The temperature at the reception was again between 22.5 and 23.5 °C measured with Eltek, I-button and Hobo’s, see figure 7. The CO₂ concentration was below 800 ppm and is not further investigated.

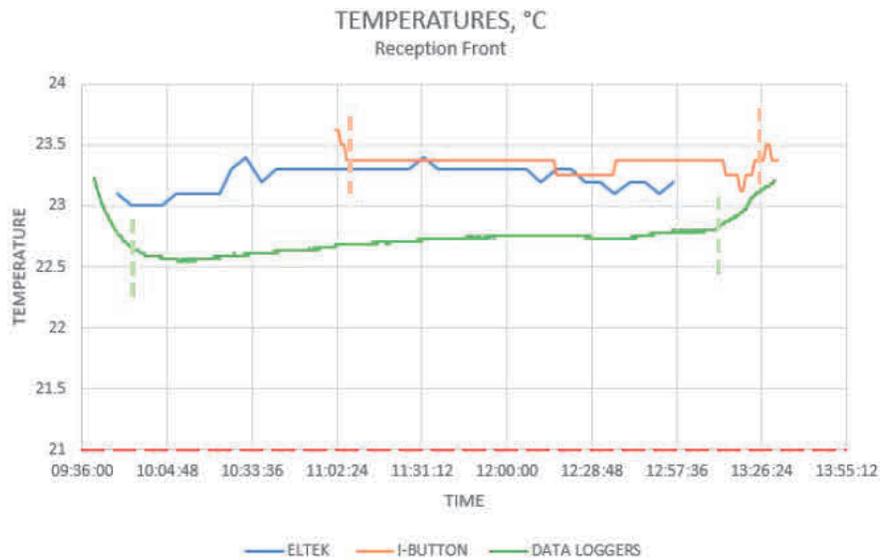
Figure 6: Indoor Temperature at the reception desk in hospital 2.

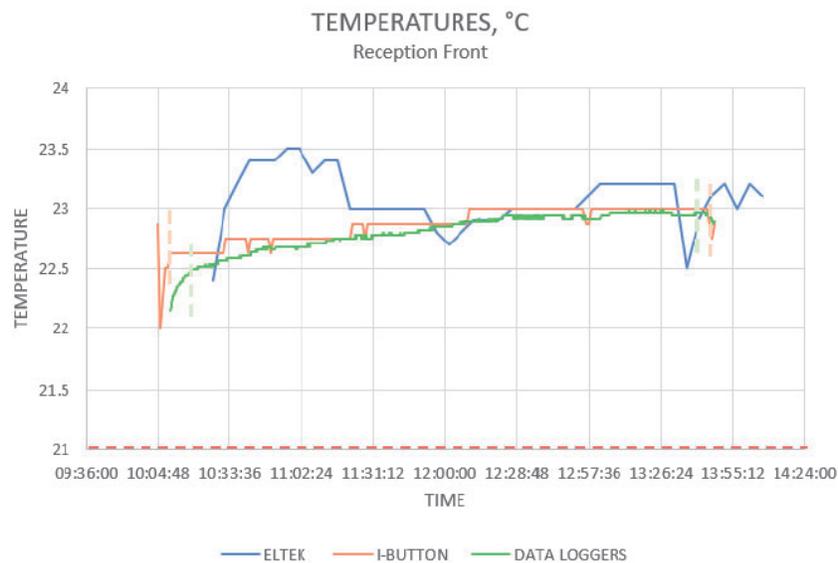
Figure 7: Indoor Temperature at the reception desk in hospital 3.

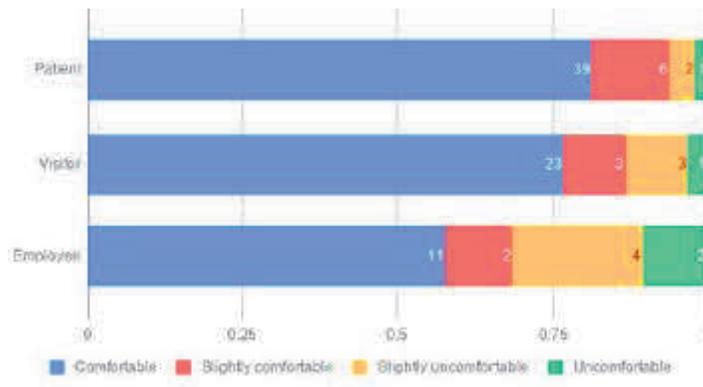
Figure 8: Level of comfort according to patients, visitors and employees in hospital 1.

Hospital 1: 24 employees were surveyed, 60 patients and 36 visitors. 43.8% of the employees were feeling (slightly) cool or cold (where only 12.5% felt slightly warm or hot); and a lot of employees felt draught (68.4%). Those two ways of expressing thermal discomfort are likely to be related. For people that are feeling cool, together with high turbulence intensities – draught can be a serious cause of discomfort, even at locations where no high values are measured for the air velocity.

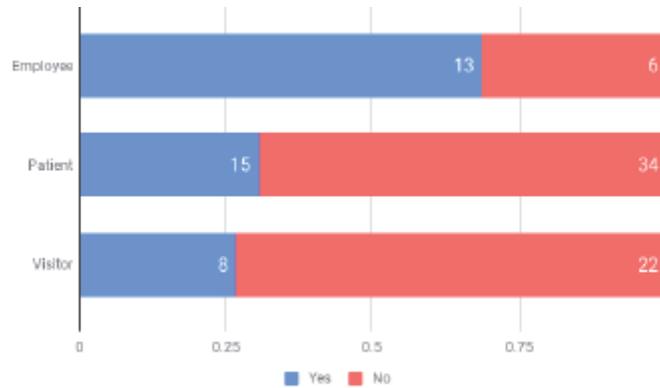
Figure 9: Perception of draught by employees, patients and visitors in hospital 1.

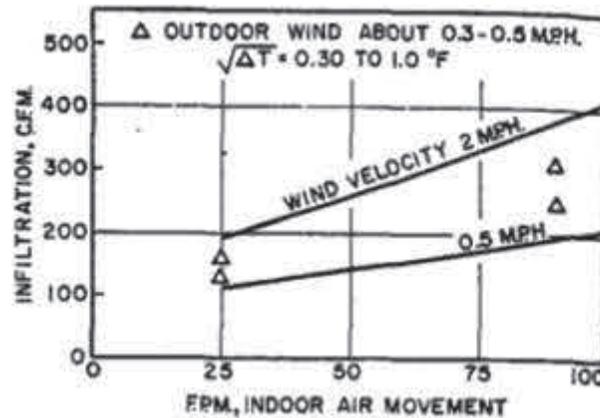
Figure 10: Effect of wind and indoor air movement on infiltration for small temperature differences and indoor speed of 5 rounds per minute [Humphreys et al., 1961].

The air infiltration when the door rotates depends on the type of revolving door, the rotation speed of the door, the size of the opening, the temperature differential and to a certain extent on the outdoor wind speed and direction and the air velocities indoors. Revolving the door causes an exchange of indoor air and outdoor air of approximately equal volume. If more people are entering, the infiltration decreases with about the volume of the people occupying the space in the revolving door. According to Humphreys et al. this impact is only small [Humphreys et al., 1961]. Figure 10 shows that a higher wind speed outside, and a higher indoor air velocity, lead to a higher infiltration rate.

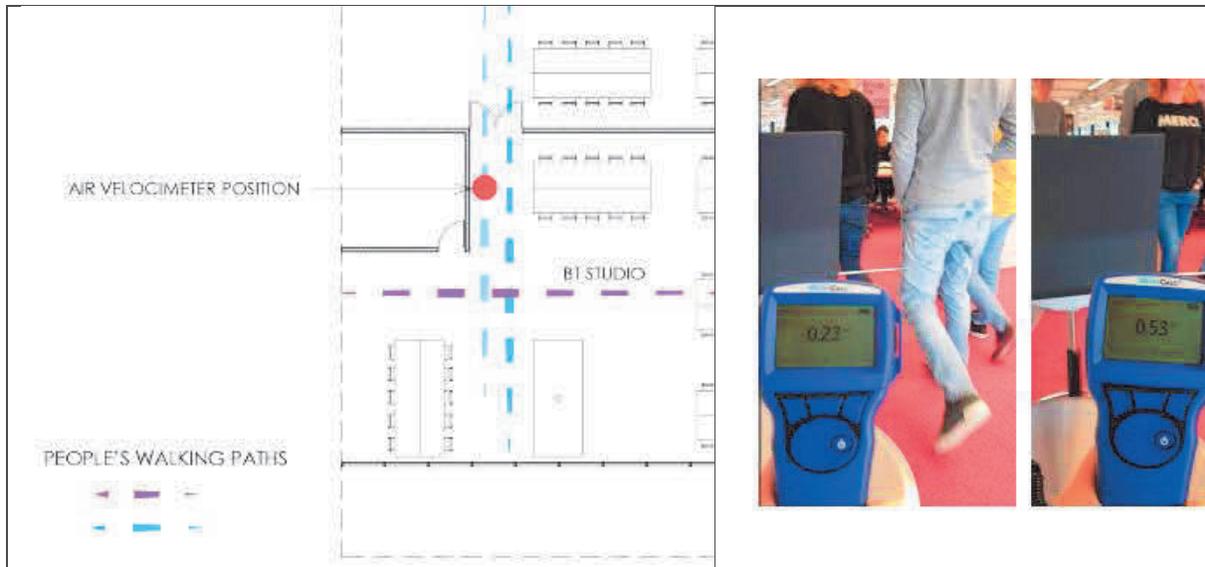
Figure 11: Building Technology Studie Floor plan, left, and group of four people walking from and towards the air velocity meter right [AR0125, 2019]

experiment was conducted is the hallway at the Building Technology studio. Figure 11 shows a scheme of how and where the experiment was conducted.

The air velocity in the hallway when there is no movement of people is 0.01 m/s, which means that there is practically no movement of air. Figure 11 shows the air velocity at the hallway when there is movement of a group of four people walking. In this case the air velocity is 0.23 m/s, measured when the group is walking by and 0.53 m/s, measured when the group is walking back. This experiment shows that when people move, they attract the air around them and that this follows the same path as the people moving. Therefore, it can be concluded that people's movement can be the cause of the air draught felt by the receptionist and the source of discomfort.
