Morphodynamic trends of the Ribb River, Ethiopia, prior to dam construction

Mulatu, Chalachew A.; Crosato, Alessandra; Moges, Michael M.; Langendoen, Eddy J.; McClain, Michael

2018

Geosciences (Switzerland)

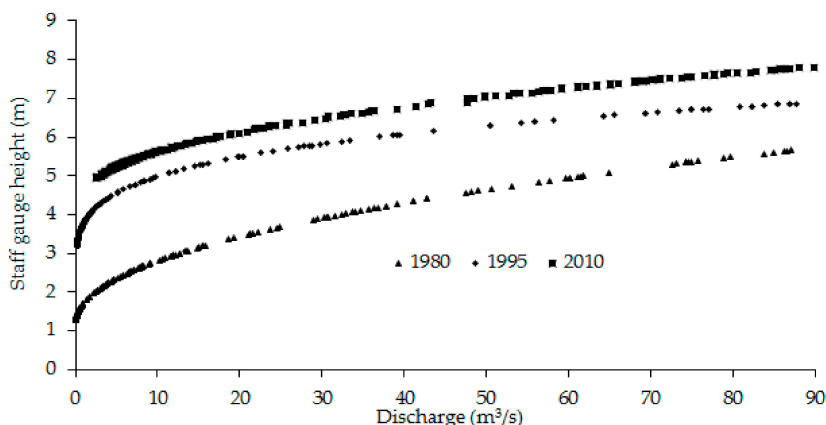
Figure 12. Ribb River staff level at the Lower gauging station with corresponding discharges (Data source: Ministry of Water, Irrigation and Energy, Ethiopia).

The time-series of daily water levels at the Lower gauging station shows that the riverbed rose by 2.2 m (14.7 cm/year) and 0.7 m (4.4 cm/year) between 1980 and 1995 and between 1995 and 2010, respectively, which is 2.9 m in 30 years (1980 to 2010) (Figure 12). Similarly, the nearby Gumara River bed rose by 2.91 m (6.3 cm/year) between 1963 and 2009 [18]. The adjacent Megech River to the north has similarly experienced sedimentation of the old channel downstream of a bifurcation since 1998 [23]. This means that sedimentation is observed in practically all rivers debouching in the Lake Tana from the Fogera plain.
