An assessment based on bow-ties

Chemical Engineering Transactions

Mechanical Integrity of Process Installations: an Assessment Based on Bow-Ties

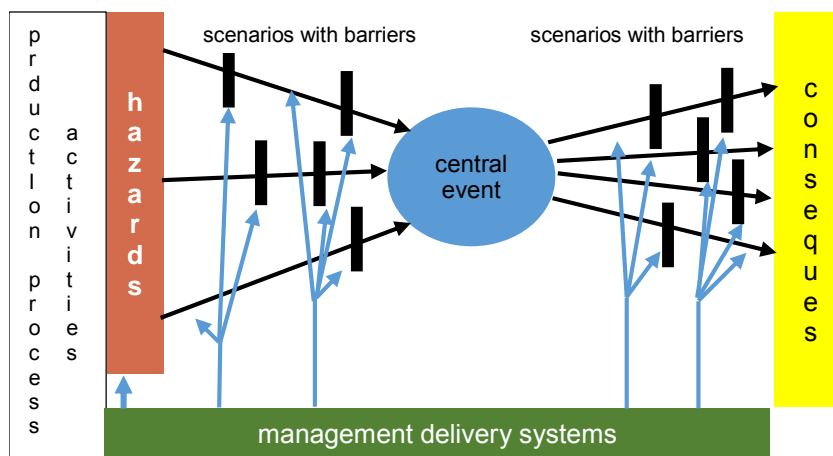
Figure 1: Bow-tie metaphor (Visser, 1998)

Bow-ties are appropriate and user-friendly for the mapping of scenarios (Chevreau et al., 2006, de Ruijter and Guldenmund, 2016). It is a metaphor for an accident process and shows the initiating event of a scenario, the consequences and the barriers that can stop the scenario from happening (Swuste et al., 2016). The simple, sequential design of bow-ties is strongly reminiscent of the 'Swiss cheese model' by Reason (1990) with the cheese slices as barriers. Figure 1 shows a bow-tie of which the explanation is included in a paper of Swuste et al., entitled "Process safety indicators, how solid is the concept?" and also published in the LP 2019 conference proceedings.
