Qi, Y., Qian, QK., Meijer, F., & Visscher, H. (2019). Identification of Quality Failures in Building Energy Renovation Projects in Northern China. *Sustainability*, 11(15), Article 4203. <https://doi.org/10.3390/su11154203>

# Identification of Quality Failures in Building Energy Renovation Projects in Northern China

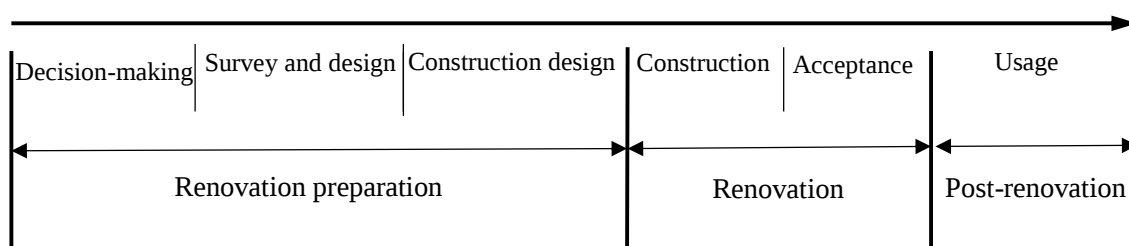
According to previous studies, complete building energy renovation processes are arranged with three stages, renovation preparation stages, renovation stages, and post-renovation stages [50]. These stages are divided into particular sub-stages, including a decision-making phase, survey, and design phase, construction design phase, construction phase, acceptance phase, and usage phase by the administrative regulations, as shown in Figure 1 [50].

**Figure 1.** The stages of renovation projects (Modified from Wu et al. [50]).

In the decision-making phase, the feasibility with renovating existing buildings is studied before building energy renovation projects are set up [51]. The major work is to judge the essentiality of building energy renovations and the local government determines which buildings will be renovated.

For the construction design phase, construction companies need to make construction plans to arrange construction resources, such as men, materials, and machines [53]. Moreover, the management plan for high construction quality also needs to be made by construction companies. The management plan is critical for stakeholders to avoid quality failures.

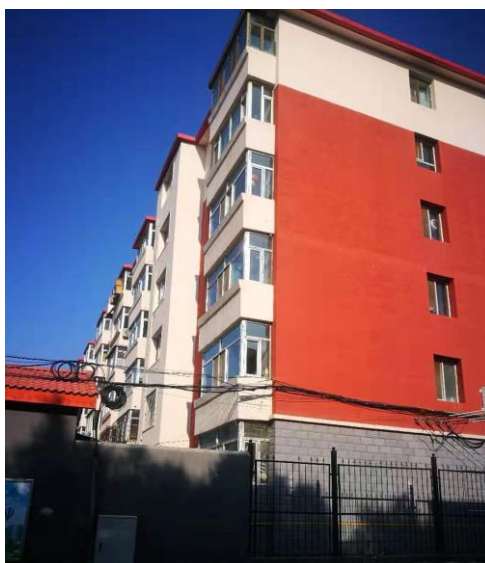
Figure 7. The residential building renovated in the case study (by the authors).

The five cases of building renovation projects were selected to be representative of the residential building renovation situations (Figure 7). They cover a broad diversity of different construction conditions such as location, contract value, renovation size, construction companies, supervision companies and the current status of building energy renovation projects (the details are illustrated in Table 1). The diversity of project characteristics is intended to know what and how quality failures occurred, based on their particular context and conditions.

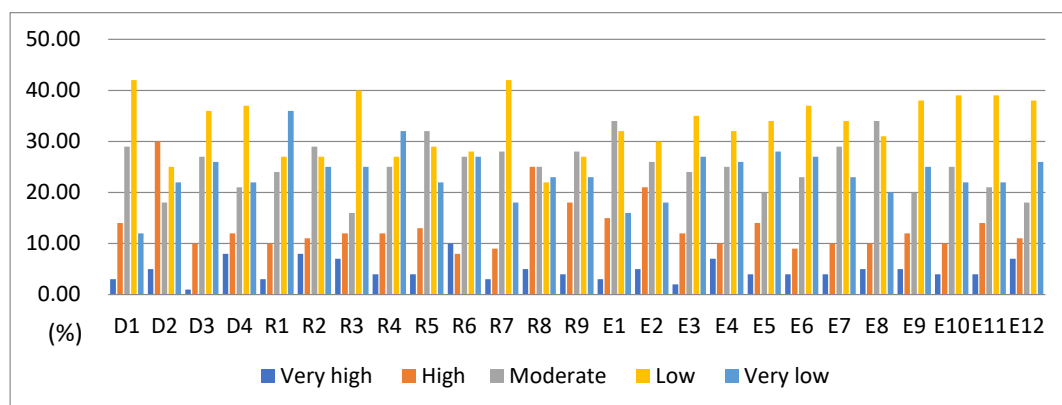
Table 6 and Figure 8 show the percentage of the respondents’ evaluation of the quality failures concerning the occurrence frequency according to the different linguistic variables.

**Figure 8.** The percentage graph of respondent evaluation of the quality failures.
