## Pyrolysis of Reclaimed Asphalt Aggregates in Mortar

International Journal of Technology

**Abstract.** Asphalt pavement consists of aggregates resulting in a waste material at end of its life. The aggregates can be reused as basic material for asphalt or cementitious binding agents. In both scenarios, the recycled aggregates should provide a good bond with the binder to achieve strength. This study focuses on reusing recycled asphalt aggregates (RAA) in mortar. The major weakness of RAA is the thin oily film originating from the asphalt residue, weakening the bond with cement. The pyrolysis method is accessed in an attempt to overcome this weakness. Three scenarios were investigated; the use of virgin aggregates (VA), RAA, and pyrolysis recycled asphalt aggregate (PRAA) as constituent in mortar. All variables were set a constant except for the aggregate type, the VA mortar function as controlling element. This research is methodologically based on experimental data conducted in the laboratory, while aggregate samples were taken from the field. To analyze the influence of pyrolysis to the aggregate-to-cement bond behaviour, qualitative and quantitative data were collected. The q

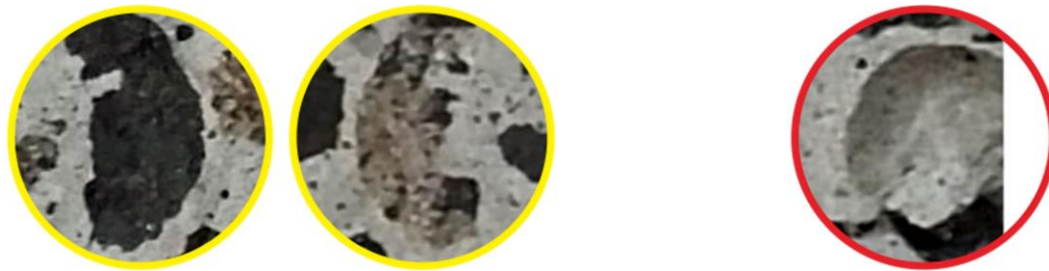
The data showed that the strength of RAA mortar is substantially lower than the strength of the VA mortar. At all ages, the ratio was 43% ~ 46%. This outcome underlined the findings of (Sola & Ozyazgan, 2017; Brand & Roesler, 2017a; 2017b; Abraham & Ransinchung, 2018; 2019a; Shi et al., 2020), where natural aggregates were gradually substituted by RAA. The findings of (Qiang et al., 2011) suggested that the asphalt film had a negative effect on the cement hydration process within the time frame of 80 hours, however, the data presented in Table 1 demonstrates that this effect had stabilized after 7 days. The pyrolysis procedure improved the performance of the aggregates, and the ratio in compression strength was in the range of 65% ~ 71% for all ages. The visual observation of the fracture plane demonstrated that failure was due to the bond loss between the aggregate and mortar, regardless of the mortar's age, and due to fracture of the outer layer of the aggregates for the RAA mortar (Figure 3). Figure 3a shows the fracture areas in the

aggregates' surface and Figure 3b shows the debonding of the interface. Debonding leaves a clean surface, while aggregate surface fracturing leaves a distinguishing mark in the cement paste.

a) Aggregate surface fracture

b) Interface debonding

**Figure 3** Visual observation of the fracture plane of RAA and PRAA mortar
