## Experimental method for investigating wear of porous thermal insulation systems exposed to realistic, hot, turbulent gas flow

# Experimental method for investigating wear of porous thermal insulation systems exposed to realistic, hot, turbulent gas flow

C. Reurings<sup>a,\*</sup>, S. Koussios<sup>a</sup>, O.K. Bergsma<sup>a,\*\*</sup>, K. Vergote<sup>b</sup>, L. Paeshuyse<sup>b</sup>, R. Benedictus<sup>a</sup>

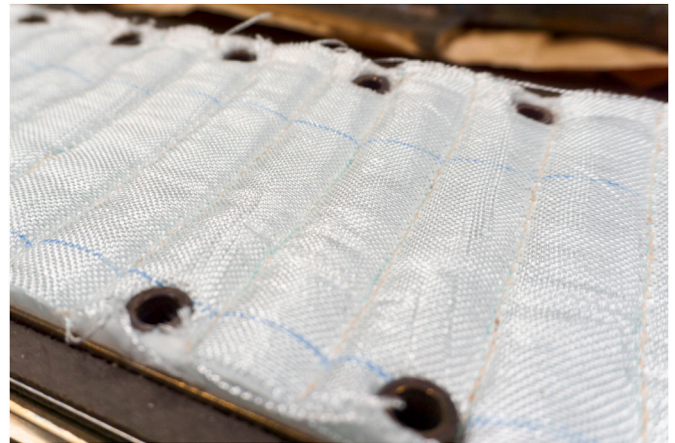
**Fig. 10.** Example of sample mounting: locally, the liner is mechanically connected to the bottom.

Figs. 8 and 9 show a mounting method that requires no modifications of the bottom part of the test rig, namely using a fabric liner held down by a metal mesh that spans the surface. This method offers the possibility to determine the influence of surface elements and of varying degrees of mechanical support on the wear by varying the mesh wire thickness and wire pitch. Another option is to connect the liner to another fabric underneath the insulation and adhere that to the bottom, as shown in Fig. 10.

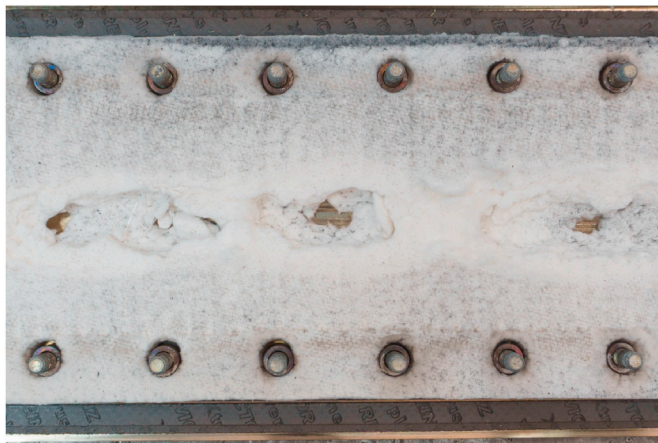
Fig. 14. Distributed insulation damage, photograph taken from the flow side with the liner removed.

In most cases however, the tested insulation systems had distributed insulation damage, which is the type that can be better correlated with the mass change. Fig. 14 shows an example. With such extensive wear, the mass change can be corrected for the presence of shot chunks in the worn region, as they remain as residue at the bottom of the sample container. This can be done by determining their mass separately after

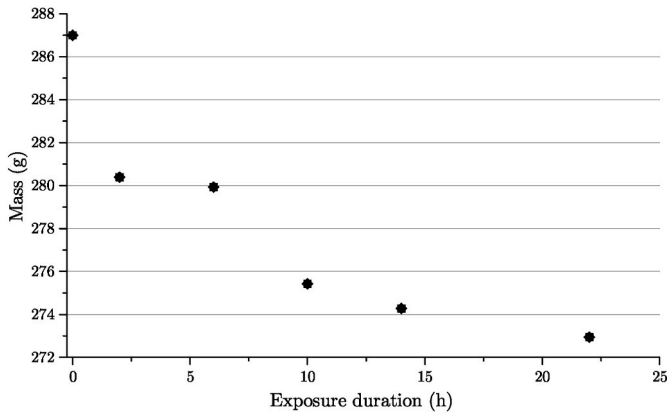
Fig. 17. Sample mass as a function of exposure time for a sample with un-aged insulation and thermally pre-aged liner exposed to combustion engine flow ( $T = 760\text{ }^{\circ}\text{C}$ ,  $Re_b = 3.5 \cdot 10^4$ )

Representative graphs of mass change with exposure time for several fibrous insulation systems are shown in Figs. 15–17. Error bars indicating the uncertainty, see Appendix A, are included. It is assumed that the gaskets and test rig do not change in mass.

Despite the difference in ageing, for all three samples of this insulation system, the observed mass change is of the order of a few percent of the sample mass. After an initial relatively large decrease the sample mass decreases more slowly with increasing exposure duration. This insulation system has blankets of amorphous ceramic fibre that contain manufacturing related residue called ‘shot’. Compared to the average fibre diameter, these chunks of shot are huge and under pressure variations, the difference in inertia will very likely stress nearby fibres. One hypothesis on the initially larger mass decrease is that it results from the larger shot elements breaking loose and falling through the network early on.
