Effect of moisture on the adhesion of CFRP-to-steel bonded joints using peel tests

Brazilian Society of Mechanical Sciences and Engineering. Journal

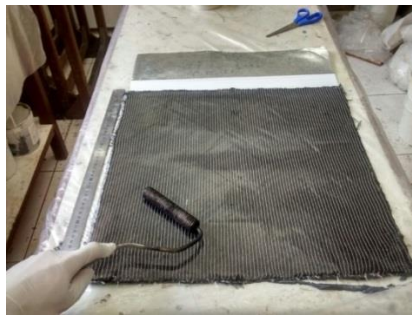
Fig. 1 Carbon fiber lamination process

41 The composite-to-metal bonded joint test specimens were manufactured by the same
42 process used in composite patch repairs of oil and gas production platforms [29-30]. The
43 carbon steel plate was blasted with G-40 steel shot and then degreased using acetone. The
44 final surface roughness measured was 12.26 μm root mean square deviation (Rq) and
45 76.12 μm total height of the roughness profile (Rt). The epoxy resin NVT201E® was then
46 applied over the treated steel plate surface. Afterwards, the lamination process started by
47 alternating application of carbon fiber fabric layers and the impregnation resin PIPEFIX®,
48 as shown in Figure 1. Six plies of carbon fiber were used to produce the composite with a
49
50
51
52
53
54
55
56
57
58
59
60
61
62
63
64
65

final layup of $[0/90]_6$. This means that the CFRP is oriented alternatively at the specimen longitudinal and transverse direction. The curing process was performed at room temperature for 2 hrs. One layer of glass fiber dry chopped strand mat (300 g/m^2) was used between epoxy adhesive and carbon fiber fabric layer to avoid direct contact between carbon fiber and steel plate. The mechanical properties of the composite laminate and adhesive were determined in a previous work [28].

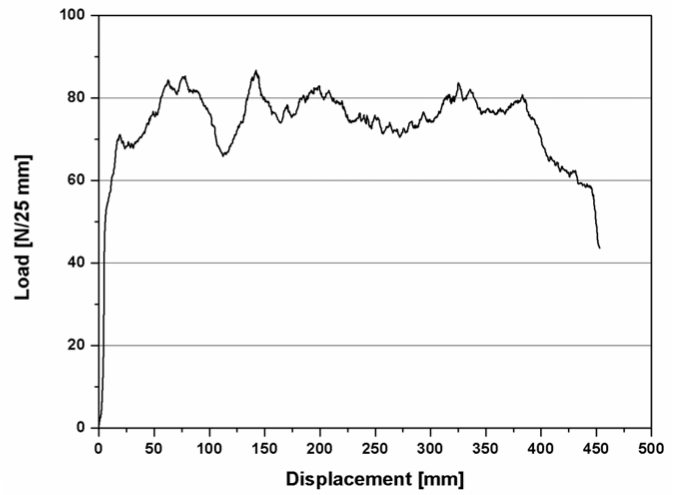
Fig. 7 Representative curves of dry specimens with: a) 250 mm length; and b) 500 mm length

10
11 The average peel load of 63.2 ± 11.8 N/25 mm was measured for non-aged specimens
12 (500 mm length) tested in the present work. While in previous work [28] similar
13 specimens with 250 mm length were tested and an average peel load of 73.6 ± 1.2 N/25
14 mm was determined along 150 mm length. Increasing the length of the specimen
15 promoted an intensification in the discrepancies of test results. This may be caused by an
16 increase in defects originated from specimens manufacture. Moreover, the salt spray
17 ageing process used in [28] generated consistent results in 90 days while the same results
18 were not reached in 150 days ageing in salt water.
19
20
21
22
23
24
25
26
27
28
29
30
