## Post-buckling behavior and collapse of Double-Double composite single stringer specimens

Composite Structures

This paper presents the work on six single-stringer specimens manufactured using the card-sliding technique with non-crimp fabrics and adopting a Double-Double (DD) stacking sequence. These specimens, representative of sub-structure level components, are used to investigate post-buckling and failure in aerospace structures. Two specimens maintain a constant thickness cross-section, while four are tapered, two of which incorporate a Teflon insert in the stringer flange. All specimens are tested under compression loading conditions, inducing skin buckling, skin-stringer separation, and eventual collapse. Numerical simulations are validated by experimental results and serve to analyze the specimens behavior and the failure mode. The load versus displacement curves of both experimental tests and Finite Element Method (FEM) analyses are compared, along with the out-of-plane displacement field. Subsequently, the observed failure modes are discussed, focusing on the various mechanisms that occurred and considering the impact of flanges and stiffener tapering. Both the FEM sim

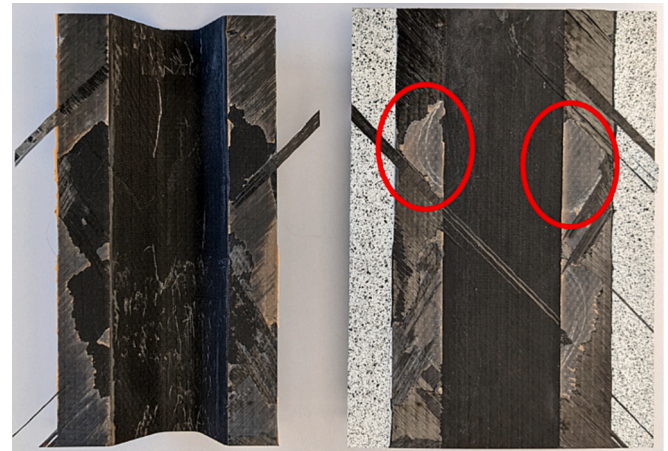
Fig. 13. Control1 Specimen Fracture Surface.

Fig. 13 illustrates the fracture surface of the Control1 specimen, attained by the tabs and forcing the complete separation of the hat and stringer post-test. The two highlighted red circles indicate the failed bonding parts in the flange leading to the collapse of the single stringer specimen. Particularly, the right circle corresponds to the first part that failed (see Fig. 10(a)). The fracture surface examination reveals adhesive failure, indicating suboptimal adhesion between the adhesive and composites. This could result from multiple factors involved in the adhesive joint preparation process, and likely underlies the unique force

vs. displacement curve exhibited by the Control1 specimen. Pre-testing C-Scan inspection, however, showed no abnormalities in any specimens. Fig. 14 presents the C-Scan inspection performed at 65 kN (left) and 70
