Foulant Identification and Performance Evaluation of Antiscalants in Increasing the Recovery of a Reverse Osmosis System Treating Anaerobic Groundwater

2022

Membranes

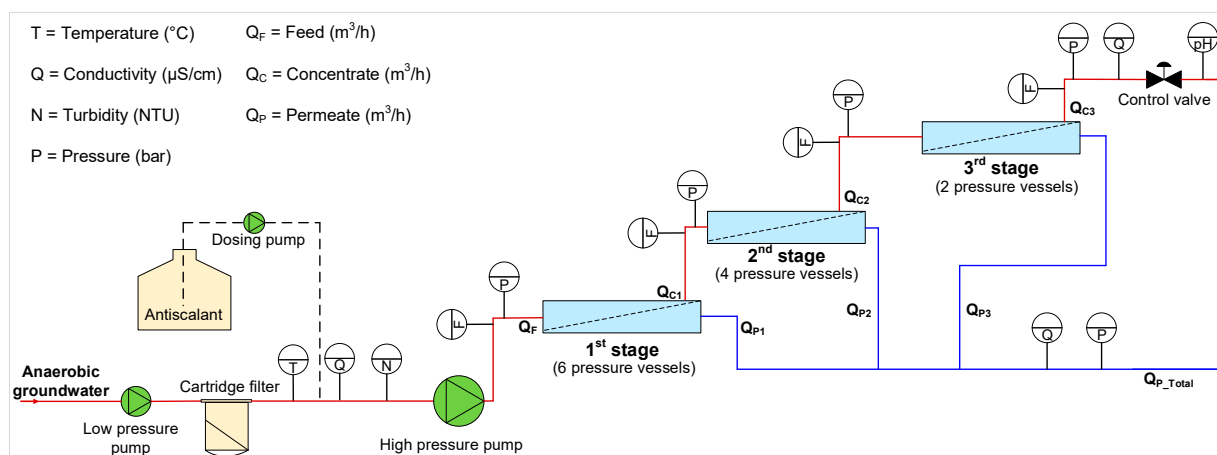
Figure 1. Schematic representation of the RO pilot installation in Kamerik [36].

Figure 1 depicts a schematic representation of the RO pilot plant. The RO installation had three stages where the pressure vessel configuration for each stage could be varied. Each pressure vessel contained three hydraulics membrane elements (ESPA2-LD-4040). The anaerobic GW (feedwater) was passed through a cartridge filter (10 µm) and then fed to the RO unit. The RO installation was operated at constant permeate water production. To assess the occurrence of scaling, the average normalized (temperature corrected) permeability (K_w , Equation (S1)) of the last stage was monitored.

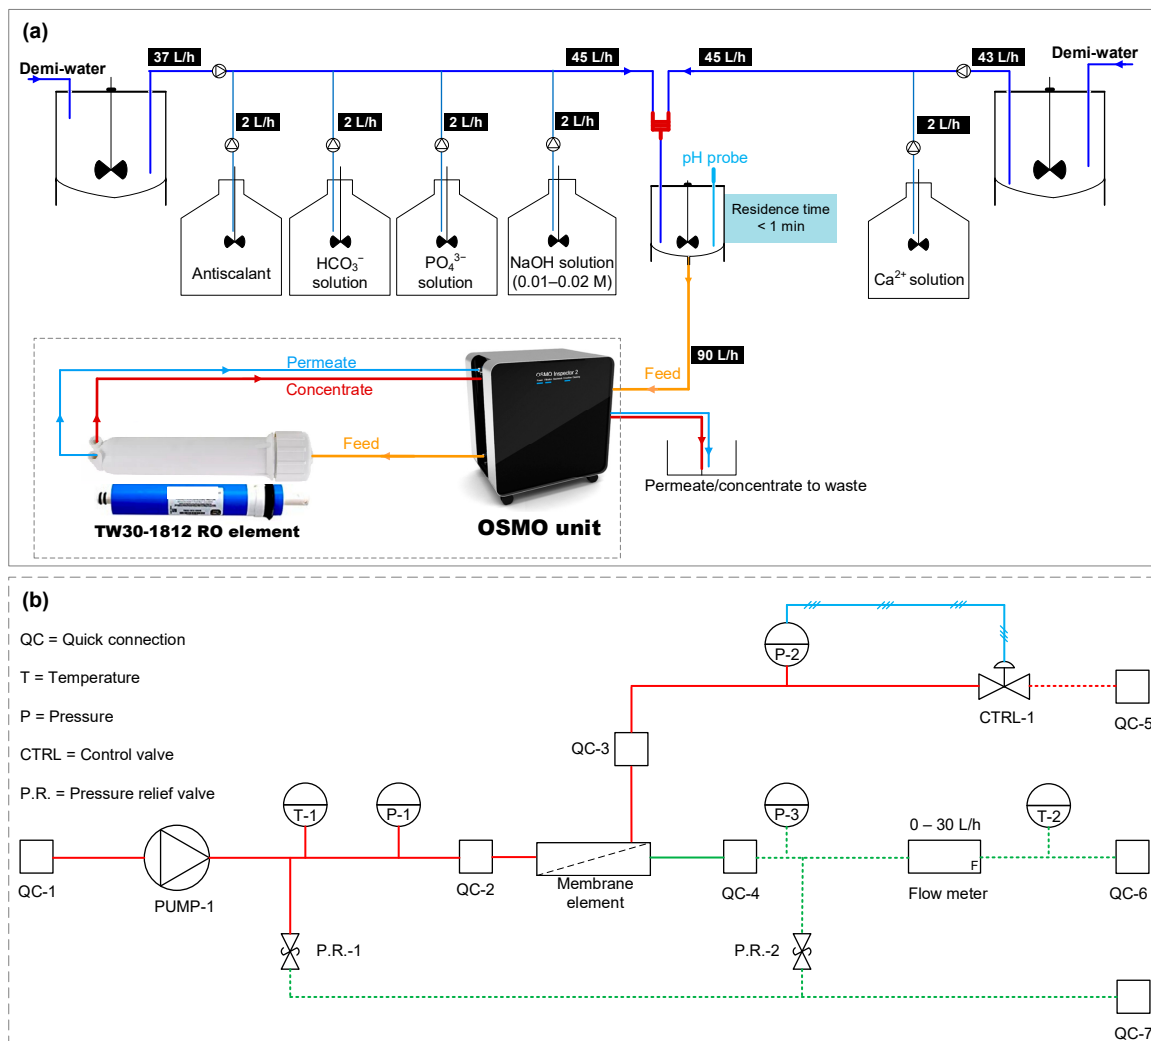
Figure 2. (a) Once-through lab-scale RO setup for testing the performance of antiscalants. (b) Piping and instrumentation diagram of the OSMO unit with the RO element [26].

An OSMO inspector unit (Convergence Industry B.V., the Netherlands) was used to feed the synthetic concentrate solution to a TW30-1812-50 RO element (OsmoPure Water Systems). An Atrato ultrasonic flow meter was installed in the OSMO unit, which could measure permeate flow rates ranging from 0.12 L/h to 30 L/h. A new TW30-1812-50 RO element was used in each experiment.

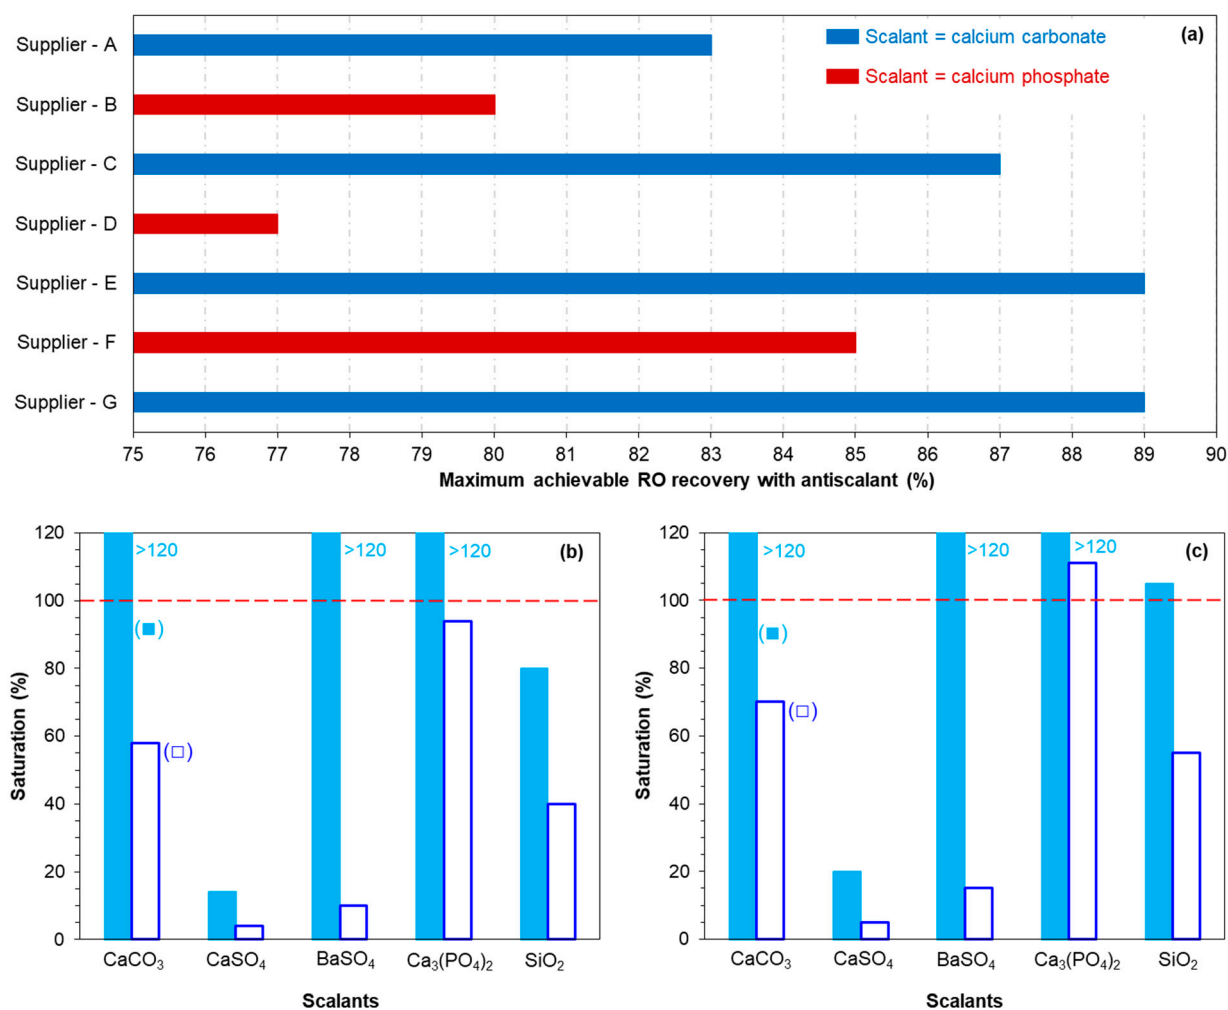
Figure 3. (a) Maximum achievable recovery of the RO unit in the presence of antiscalants determined with the projection programs of various antiscalant suppliers. (b) Scaling potential of commonly encountered scalants at 80% recovery of the RO unit (■) in the absence of antiscalant, and (□) in the presence of antiscalant. (c) Scaling potential of commonly encountered scalants at 85% recovery of the RO unit (■) in the absence of antiscalant, and (□) in the presence of antiscalant. (b,c) are determined with the projection program of supplier B.

Figure 3a shows the maximum achievable recoveries in the presence of antiscalants for the RO unit, which were determined by the projection programs of seven different antiscalant suppliers. As can be seen, the recommended maximum achievable RO recovery was different for all the projection programs of the antiscalant suppliers. In addition, the scalant compound, which may limit RO recovery, was not the same, according to the projection programs of different suppliers. For instance, according to the projection programs of suppliers A, E, C, and G, recovery of the RO unit was limited due to calcium carbonate scaling, while calcium phosphate scaling was limiting RO recovery according to suppliers B, D, and F. The maximum achievable RO recovery (limited due to calcium carbonate) was 89% according to suppliers E and G, and 83% and 87% according to suppliers A and C, respectively. The maximum achievable RO recovery (limited due to calcium phosphate) was 77%, 80%, and 85% according to suppliers B, D, and F, respectively. From Figure 2a, one can clearly recognise that the projection programs of the antiscalant suppliers are not consistent in identifying the maximum RO recovery.

Figure 3b,c present the scaling tendency (performed with the projection program of supplier B) of some commonly encountered scalants in the RO concentrate at 80 and 85% recovery, respectively. The scaling tendency of the RO concentrates at 80 and 85% recoveries is presented because the RO pilot, in this study, was operated initially at 80% recovery and then at 85% recovery. The scaling tendency is shown both with and without the addition of antiscalant to the RO feed.

The projection program of supplier B advised that at 80% recovery without antiscalant, the RO unit may experience calcium carbonate, barium sulphate, and calcium phosphate scaling, while with the addition of antiscalant to the RO feed, none of the mentioned scalants will precipitate in the RO unit. Furthermore, at 85% recovery with no antiscalant, the program indicated that silica may also precipitate together with calcium carbonate, barium sulphate, and calcium phosphate. The program suggested that, with the addition of antiscalant, calcium carbonate, barium sulphate, and silica may not precipitate in the RO unit at 85% recovery, while calcium phosphate may precipitate even with the addition of antiscalant.

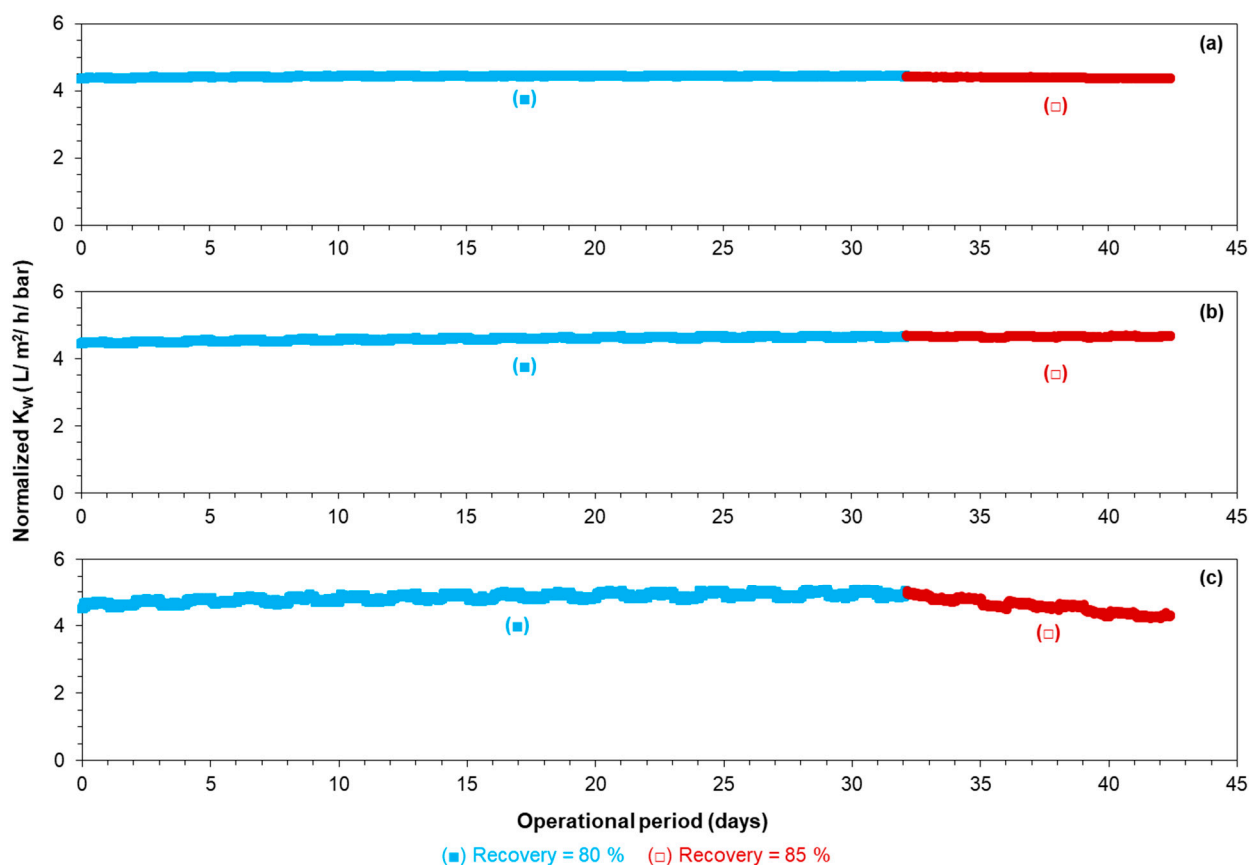
Figure 4. Average normalized permeability of the (a) first stage, (b) second stage, and (c) third stage of the RO unit at 80 and 85% recoveries without antiscalant addition.

Figure 4 presents the average normalized permeability of the first, second, and third stages of the RO unit at 80–85% recoveries when no antiscalant was added to the RO feed.

At 80% recovery without antiscalant, the normalized permeability remained constant, where calcium carbonate, barium sulphate, and calcium phosphate had the tendency to scale the RO unit, according to the projection program of supplier B. On the other hand, at 85% recovery, the normalized permeability of the last stage decreased in the absence of antiscalants. At 85% recovery, the normalized permeability of the second stage remained constant, where the total recovery of the first and second stages was approximately 77%. As no decrease in membrane permeability of the last stage at 80% recovery without antiscalant was observed, it was expected that permeability would remain constant at 77% recovery.

Surprisingly, the average normalized permeability of the first stage with a recovery of 52% had a slight decreasing trend (with a—0.005 slope). The slight decrease in the first stage may not be due to the deposition/precipitation of newly formed particles/crystals. It could be that the RO feed contained particles that were deposited in the first stage and caused permeability decline. To understand what compounds caused permeability decline in the third stage and in the first stage, the tail elements of the mentioned stages were taken out for autopsy.

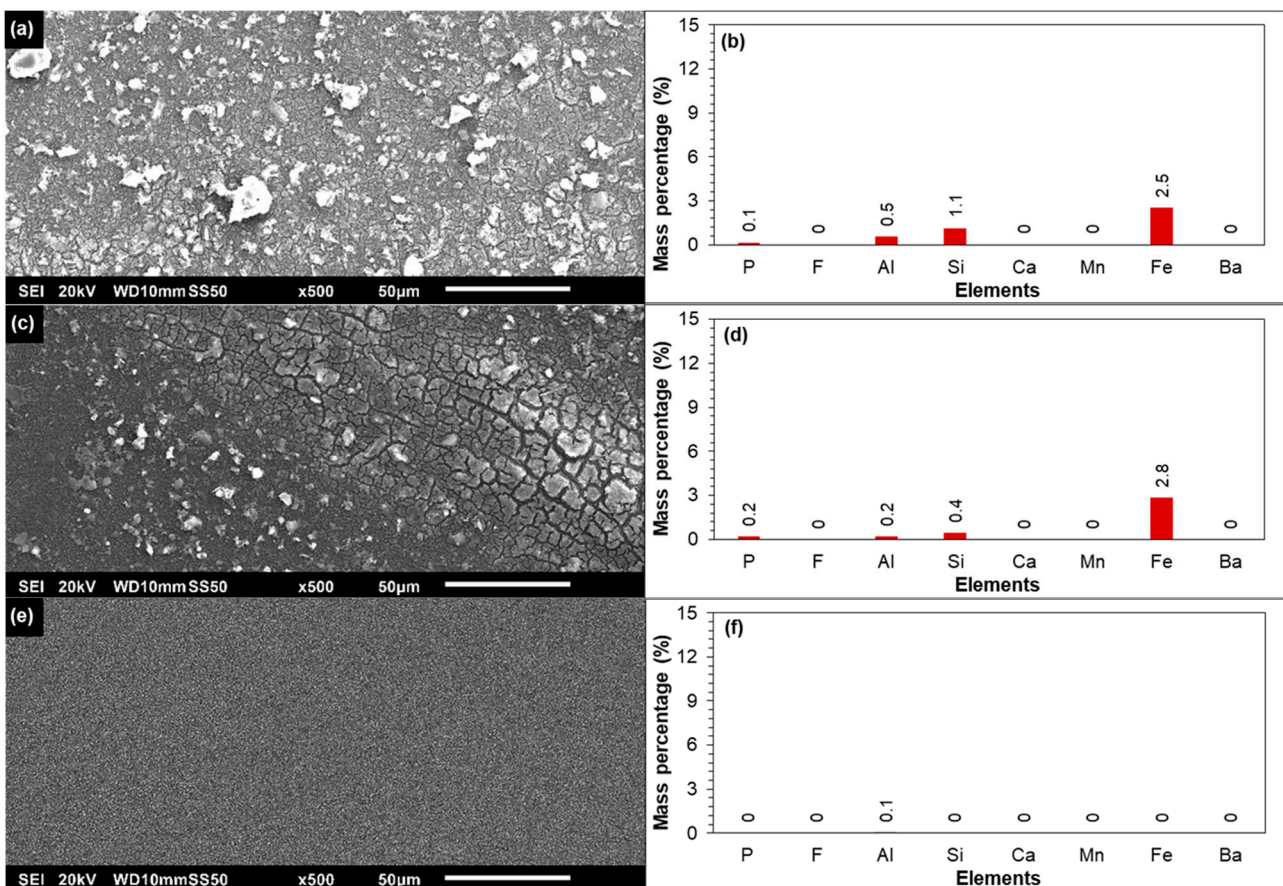
Figure 5. (a) SEM and (b) EDX analyses of the tail element of the first stage with decreased permeability. (c) SEM and (d) EDX analyses of the tail element of the first stage cleaned with a 0.05 M NaOH solution. (e) SEM and (f) EDX analyses of the tail element of the first stage cleaned with a 0.05 M HCl solution.

The SEM and EDX analyses of the tail element of the first stage (with decreased permeability) are presented in Figure 5a,b, respectively. The SEM picture showed that the membrane surface was covered by deposits. The EDX results in Figure 5b indicated that the deposited material on the membrane surface consisted of aluminium, silicon, and iron. In the EDX analysis (Figure 5b), only those elements that are not part of the membrane material are presented. The presence of aluminium and silicon on the membrane surface could be attributed to clay particles that might be present in the RO feedwater that were not retained by the 10 µm cartridge filter. The presence of iron may be related to the deposited clay particles, as iron may be present in the composition of the clay particles, and/or to the iron oxide particles that may be present in very low concentrations in the RO feed.

Figure 5c,d present the SEM image and the EDX of the membrane cleaned with 0.05 M NaOH solution, respectively. It was observed that the NaOH solution was unable to remove the deposited particles from the membrane surface, and the layer (after cleaning) still consisted of aluminium, silicon, and iron. On the other hand, the deposited particles disappeared when the membrane was stirred in 0.05 M HCl solution (Figure 5e). In the EDX analysis (Figure 5f), no aluminium, silicon, and iron were detected. This showed that the deposited layer was removed with HCl solution. At this point, it was not clear if the deposited particles were dissolved in the HCl solution and/or were detached from the membrane surface due to mechanical forces.

In brief, based on the SEM-EDX results of Figures 5 and 6, it may be concluded that the deposition of clay and iron oxide particles (present in the RO feed) were contributing to the slight permeability decline of the first stage.

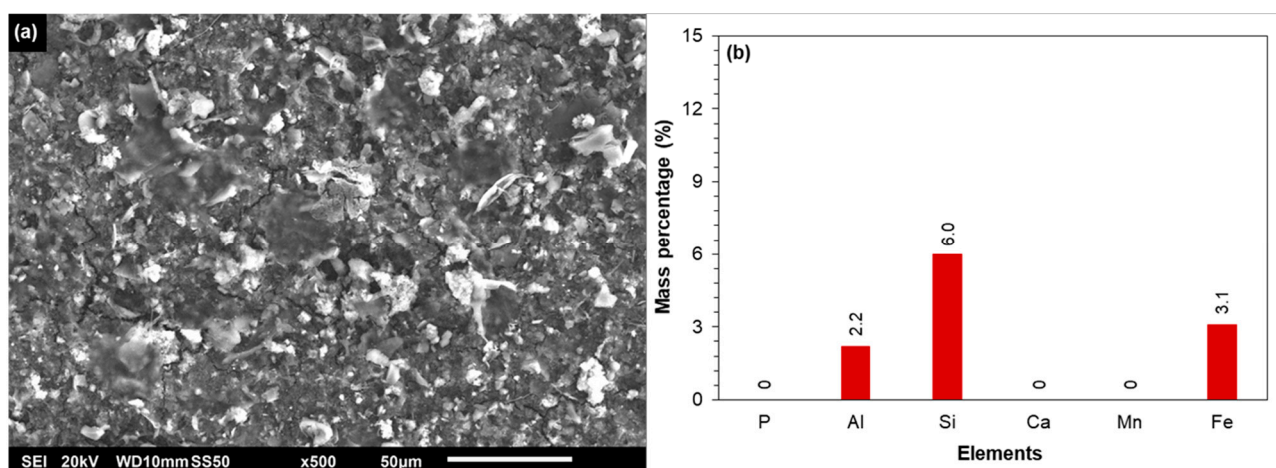
Figure 6. (a) SEM image and (b) EDX analysis of the 0.45 μm filter after filtration of the 0.05 M HCl solution (of the tail element of the first stage).

In Figure 6, the SEM-EDX analysis of the retained deposits on the 0.45 μm filter (after filtering the 0.05 M HCl cleaning solution) is shown. As can be seen, the retained deposits consisted of aluminium, silicon, and iron suggesting that clay particles from the membrane surface were not dissolved in the HCl solution, but actually were detached from the membrane surface. Figure 6b also indicated that a part of the iron on the membrane surface of the tail element of the first stage (Figure 5a,b) could be linked to clay particles, since if all iron was present as iron oxides, then it should have been dissolved in 0.05 M HCl solution. In Figure 6b, the mass percentage of iron (on the filter surface) was approximately half the mass percentage of silicon. However, in Figure 5b, the mass percentage of iron on the membrane surface of the tail element of the first stage was higher than silicon. This may indicate that the additional mass percentage of iron in Figure 5b could be due to the iron oxide particles.

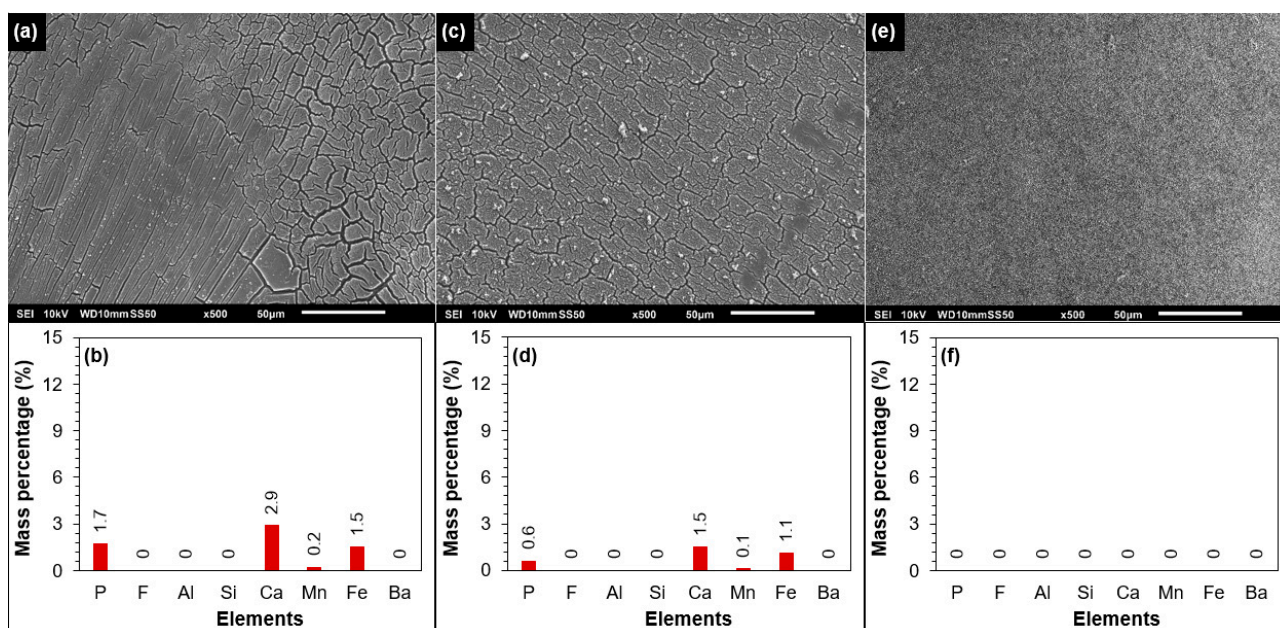
Figure 7. (a) SEM and (b) EDX analyses of the fouled tail element of the third stage. (c) SEM and (d) EDX analyses of the tail element of the third stage cleaned with 0.05 M NaOH solution. (e) SEM and (f) EDX analyses of the tail element of the third stage cleaned with 0.05 M HCl solution.

In Figure 7a,b, SEM-EDX analysis of the fouled/scaled RO membrane of the tail element of the third stage is shown. As can be seen, the membrane surface apparently was covered with an amorphous layer. According to the EDX analysis, the foulant was composed of calcium, phosphorous, and iron. A small mass percentage of manganese could also be observed. In the EDX analysis, aluminium and silicon were not observed on the membrane surface, which suggested that clay particles did not contribute to the permeability decline of the third stage at 85% recovery. According to the antiscalant projection program of supplier B (Figure 3c), calcium carbonate, barium sulphate, calcium phosphate, and silica have the potential to scale the RO at 85% recovery in the absence of antiscalant. As silica was not observed on the membrane surface in the EDX analysis

(Figure 7b), it can be concluded that silica scaling did not occur in the RO unit at 85% recovery without antiscalant.

Furthermore, barium sulphate scaling did not occur at 85% recovery, as barium was not present on the fouled membrane surface (Figure 7b). Based on a study by Boerlage, et al. [37] where they reported that barium sulphate has very slow precipitation kinetics and its precipitation is hindered by humic substances (HS), it was expected that the barium sulphate scale would not occur in the RO unit in Kamerik. In the anaerobic groundwater of Kamerik (RO feed), the concentration of HS was approximately 5.3 mg/L (Table 1), which might inhibit barium sulphate scaling in the RO unit. Several researchers [38–42] have reported that HS significantly hinder the formation of calcium carbonate. Also, in a study by the current authors [36], it was demonstrated that HS, as well as the phosphate present in the GW, were able to inhibit calcium carbonate scaling in the RO unit in Kamerik. We showed that due to the presence of HS and phosphate, the induction time of the real RO concentrate at 80% recovery was longer than 7 days, whereas at the same supersaturation level in the absence of phosphate and HS, the induction time of the synthetic RO concentrate of 80% recovery was around 1 h. Due to the long induction time (>168 h) of the RO concentrate of 85% recovery in the absence of antiscalants (Figure S1), it is also expected that calcium carbonate scaling would not occur at 85% recovery when antiscalants are not added to the RO feed. In the XRD analysis (Figure S2), calcium carbonate crystals were not detected, which also indicates that calcium carbonate scaling was not the reason for the permeability decline in the last stage, as seen in Figure 4c.

In Figure 7b, the mass percentage of calcium and phosphorous on the membrane surface could be attributed to (amorphous) calcium phosphate scaling, which was also predicted by the projection programs of suppliers B, D, and F (Figure 3a). However, the presence of iron on the fouled membrane is not clear. As aluminium and silicon were not observed on the fouled membrane of the third stage (Figure 7a), the presence of iron could not be due to clay particles. One may suggest that the presence of iron on the membrane could be due to the presence of iron oxide particles in the RO feed. The presence of iron (and also of calcium and phosphorous) on the fouled membrane is elucidated via XPS analysis later.

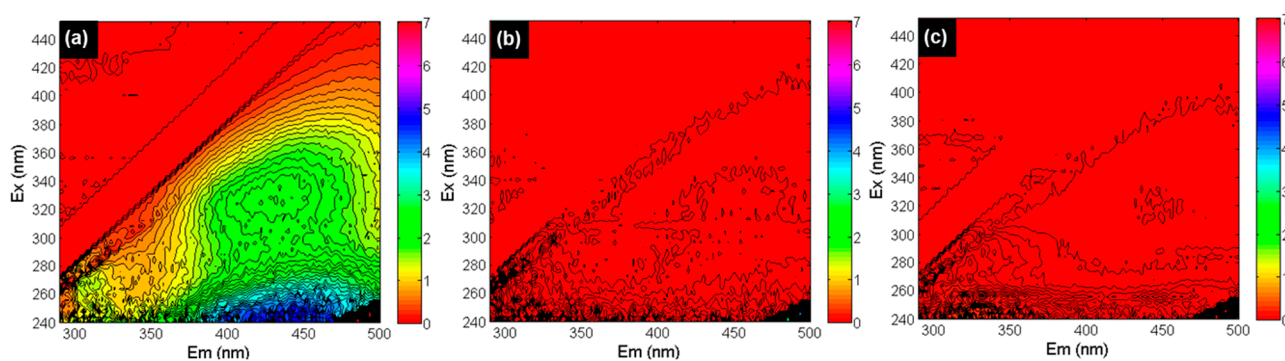
**Figure 8.** FEEM analysis of the (a) RO concentrate at 85% recovery, (b) 0.05 M NaOH cleaning solution, and (c) 0.05 M HCl cleaning solution (Ex and Em represent excitation and emission wavelengths).

In Figure 8, fluorescence excitation-emission matrix (FEEM) analysis of the RO concentrate (at 85% recovery) and the HCl and NaOH cleaning solutions of the tail elements of the third stage are shown. In this study, the locations of the EEM peaks of humic acid (HA) and fulvic acid (FA) were based on the EEM regions reported by Chen et al. [48]. The HA peaks were observed in the 380–500 and 250–400 nm emission and excitation wavelength ranges, respectively, while the 380–400 and 200–250 nm emission and excitation wavelength ranges, respectively, were attributed to FA [48].

As illustrated in Figure 8a, peaks for both HA and FA (with high intensity) were observed in the RO concentrate, which verifies the presence of HS in the anaerobic GW. However, HA and FA peaks were not visible in the cleaning solutions of the tail element of the third stage, as shown in Figure 8b (NaOH solution) and Figure 8c (HCl solution). The absence of HA and FA peaks in the HCl and NaOH solutions suggests that HS were likely not responsible for the permeability decline of the third stage of the RO unit in Figure 4c.

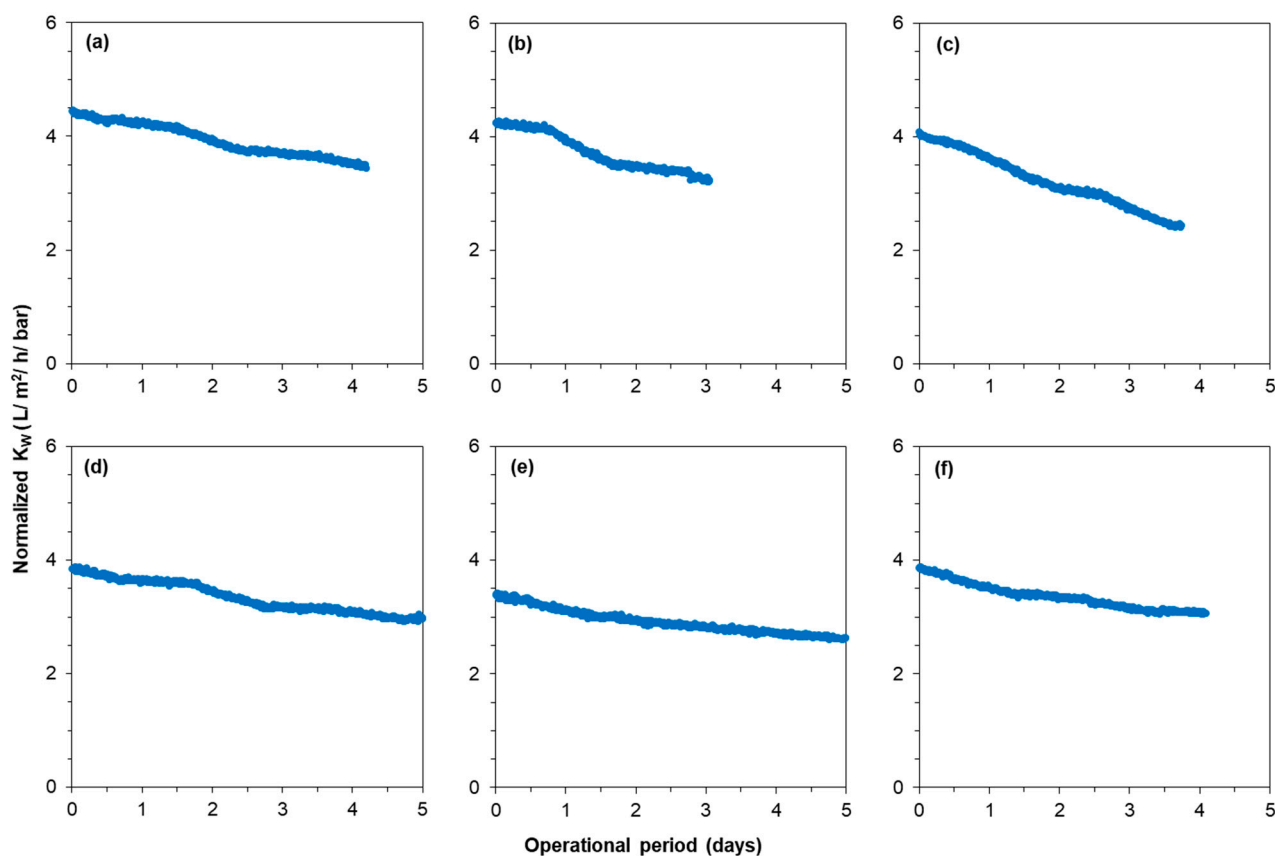
Figure 9. Average normalized permeability of the last stage of the RO unit at 85% recovery (a) without antiscalant, (b) with 2.5 mg/L AS-1, (c) with 2.5 mg/L AS-2, (d) with 2.5 mg/L AS-3, (e) with 5 mg/L AS-4, and (f) with 5 mg/L AS-5.

Figure 9 shows the average normalized permeability of the third stage of the RO unit at 85% recovery in the absence and presence of the five tested antiscalants. As can be seen, none of the antiscalants could prevent the permeability decline of the third stage. After operating the RO unit with antiscalant (AS-5), the tail element of the third stage was examined with SEM-EDX, and the results were similar to those shown in Figure 7. It is worth mentioning that the permeability of the third stage also decreased at 83% recovery in the presence of antiscalants (Figure S5). The RO operation at 81 and 82% recovery was not investigated.

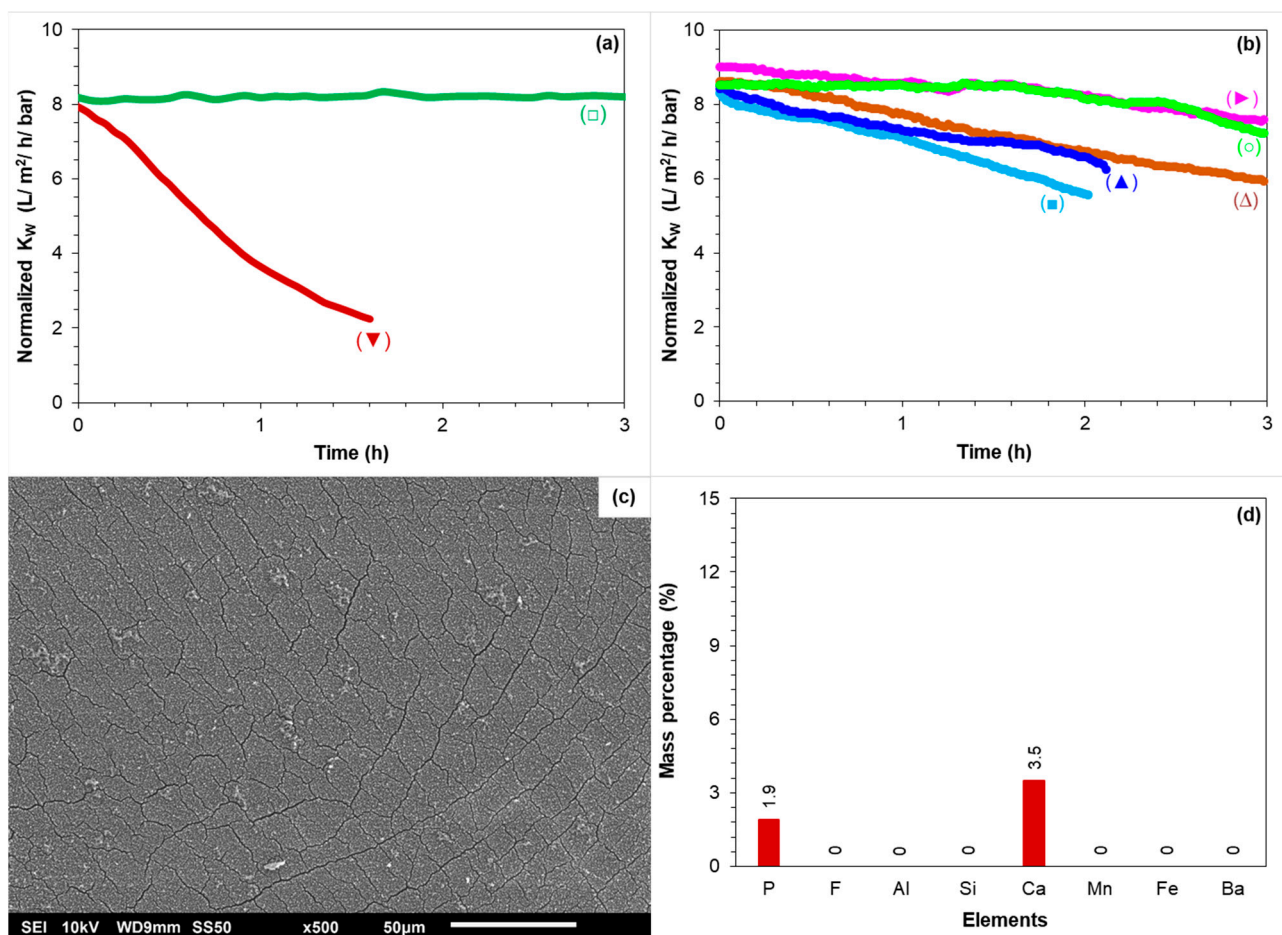
Figure 10. (a) Normalized K_w of the small RO element when fed with the synthetic concentrates of (□) 80% recovery without antiscalant and (▼) 85% recovery without antiscalant. (b) Normalized K_w of the small RO element when fed with the synthetic concentrates of 85% recovery with 33.3 mg/L of (■) AS-1, (▲) AS-2, (○) AS-3, (△) AS-4, and (▶) AS-5. (c) SEM image of the membrane surface fouled with calcium phosphate without antiscalant addition. (d) EDX analysis of the membrane fouled with calcium phosphate without antiscalant addition.

Figure 10a shows the normalized permeability of the TW30-1812-50 membrane element when fed with the synthetic concentrates of 80 and 85% recoveries in the absence of antiscalants (see Table 4 for the testing conditions). As can be seen, the normalized permeability of the membrane remained constant when fed with the synthetic concentrate of 80% recovery. This result is consistent with the RO pilot results (Figure 4c), where the normalized permeability in the third stage remained constant at 80% recovery without antiscalant. On the other hand, when the membrane element was fed with the synthetic concentrate of 85% recovery, the normalized permeability decreased sharply, as illustrated in Figure 10a. This result also verifies that calcium phosphate was one of the scalants that caused permeability decline of the third stage of the RO pilot in Figure 4c. A SEM image and an EDX analysis of the membrane with decreased permeability (Figure 10a) are given in Figure 10c,d, respectively. As can be seen, the membrane surface was covered with an amorphous layer (verified with XRD analysis (Figure S6)) of calcium phosphate particles. In the EDX analysis, the mass percentage of fluoride, aluminium, silicon, manganese, iron, and barium was zero, which was because they were not present in the synthetic concentrate of 85% recovery.

Figure 10b shows the normalized permeability of the RO when fed with the synthetic concentrate of 85% recovery in the presence of 33 mg/L (equivalent to 5 mg/L dose in the RO feed) of various antiscalants. The normalized permeability decreased by at least 10% with each antiscalant in a 3 h experimental period, indicating that none of the antiscalants could prevent calcium phosphate scaling. From Figure 10b, one can also observe that the poor performance of the antiscalants in preventing the permeability decline of the third stage of the RO unit in Figure 9 was not (mainly) due to the presence of a high concentration of iron (II). The permeability of the small RO element in Figure 10b decreased more sharply than the permeability of the third stage of the RO unit in Figure 9. One possible explanation is that the supersaturation level of calcium phosphate in the synthetic RO concentrate was slightly higher than that of the real RO concentrate because the once-through lab-scale RO experiments were performed at room temperature (approximately 22 °C), whereas the RO concentrate was at around 12 °C. Furthermore, Figure 9 shows the average permeability of three membrane elements, implying that the actual permeability decline of the last element of the RO unit could be sharper than the ones of third stage shown in Figure 9.
