**Effectiveness of community-based mangrove management for coastal protection  
A case study from Central Java, Indonesia**

Ocean and Coastal Management

# Effectiveness of community-based mangrove management for coastal protection: A case study from Central Java, Indonesia

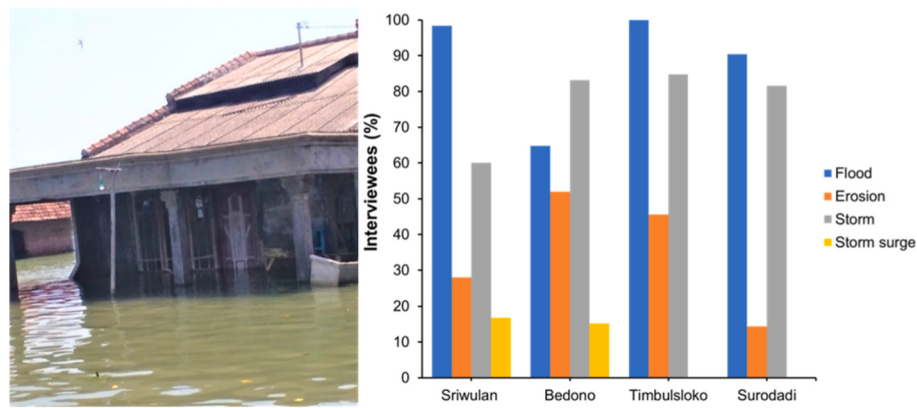
Fig. 2. Coastal flooding in Sriwulan (left) and experience of coastal hazards in the four villages (right).

The studied communities have been threatened by repeated occurrences of coastal hazards. Nearly all interviewees (97%) experienced at least one out of four types of coastal hazards, floods, erosion, storms and storm surges (Fig. 2). Coastal flooding was most frequently experienced in Sriwulan, Timbulsloko and Surodadi, followed by storms in Bedono, Timbulsloko and Surodadi. Flooding was only experienced by half of the interviewees in Bedono, but they all experienced storms. Additionally, storm surges (locally known as 'unju-unju') were only experienced by interviewees in Sriwulan and Bedono who lived less than 1 km from the coastline.

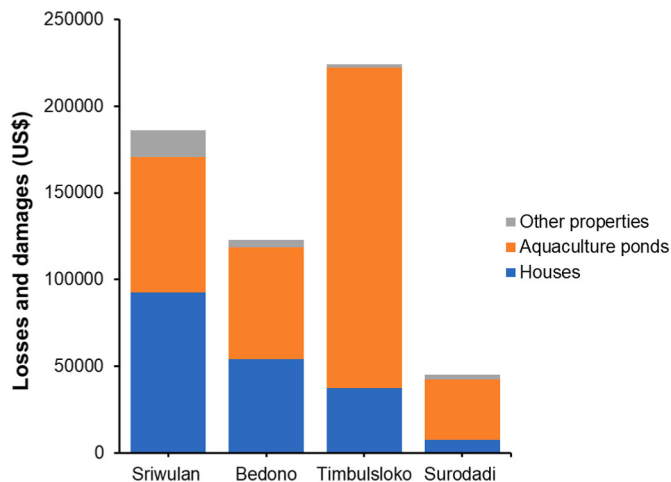
Fig. 3. Losses and damages caused by coastal hazards from 2011 to 2015 (367 interviewees) Other properties refer to boats, boat engines, fishing gear, electronic devices, cars and motorcycles.

Between 2011 and 2015 the recurring floods, storms and erosion events caused substantial losses to more than two-thirds of all interviewees. Over 90% of losses involved destruction or damage to houses and aquaculture ponds, and the remainder involved losses or damage of other properties (i.e. boats, fishing gears and electronic devices). The total losses (Fig. 3) in this period were US\$578500<sup>1</sup> ( $n = 367$ ), which averaged to US\$1570 per household. The average annual loss per household is, therefore, US\$310, which accounted for 12%–16% of the yearly household income (Table 2). The highest losses were recorded in Timbulsloko, where the aquaculture ponds were especially hard hit (Fig. 3), followed by Sriwulan, Bedono and Surodadi. The loss and damage of aquaculture ponds resulted in a socio-economic response of occupational shifts in all four villages. The response was most prominent in Timbulsloko, where almost a quarter of the interviewees shifted from fish farming to fishing or manual labour (Table 2) (see Table 3).

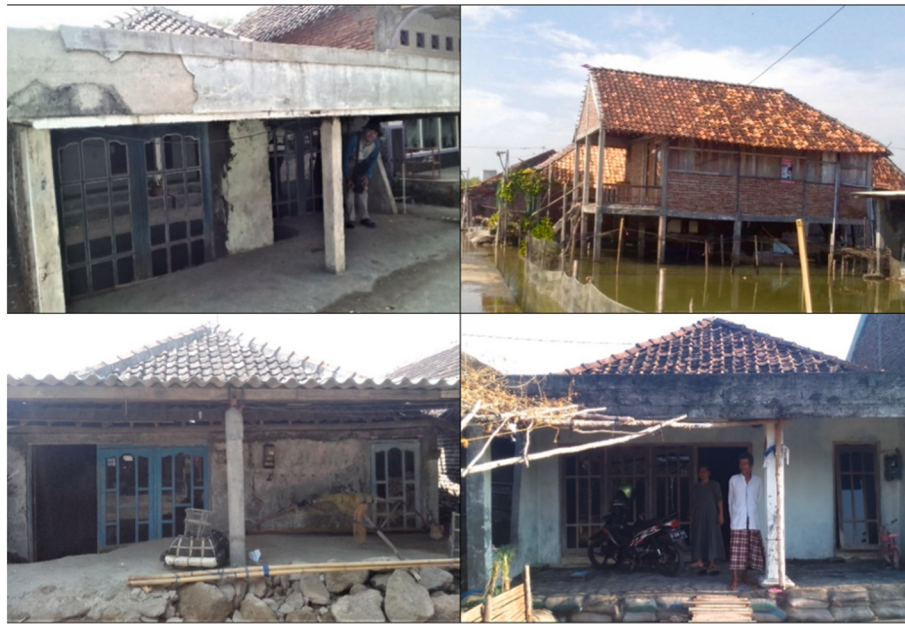
Fig. 4. Adaptation strategies through floor elevation (top-left), total house elevation (top-right), stone dike (bottom-left) and sand dike (bottom-right).

Despite the damage to their residential houses, none of the interviewees was willing to move to other places. Their motivation included, particularly, their occupation (30%) and attachment to their birthplace (25%) and their families (12%). To deal with the repeated occurrence of coastal hazards, almost all interviewees allocated additional budget to elevate their houses (Fig. 4), except in Surodadi, where only half applied this strategy. A few interviewees in Sriwulan, Bedono and Surodadi also built simple stone or sand dikes around their houses to increase flood protection (Fig. 4). Each of the affected households in the

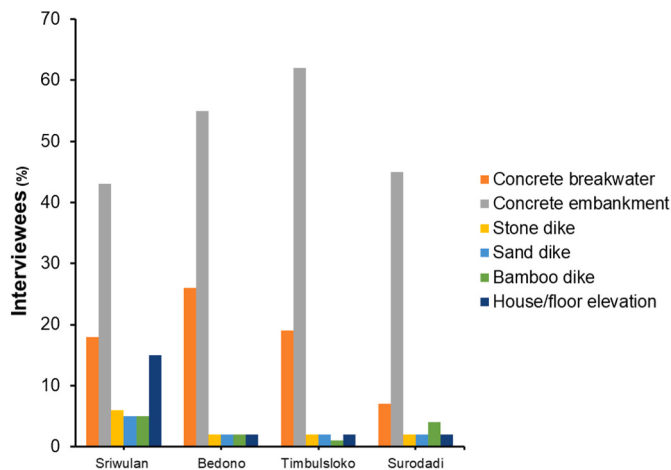
Fig. 5. Additional coastal defence strategy to complement mangroves.

Aside from these adaptation strategies, various other coastal defence measures were implemented, ranging from constructing breakwater systems (i.e. concrete, stone, bamboo, rubber and semi-permeable structures to enhance sedimentation and stimulate mangroves' natural regeneration) to active rehabilitation of mangrove forests. Among these measures, mangrove forest rehabilitation was most commonly applied in all four villages, whereas the others were mainly applied in Bedono and Timbulsloko.
