Boot, T., Kömmelt, P., Hendrikx, R. W. A., Böttger, A. J., & Popovich, V. (2025). Effect of plastic deformation on the hydrogen embrittlement of ferritic high strength steel. *npj Materials Degradation*, 9(1), Article 39. <https://doi.org/10.1038/s41529-025-00592-9>

Effect of plastic deformation on the hydrogen embrittlement of ferritic high strength steel

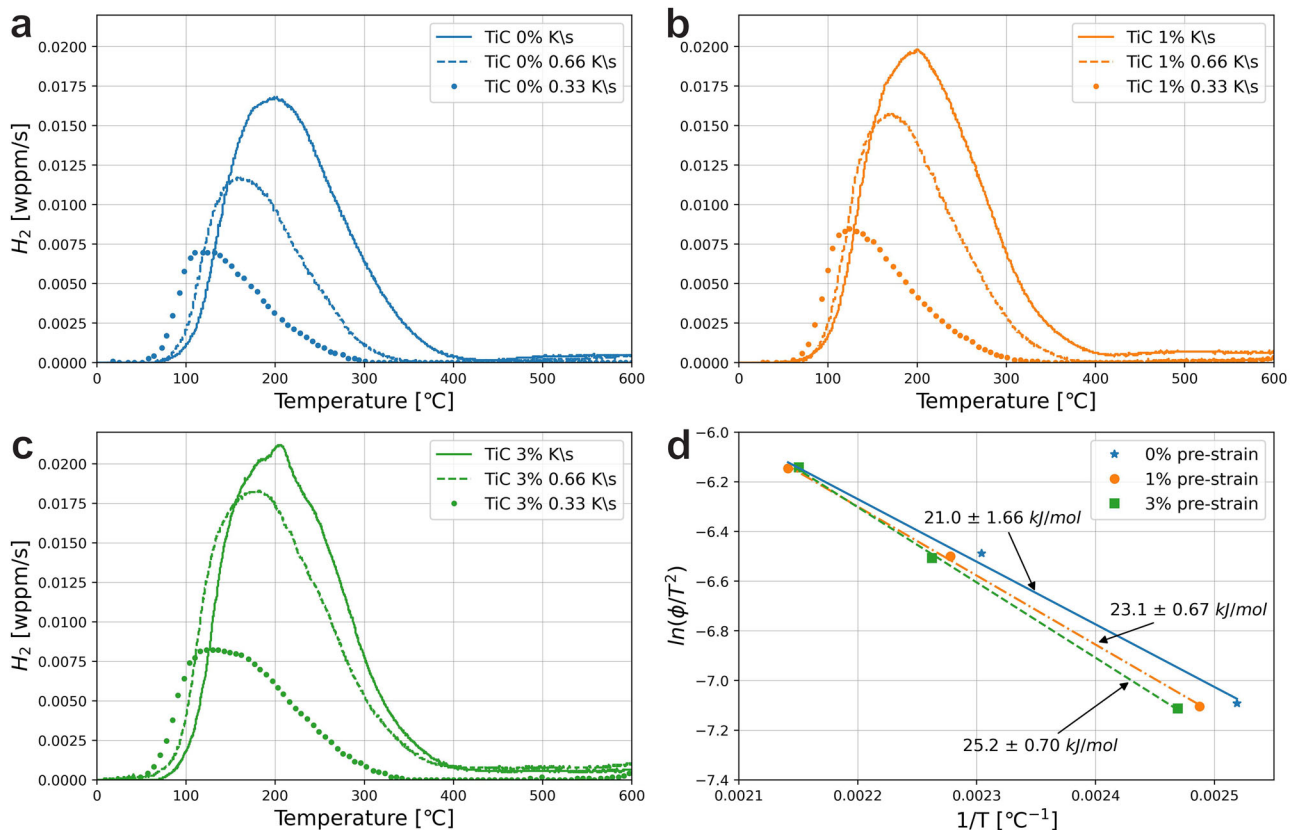
Fig. 1 | Hydrogen desorption and Kissinger curves. a 0%, b 1%, and c 3% plastic strain as well as d the Kissinger plot of the activation energies E_A for all pre-strains.

Table 1 contains an overview of the amount of absorbed hydrogen in each specimen after the charging and holding time of 2 h. The amount of H absorbed by the unstrained benchmark specimens was measured in our previous research under identical charging conditions and was found to be 2.18 ± 0.28 wppm³⁶. It should be noted that the incoherent precipitates that are also present in the steel trap hydrogen in stronger sites that show desorption peaks at higher temperatures. These were, however, shown not to be further charged by the method of charging in this work, and they do not influence the mechanical behaviour of the steel^{11,26}. Higher temperatures were therefore left out of the TDS measurements for this work. The hydrogen content found for the 0% pre-strained specimens is 2.36 ± 0.17 wppm, which is within the spread of that of the benchmarks. In contrast, the absorbed hydrogen content rises significantly upon the application of plastic pre-strain. The 1% and 3% plastically pre-strained specimens were found to absorb 3.00 ± 0.11 and 3.69 ± 0.26 wppm, respectively. The differences in hydrogen absorption between elastic and plastic pre-strain show the relative importance of dislocations as hydrogen trapping sites. The desorption curves for all specimens have been shown in Fig. 1. Skewed Gaussian peaks were fit to the measurement data represented in the figure, of which the maximum peak temperatures were used to calculate the activation energy of desorbed hydrogen in the peak. Table 1 shows them to be 21.0, 23.1, and 25.2 kJ/mol for increasing plastic pre-strain. The activation energy increases with plastic strain, but the extra hydrogen that is absorbed is stored in the same type of trap, namely the dislocation. Since trap occupancy in dislocations increases significantly, the increase in calculated activation energy can be understood to be an effect of re-trapping of

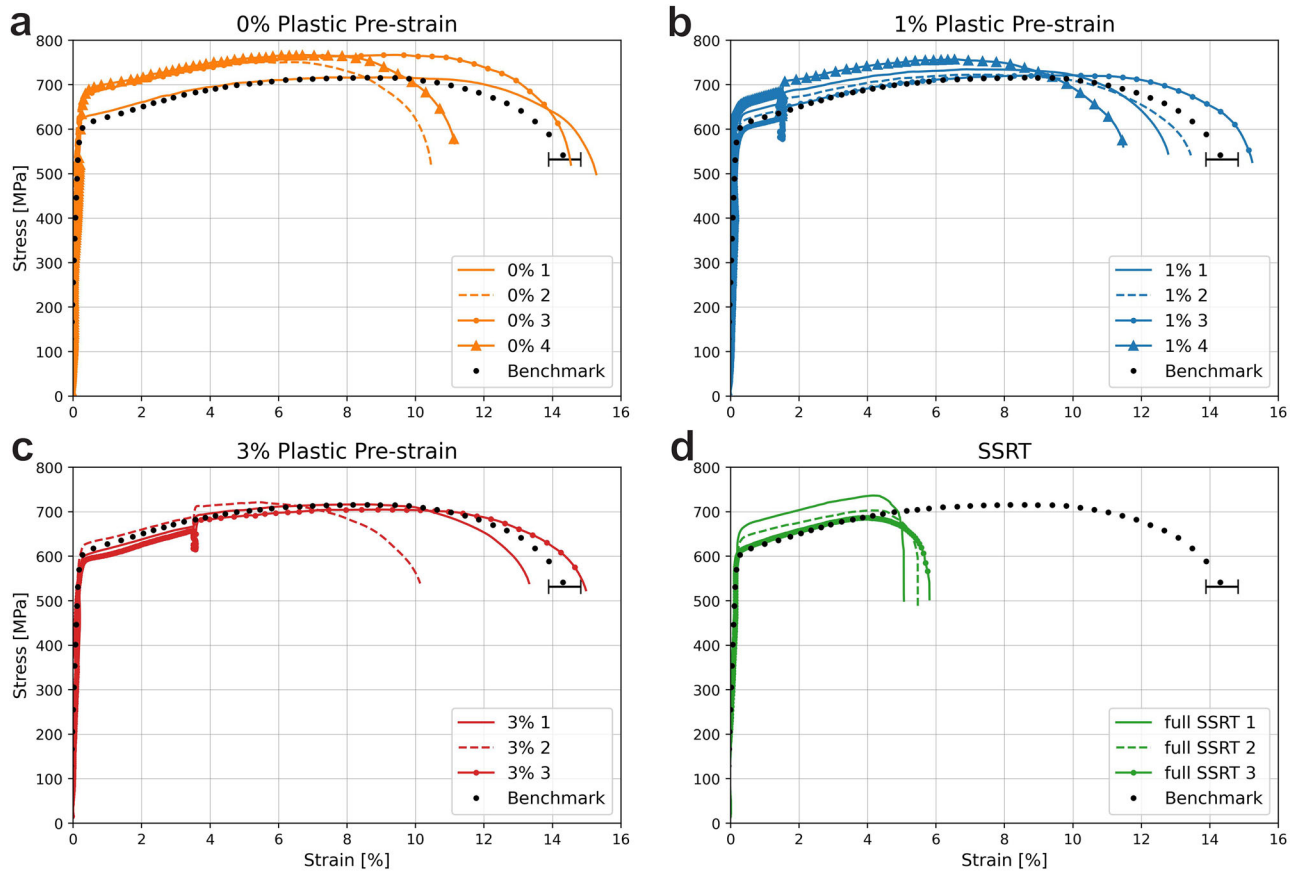
Fig. 2 | Strain curves for all specimens. a 0%, b 1%, and c 3% pre-strain, and d full SSRT curves. All tests except for benchmarks were performed during hydrogen charging. The error bar for the benchmark tests indicates the standard deviation of the final fracture strain.

Observing the mechanical behaviour in Fig. 2, it is evident that the increase in hydrogen uptake with increasing plastic pre-strain is not directly related to earlier final fracture. A trend is visible in the tensile curves, showing that, regardless of the amount of pre-strain, most tensile samples are not significantly more brittle than the uncharged benchmarks. Some individual samples are embrittled, but the degree of embrittlement is similar between specimens with different amounts of pre-strain or hydrogen uptake. The average HEI for the specimens was calculated to be 9.2%, 6.6%, and 9.5% for the 0%, 1%, and 3% pre-strained specimens, respectively. On the other hand, the SSRT specimens are consistently embrittled and fail around a strain of 5% even though they have been exposed to the charging environment for approximately 1 h, which is their time to fracture. A fractured SSRT specimen was measured in the TDS shortly after fracture and was found to have a hydrogen content of 3.48 wppm, which is within the spread of samples strained to only 3% after 2 h of charging. It therefore

seems to have absorbed hydrogen more quickly. However, the strain after fracture is not homogeneous, so hydrogen is most likely segregated to regions of high ductility. Therefore, no conclusive quantitative statements can be made about the hydrogen concentration in the fracture specimen. The SSRT specimens are severely embrittled and have an HEI of 60%.

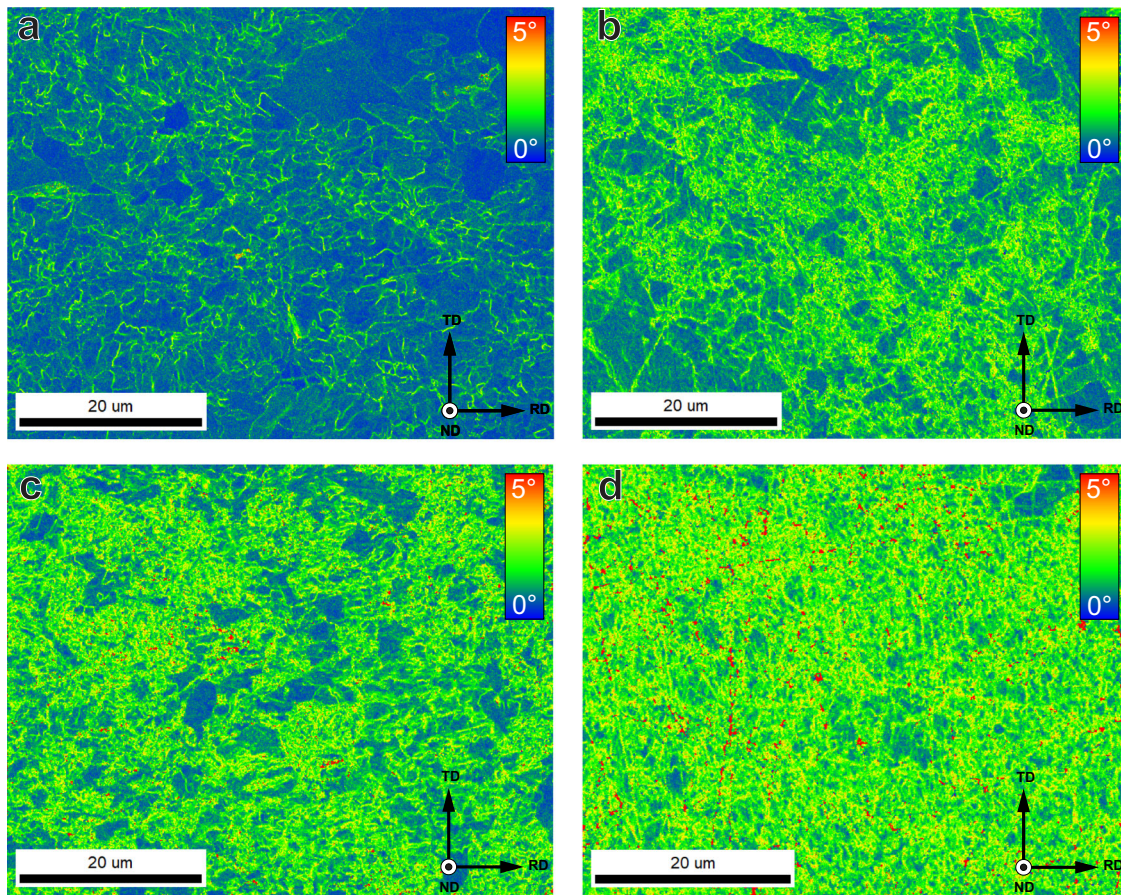
Fig. 3 | Kernel average misorientation maps. Specimens strained at **a** 0%, **b** 1%, **c** 3% plastic strain, and **d** in the necked area of a fractured SSRT sample.

Other than hydrogen content, for specimens at pre-strains of 0, 1, and 3%, the dislocation densities were determined through XRD and the KAM through EBSD. The necking area of an SSRT specimen was also characterised for both to provide data for the microstructure near the fracture in hydrogen. The results are shown in Table 2 and an overview of the KAM measurements is shown in Fig. 3. Although KAM measurements only include information on the density of Geometrically Necessary Dislocations (GNDs), and measurements from XRD also include Statistically Stored Dislocations (SSDs), the relative number of GNDs has been shown to constitute the majority of all dislocations up to the point of necking under tensile loading conditions³⁷. The two techniques can therefore be used comparatively in this strain regime. Since the dislocation density is never zero, the specimen strained below the yield point already has a dislocation density of $1.8 \pm 0.3 \cdot 10^{14}m^{-2}$, which corresponds to an average KAM of 0.6° . Both values increase with strain, where the largest relative increase is found between 0 and 1% plastic strain. The maximum is found in the necking area where the dislocation density is $4.4 \pm 0.7 \cdot 10^{14}m^{-2}$ and the average KAM is 1.4° . It should be noted that the XRD is a macroscopic characterisation technique with an analysed surface area of roughly 1 cm^2 . Since the necked region has strain heterogeneities, the measurement for the SSRT specimen therefore has a larger error than the other dislocation densities. The KAM measurement is much more localised and was therefore taken in an area close to the fracture surface. This, as such, gives a

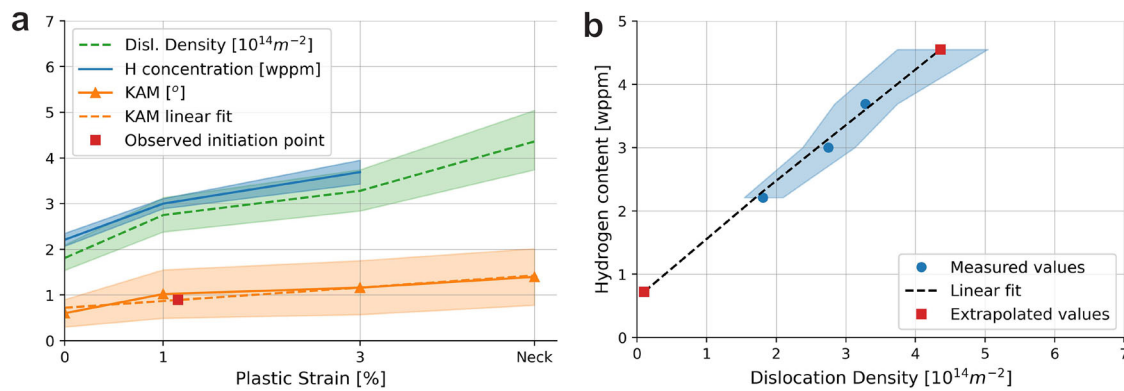
Fig. 4 | Correlations between dislocation density, hydrogen content, and kernel average misorientation. **a** The hydrogen content, dislocation density, and KAM as a function of the amount of Plastic Strain. Data for the ‘Neck’ point on the x-axis was obtained on a necked area of an SSRT specimen. The average KAM value underneath

brittle crack surfaces was indicated as the ‘Observed initiation point’. **b** The H content as a function of the Dislocation Density with extrapolated data for the ideal case of no dislocations, as well as the H content in the necked area of an SSRT specimen.

In this work, we attempt to quantify deformation of the microstructure by plotting the dislocation density, KAM values, and the hydrogen content as a function of plastic strain. Through measuring all three on specimens with known homogeneous macroscopic plastic strains for 0, 1, and 3%, a relation between them is established, and the effect of dislocations can be isolated. Figure 4a shows a graphical overview of the dislocation density, the KAM,

and the hydrogen content of the specimens as a function of the plastic strain. The amount of plastic strain for the SSRT specimen is denoted as “Neck”, for which the location on the axis was determined as 4.8% by fitting it to the KAM measurements obtained for that area. Upon plastic straining, the amount of hydrogen traps increases in the form of newly generated dislocations. Figure 4b shows the hydrogen content as a function of the dislocation density to illustrate this effect. The data closely follows a linear regression, which has been extrapolated to both the average dislocation density in the neck region as well as a theoretical density of 0 for a dislocation-free polycrystal. The hydrogen content in the most deformed

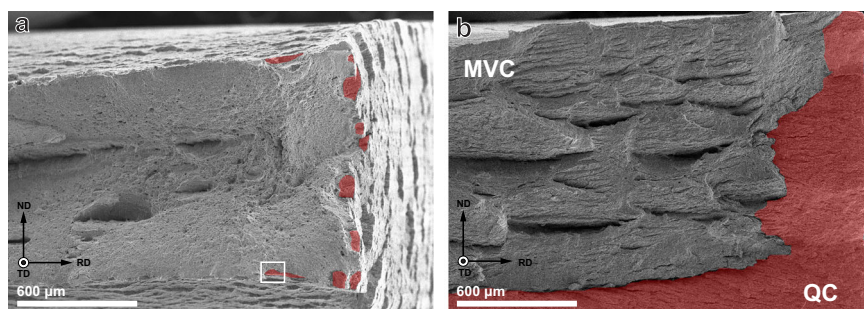
Fig. 5 | Fractographic overviews. Specimens **a** 3% and **b** SSRT, where brittle quasi-cleavage (QC) crack-initiated zones are indicated in red and microvoid coalescence (MVC) regions remain unmarked.

higher hydrogen content than what is required to cause fracture, given that the plastic deformation is kept below a certain limit, in this case approximately 5%. This raises the question, however, of what happens at this level of deformation to cause the sudden fracture of the specimen. The fracture surfaces of post-mortem specimens can indicate the progression of a crack in the specimen. Figure 5a, b shows the fracture surfaces of the 3% 2 specimen and an SSRT specimen, respectively. As is also frequently observed in literature, brittle fracture initiation zones were discovered around the edges that were exposed to the hydrogen environment^{27,28,38–40}. These zones correspond to the macroscopically brittle quasi-cleavage (QC) fracture mode and are indicated in red. The length of the brittle crack initiation zone corresponds to the width of the QC fracture zone on the fracture surface. This was measured to be between 30 and 50 μm for the pre-strained specimens, and it was found to be independent of the degree of plastic pre-straining. The SSRT specimens on the other hand, show a brittle zone of up to 500 μm, as can be seen in Fig. 5b. The fracture surface outside the brittle zones shown microvoid coalescence (MVC) type fracture that forms when the crack growth speed is too high to allow for continuous hydrogen diffusion to the crack tip. This can therefore only be formed during the fast fracture stage of the test. Since brittle fracture initiation occurs even in the 3% specimens, this is not the cause of failure that happens in the SSRT specimens. A higher magnification overview of the transition zone from QC to MVC fracture in a 3% specimen is given in Fig. 6.

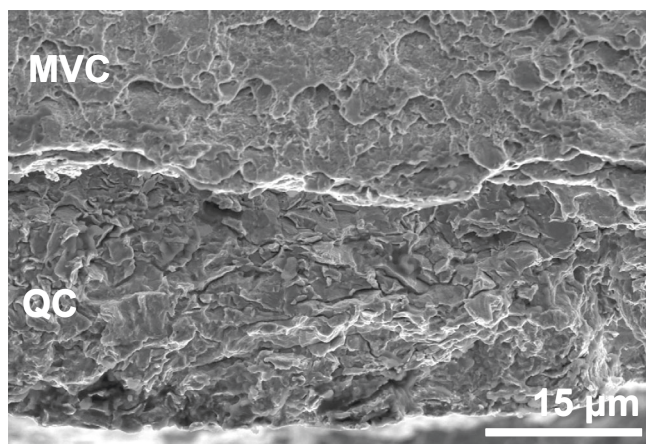
Fig. 6 | Close-up fracture surface. Transition zone from quasi-cleavage (QC) to microvoid coalescence (MVC) fracture in a 3% specimen, taken from the area indicated in Fig. 5a.

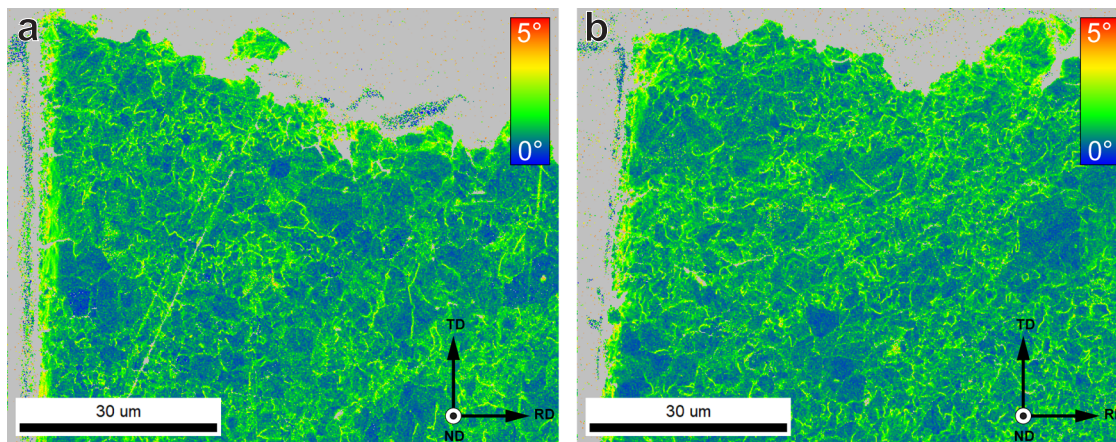
Fig. 7 | Post-mortem kernel average misorientation maps. Areas below a brittle initiation point on the fracture surface of **a** 0% and **b** SSRT specimens. Grey pixels were not included in the KAM measurement.

To find out at what point brittle initiation occurs, EBSD measurements were performed on cross-sections of selected specimens post-mortem. KAM maps of the sub-fracture surface microstructure beneath the brittle initiation zone were obtained. Figure 7a, b show two examples of these KAM maps. Figure 7b corresponds to the same sample shown in Fig. 5b, while 7a was taken from a 0% specimen exhibiting clear crack initiation on one side, providing a good study case to observe the amount of deformation required for brittle crack initiation. The average KAM values calculated beneath the crack surface are $0.89 \pm 0.47^\circ$. This point is indicated in Fig. 4a to belong to a plastic deformation of just over 1% if fit to the regression. This value itself, however, is markedly below that of 1.02° obtained for a homogeneous plastic strain of 1%. This indicates that first crack initiation in the tests takes place early on during the deformation, when a homogeneous strain of 1% is reached. Evidently, these cracks do not propagate in the 3% specimens, but do in the SSRT specimens, where they grow large enough to cause macroscopic fracture.

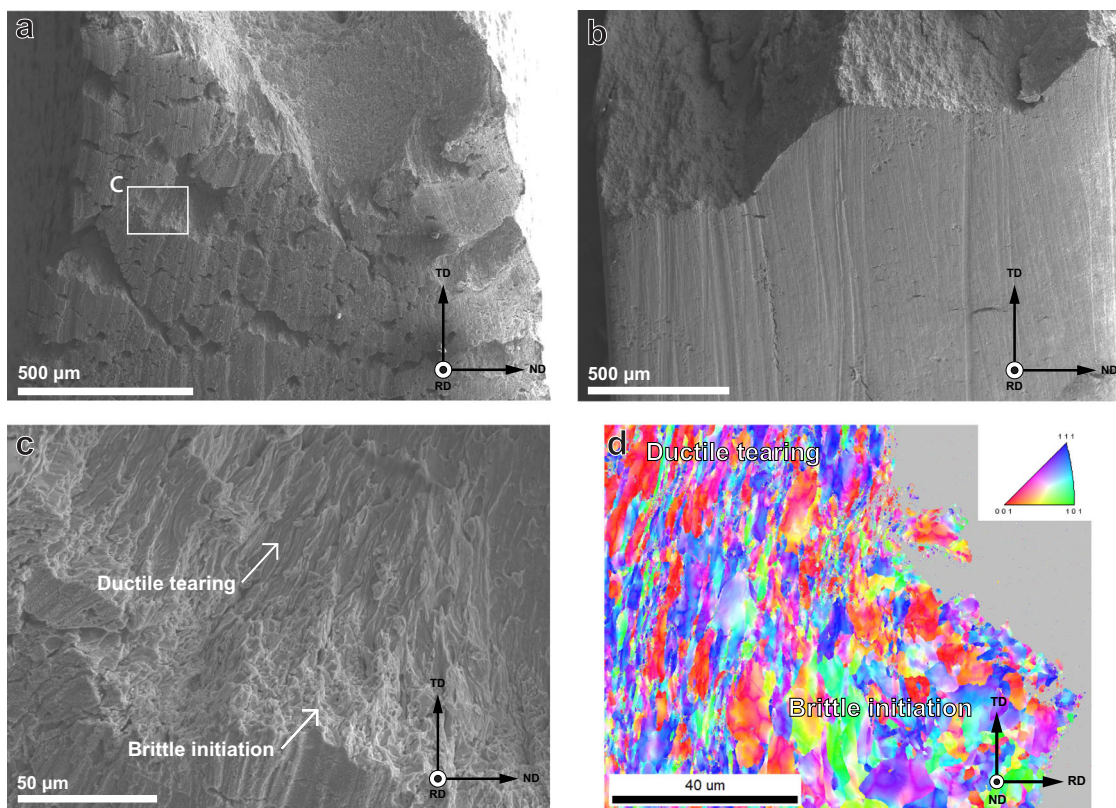
Fig. 8 | Tilted side views of post-mortem specimens. 45° tilted specimens **a** 3% and **b** SSRT. **c** shows a zoomed-in section of a crack in **(a)** to highlight the transition from brittle to ductile fracture. An Inverted Pole Figure (IPF) map of the cross-section of a similar transition is shown in **(d)**, where the start of plastic deformation can be observed.

This finding is supported by Fig. 8a, b, which show the sides of the 3% 2 specimen and a SSRT specimen, respectively. The 3% pre-strained specimen shows a high amount of secondary cracks on the side surface, with significant crack mouth opening. In the SSRT specimen, on the other hand, the fracture is entirely localised to a single crack. Some secondary cracks can be observed, but they have not been opened. The opening of the secondary cracks in the 3% specimen is shown at a higher magnification in Fig. 8c. Here, the crack clearly displays a brittle fracture initiation zone that transitions into a region of ductile tearing. This is supported by an IPF map obtained from EBSD, shown in Fig. 8d, which shows the contrast between the relatively equiaxed grains beneath the brittle surface and the heavily deformed grains in the plastic region. These findings indicate that brittle cracks initiate at several locations during either the straining or hold time of the 3% specimen, but they arrest and are only opened during the further

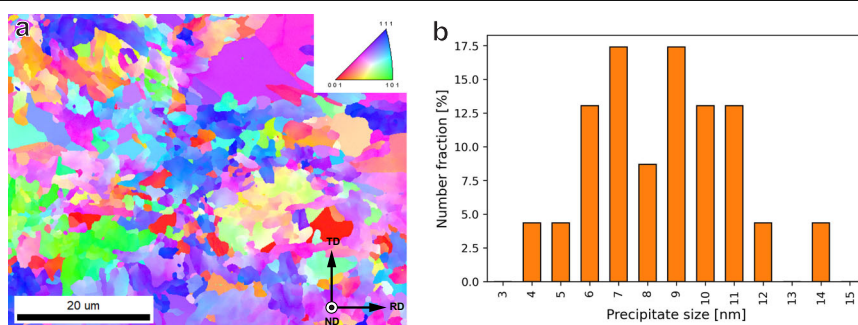
Fig. 9 | Overview of microstructure and precipitate sizes. a An IPF map of the microstructure of the undeformed steel, and b a histogram showing the distribution of semi-coherent precipitate sizes.

The steel used in this research was cast by Tata Steel in IJmuiden. The composition was measured on a PANalytical Axios Max Wavelength Dispersive X-ray fluorescence (WDXRF) instrument and is shown in Table 3. This composition was chosen to obtain a ferritic microstructure with finely dispersed TiC nano-precipitates for which the atomic ratio of Ti:C was kept as close to 1:1 as possible. The steel was heat treated by the same process as used in our previous work¹¹, which consists of a heat treatment in pure N₂ at 700 °C for 2 h. This time excludes a warm-up at 5 °C/min and a cooling-down that was furnace-limited at approximately 1 °C/min. Before the heat treatment, each specimen was sanded to a P1000 grit finish. The resulting microstructure can be observed in Fig. 9a, and b shows the histogram of precipitate sizes measured using TEM. The average grain area is $3.8 \mu\text{m}^2$, but extremes can be found on both the low and high ends. The sizes were therefore chosen to be listed in Table 4 according to the ASTM E1181 standard for randomly distributed grain sizes of a large range, the total range of observed grain areas was between 0.1 and $160 \mu\text{m}^2$.

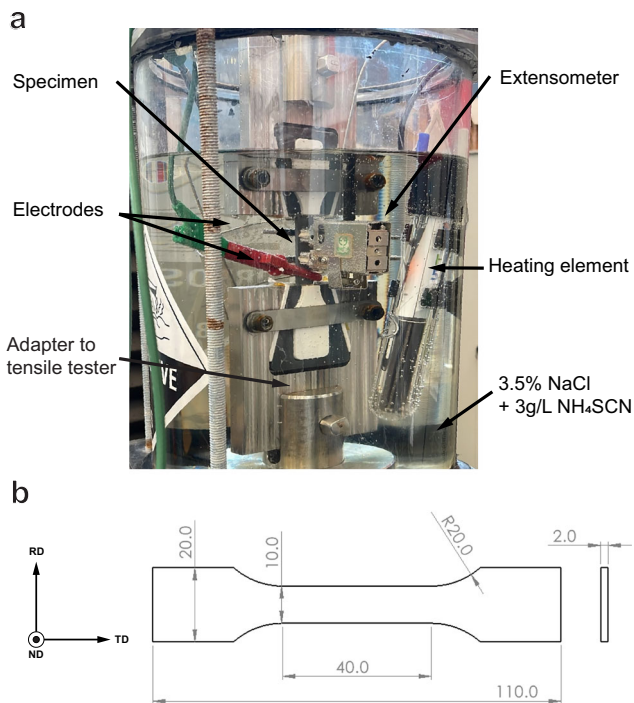
Fig. 10 | Overview of test equipment. **a** Overview of the in-situ hydrogen setup used for tensile testing and **b** the dimensions (in mm) of the tensile specimen geometry used in this study. Adapted from ref. 26.

All tests performed for this research were conducted in a custom-designed setup to allow for in-situ hydrogen charging during tensile loading. The setup and specimen geometry are shown in Fig. 10. The specimens are submerged in a 3.5% NaCl + 3 g/L ammonium thiocyanate (NH₄SCN) solution for the duration of the test to allow for hydrogen charging. The charging is

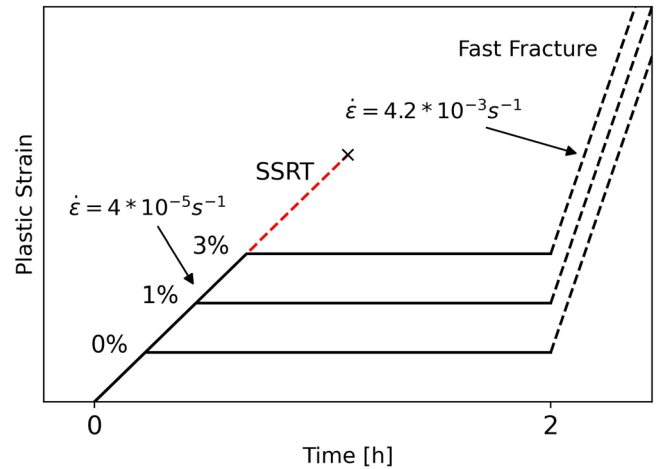
Fig. 11 | Overview of the test procedure. The entire test is performed during hydrogen charging, axes are not to scale.
