Published in Aeronautical Journal

Static Test of a Variable Stiffness Thermoplastic Composite Wingbox under Shear, Bending and Torsion

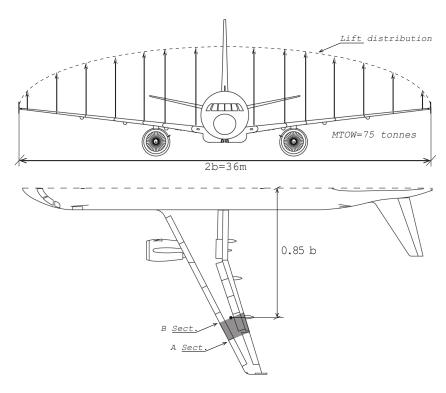
Figure 1: Positioning of the wingbox section and loads

The wingbox was chosen to be representative of a civil aircraft (e.g., B-737/A320) with a wingspan (2b) of 36 m and maximum take-off weight (MTOW) of 75000 kg, as illustrated in Fig. 1. Since it was a manufacturing demonstrator, it is worth noting that the overall design process does not reflect a real wingbox structure for this type of airplane. Therefore, the design did not take into account all regulations of real flight vehicle structures. The section was assumed to have a length of l=750 mm in between two ribs referred to as sections A and B in Fig. 1.

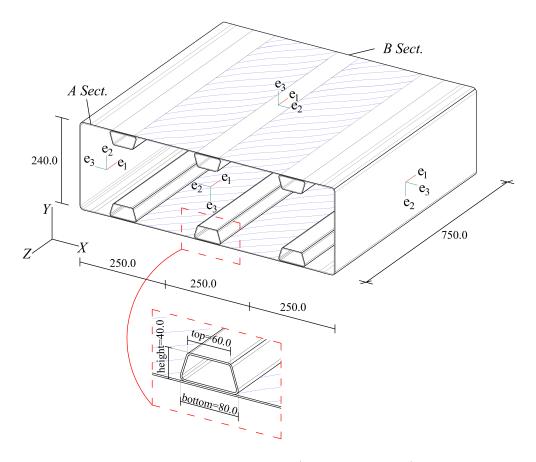
Figure 2: Geometry of the wingbox (dimensions are in mm).

The properties of the carbon fibre thermoplastic material used in manufacturing the wingbox are shown in Table 1 and the geometrical features including the stiffeners shape and geometry are shown in Fig. 2.

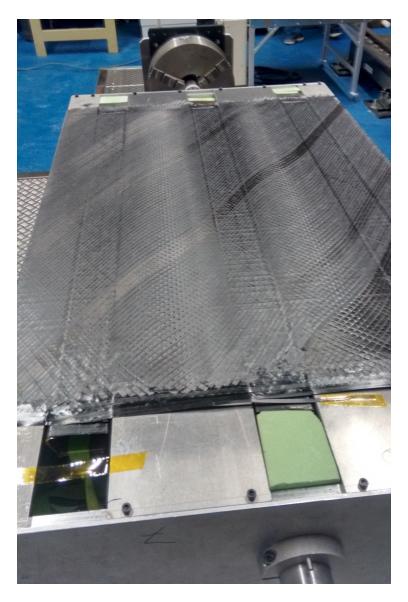
Figure 3: Stiffeners put in place in the mould and skin plies placed over them.

A combination of winding and laser-assisted tape placement (LATP) were used to manufacture the wingbox and stiffeners. The stiffeners were made separately first and then were placed in a mould. Afterwards, the first layer, i.e., the 90° tows, were placed over the mould and stiffeners to result in a unitised, integratedstiffener box due to in-situ consolidation of the PEEK material at the interface of skin and stiffeners (Fig. 3). The manufacturing challenges and quality of the final product in terms of the interfacial bond strength and quality of steered parts and corners are described in detail in [14, 15].

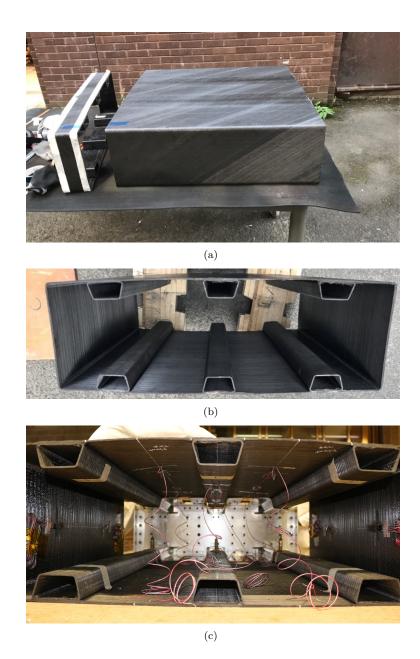
Figure 4: Finished wingbox: (a) side view, (b) section view and (c) during strain gauge installation.

The finished wingbox, with the steered layers on the outside of the skin bays, is shown in Fig. 4.

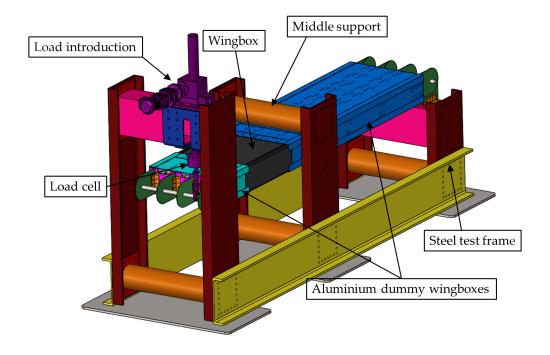
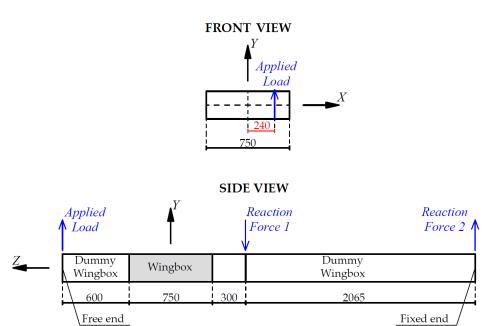
Figure 5: The schematic of the testing assembly and the parts (dimensions are in mm).

A schematic of the Shear-Bending-Torsion test is shown in Fig. 5, in which the load was applied at one end and reacted by the middle and end supports. To this end, a steel test frame was designed and built. In addition, two dummy wingboxes made of mainly aluminium were designed, manufactured and attached to the composite wingbox to avoid boundary effects and stress concentrations in the composite wingbox during loading, as well as to facilitate the smooth transition of the load from the load introduction mechanism to the supports. The shape of the cross sections, as well as the flexural stiffness of the dummy wingboxes were designed and built so that they conform and match as closely as possible with those of the composite wingbox [16]. Figure 6 shows the manufactured test frame and the wingbox assembly.

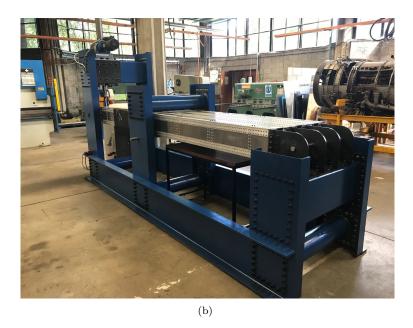
Figure 6: The wingbox assembly installed on the test frame: (a) front and (b) rear view.

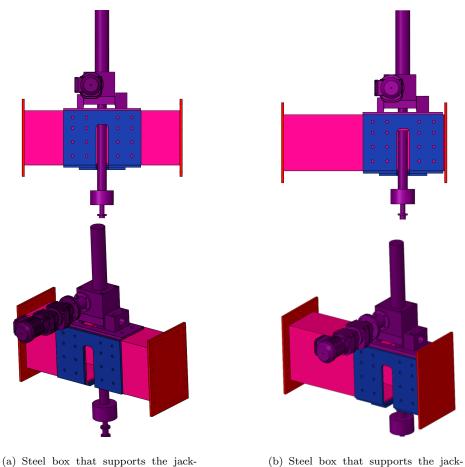
(b) Steel box that supports the jackscrew unit in SBT test

Figure 7: Modification of the load introduction (jack-screw) support steel box for SBT test.

Applying the combined SBT load was performed by shifting the load introduction point by a prescribed offset distance (240 mm) from the centre of the wingbox cross-section. To this end, the steel box that supports the load introduction unit (jack-screw) was replaced by a modified one to accommodate the offset. The rest of the test set-up remains as it was for shear-bending. Figure 7 shows the above mentioned modification. The whole test frame as it was for the SB test, as well as the modified one for the SBT test is also shown in Fig. 8.

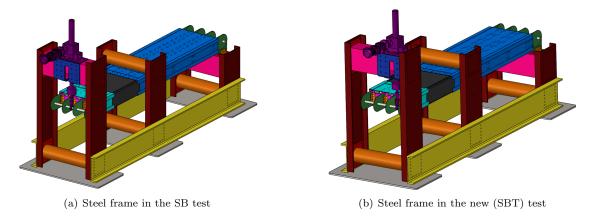
Figure 8: Modification of the steel test frame for SBT test.

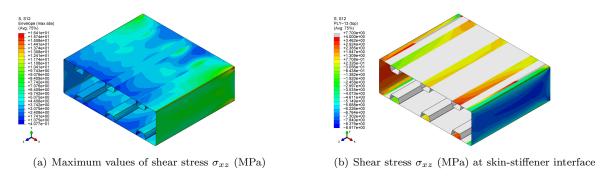
Figure 10 shows the shear stress σ_{xz} contour maps. As expected, the combination of the shear and torsion results in a nonsymmetric distribution with a relatively low maximum value of $\sigma_{xz} = 16.4 \,\mathrm{MPa}$ in the right side of the wingbox at the corner region. Figure 10(b) shows the shear stress σ_{xz} at the skinstiffener interface and the spar webs. The maximum value of σ_{xz} in this region also occurs for the two stiffeners on the right side of the wingbox. As expected, its variation remains almost linear with respect to the distance to the shear centre of each section with an insignificant maximum value of 4 MPa.

Figure 10: Shear stress σ_{xz} at the buckling load.

The in-plane shear stress (σ_{xz}) contour is shown in Fig. 16. The highest value of this shear stress occurs at the same region that the 2D model predicted (Fig. 10), i.e. in the skin-spar web corner region and its highest value is again highly localized at the boundary side as in the 2D model.

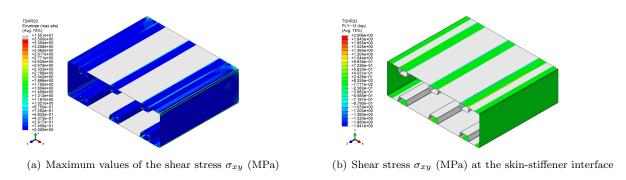
Figure 11 reveals that the shear stresses σ_{xy} at the skin-stiffener interface and at the corner regions are also small. The numerical results show the maximum values of $\sigma_{xy} = 2.0 \,\mathrm{MPa}$ and $\sigma_{xy} = 3.5 \,\mathrm{MPa}$ at the skin-stiffener interface and the corner regions, respectively.

Figure 11: Shear stress σ_{xy} at the buckling load.

Figure 17 shows the value of the shear stresses σ_{xy} at the spar web and the corner regions. The numerical results of the mixed model show a higher, yet still small, value of the maximum shear stress $\sigma_{xy} = 17.7 \,\mathrm{MPa}$ compared to the 2D model (see Fig. 11).

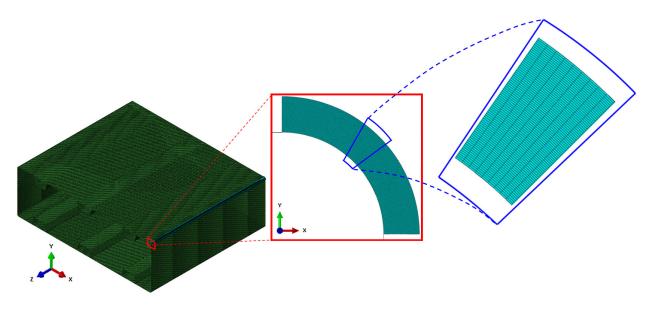
Following identification of the critical regions in the 2D model, the mixed FE model partially meshed with 3D elements was generated to further study the stress and strain states in those regions with more accuracy and details. Figure 14 shows the mixed model in which the right hand corner regions were meshed by 3D finite elements.

Figure 14: The mixed model in which the critical region (top right corner) was meshed by 3D finite elements.

As shown in the FE analysis of the mixed model (Fig. 14) the most critical part that experiences severe stresses and strains is the top corner of the wingbox at the load offset side (Figs. 16-21). Figure 32 shows the strains measured at the top surface of this corner during loading/unloading. The maximum strain values are not considerable (below $1200~\mu\varepsilon$), however, a tensile strain in the chord-wise direction (strain gauge 22) shows the considerable expansion of the top skin in that direction due to the Poisson effect.

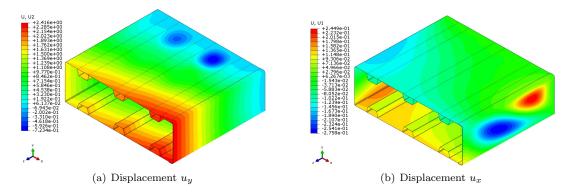
Figure 15 shows the displacement contour maps resulting from the nonlinear analysis of the mixed FE model using the Riks algorithm. As expected, the results are in agreement with the 2D model results (Fig. 9) at the same load.

Figure 15: Displacements contour maps at the buckled state using the mixed model.

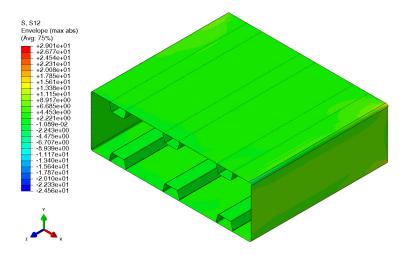
Figure 16: Shear stress σ_{xz} (MPa) at the buckling load using the mixed model.

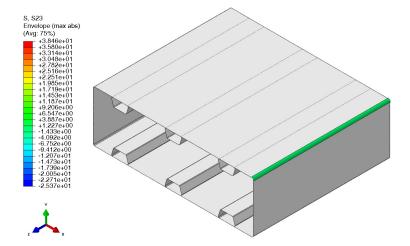
Figure 17: Shear stress σ_{xy} (MPa) at the buckling load using the mixed model.

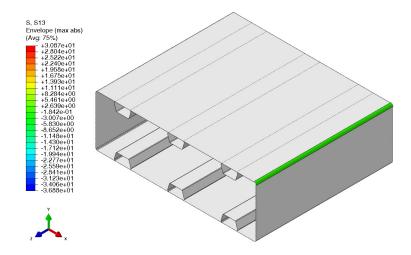
Figure 18 shows the values of the out-of-plane shear stress σ_{yz} in the critical regions using the mixed model. Although the maximum value $\sigma_{yz}=24\,\mathrm{MPa}$ is higher than the 2D model (see Fig. 12) it is not significantly high.

Figure 18: Shear stress σ_{xy} (MPa) at the buckling load using the mixed model.

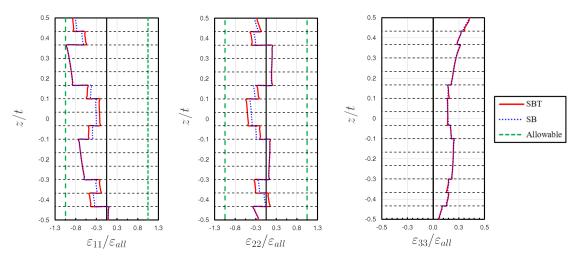
Figure 22: Through the thickness normal strain profiles at the buckling load evaluated at the right top corner of the support side of the wingbox.

To evaluate the maximum strain values in the SBT load case, an investigation of the strain profile through the thickness was also conducted. In particular, since the highest values of strain were observed at the top right corner of the wingbox in the support side, the strain profiles were obtained for this zone only and compared with the maximum allowable principal strain which was set at $2500\,\mu\epsilon$ in this study. Figures 22 and 23 show the normal and shear strain profiles through the thickness. All values of strain are normalized by the maximum allowable principal strain. In all plots the red line represents the strain value at the buckling load for the SBT loading condition, whereas the blue dotted line corresponds to the SB loading condition and the green dashed line represents the value of the maximum allowable strain. It is worth noting that the added torsion, which is considerable, did not significantly change the maximum strain values in SBT compared with SB loading case. Although the analysis shows that the maximum shear strains are ϵ_{xy} and ϵ_{xz} and occur at the corner which is the most critical area, the contour of the strains (Figs. 20 and 21) show that it is highly localized and is related to boundary effects of the FE analysis. In other words, in reality the strains are expected to be lower than those predicted by FE analysis.

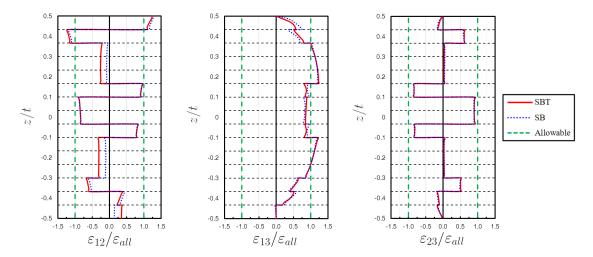
Figure 23: Through the thickness shear strain profiles at the buckling load evaluated at the right top corner of the support side of the wingbox.

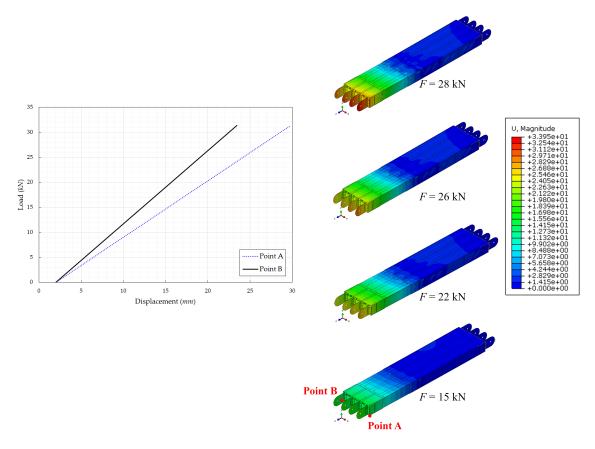
Figure 24: Load-displacement behaviour of the wingbox assembly predicted by FE analysis of the full model.

To further study the structural behaviour of the wingbox assembly, a full model was also generated including the dummy wingboxes attached to the composite wingbox with their associated loading and boundary conditions. The load was applied at an auxiliary beam linked to the dummy wingbox at the loading side and the other end was simply supported. The middle support condition was also simulated by fixing the vertical movement of the nodes of the assembly at the contact line in that location. The vertical displacement of the assembly in four load values are shown in Fig. 24. It shows about 28 mm vertical displacement at the loading end bottom part of the wingbox assembly in the load offset side and about 22 mm at the opposite side, where the displacement gauges are installed in the test (Point A and Point B in Fig. 24). The predicted 6 mm difference quantifies the twisting at about $F = 31 \,\mathrm{kN}$ which is approximately 10% above the predicted buckling load. The load-displacement also shows an almost linear behaviour of the wingbox assembly during the loading/unloading. It is worth noting that the 2 mm initial offset of the load-displacement plot is due to a small gap set initially between the wingbox assembly and the middle support as an initial condition in the finite element simulation.

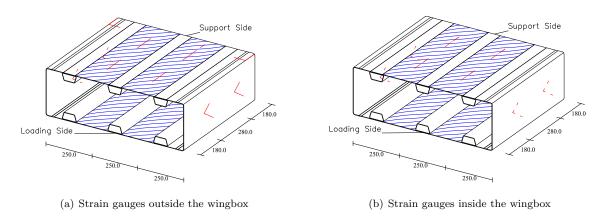
Interrogation of the wingbox during the test was performed via two methods simultaneously: (1) strain gauging and (2) digital image correlation (DIC) system. Figure 25 schematically shows the location of the strain gauges installed on the wingbox to measure the strains in the regions of interest. For those areas prone to buckling the strain gauges were installed back-to-back, i.e., at the two sides of the skin, to capture the onset of the formation of localized bending due to buckling. Two displacement measuring sensors were also installed at the bottom of the dummy wingbox at the load introduction side (Fig. 26 to record the

Figure 25: Location of the strain gauges installed on the wingbox.

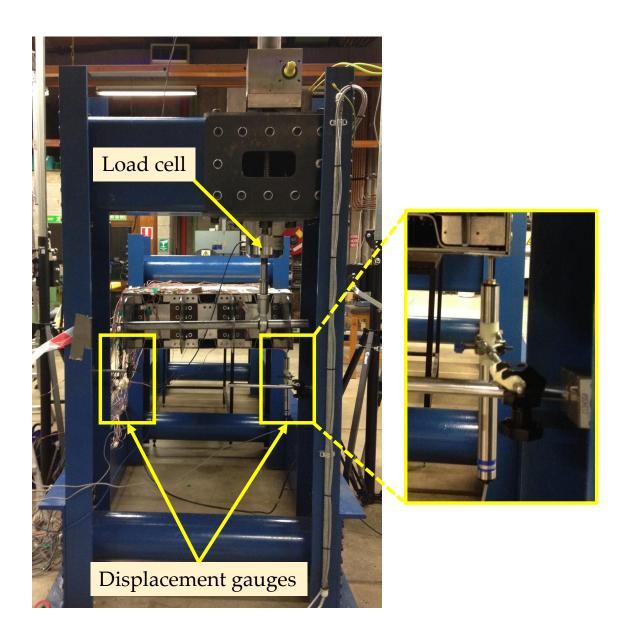
Figure 26: Location of the displacement gauges installed at the bottom end of the wingbox assembly.

end displacement of the wingbox assembly. In this way, it was also able to record the twist/rotation of the wingbox assembly due to SBT loading. The load is applied by a vertical displacement introduced by a constant speed (2 mm/min) jack-screw unit at the end point of the wingbox assembly. A load cell was placed between the jack-screw and a bar connected to the end of the wingbox assembly to record the load value during the test. Figure 27 shows the whole assembly with the DIC cameras installed above the test rig to capture the deformation of the wingbox in the skin area. It is worth noting that, as only two DIC cameras were available, the test was repeated with the cameras installed at the side to record the side wall deformation during loading/unloading.

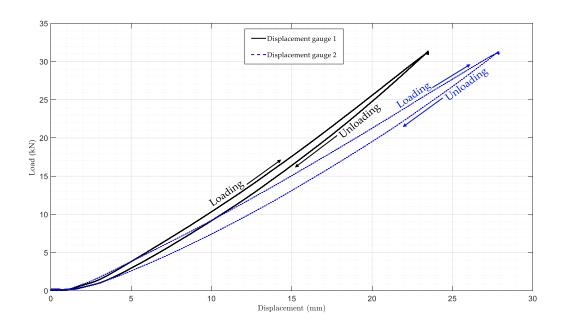
Figure 28 shows the end displacements of the wingbox assembly measured by the displacement gauges during loading and unloading. As expected, the end displacement at the load offset side is about 5 mm more than the other side because of twisting. A small clearance between the wingbox assembly and middle support resulted in about 1 mm end displacements before picking up the load. There was also a small horizontal misalignment that caused a slight twist in the opposite direction of the applied torsion in the beginning of the loading, as seen in Fig. 28. It caused the offset-side edge (right hand side in Fig. 26) of the wingbox assembly to reach the middle support first, the load then started to increase until the other edge reaches the middle support at the other side. At this point $(F = 4 \,\mathrm{kN})$ the wingbox assembly is fully parallel to the middle support and a full contact between them is formed, beyond which the twist due to the torsional load exceeds the opposite initial twist due to misalignment. The effect of friction between the joints in the wingbox assembly is also worth noting from Fig. 28 when the loading path is compared with unloading.

Figure 28: Load vs. end displacements of the wingbox assembly.

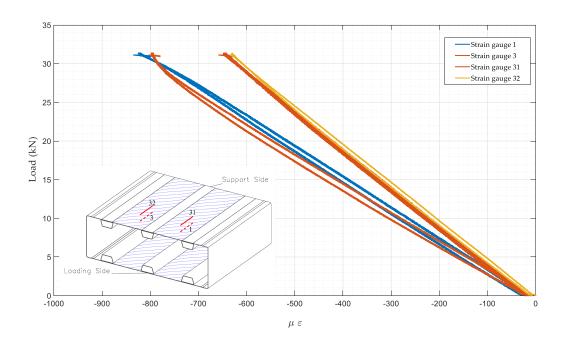
The axial strain variation during loading/unloading at the top skin at the loading side is shown in Fig. 29. The maximum strain occurs at the load offset side and is slightly more than $800 \,\mu\varepsilon$ at the maximum applied load (31 kN). The deviation of the strain values measured from back-to-back gauges is believed to be related to initial imperfection of the top skin, not due to buckling in this region, as later it is shown that buckling occurred earlier at the support side.

Figure 29: Load vs. strains at the top skin in load side of the wingbox (dashed lines indicate inside).

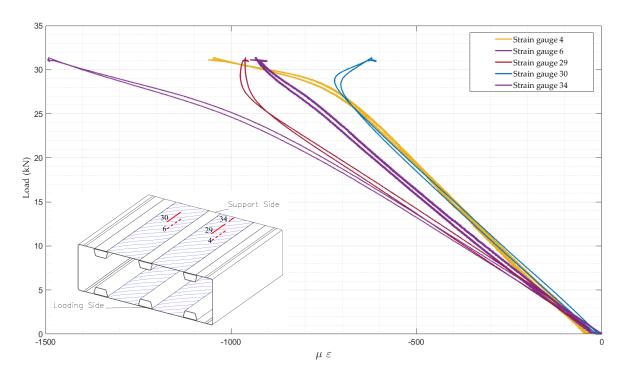
The predicted region for buckling was at the support side as shown in Fig. 9. Therefore, the back-to-back strain gauges at the two skin bays in this area were installed to interrogate these areas, as shown in Fig. 30. As observed in both regions a deviation was observed at a load of about $F = 26 \,\mathrm{kN}$. The different slopes of the load-strain behaviour of back-to-back gauges are again related to the initial imperfection of the skin. However, the large change of the slopes (deviation) clearly shows the local bumps due to buckling in these regions. Comparing the two gradients for strain gauges No. 4 and 29 shows that it is an outward bump, whereas it was expected to be inward (see Fig. 9). The reason is that the biggest inward half wave occurs at a location a bit closer to the support side, where strain gauge No. 34 is installed. This strain gauge was not initially installed before the assembly (there was no access to the inside of the wingbox to install another strain gauge inside the skin at this location). However, it shows the inward bump with a significantly larger strain compared to strain gauges No. 4 and No. 29. In other words, the main (longest) half wave of the buckling is inward and at this location as predicted from the nonlinear finite element analysis (Fig. 9).

Figure 30: Load vs. strains at the top skin in support side of the wingbox (dashed lines indicate inside).

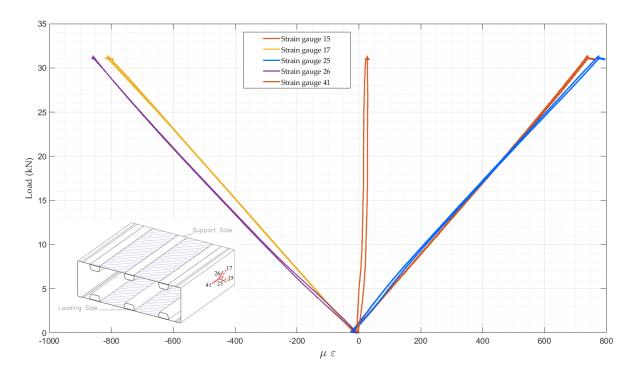
The other region that was prone to buckling based on the nonlinear FE analysis was the load offset side wall of the wingbox. Figure 31 shows the strain variations at this location. As observed, there is no sign of a significant slope change in the strains measured from the back-to-back gauges. The DIC images do show more in this case and are discussed later in this section.

Figure 31: Load vs. strains at the side wall in support side of the wingbox (dashed lines indicate inside).

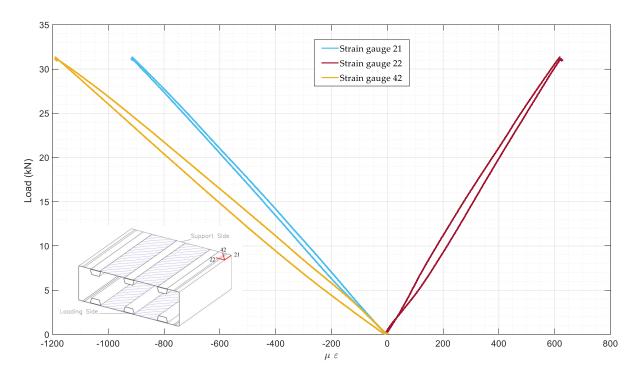
Figure 32: Load vs. strains at the corner of the wingbox.

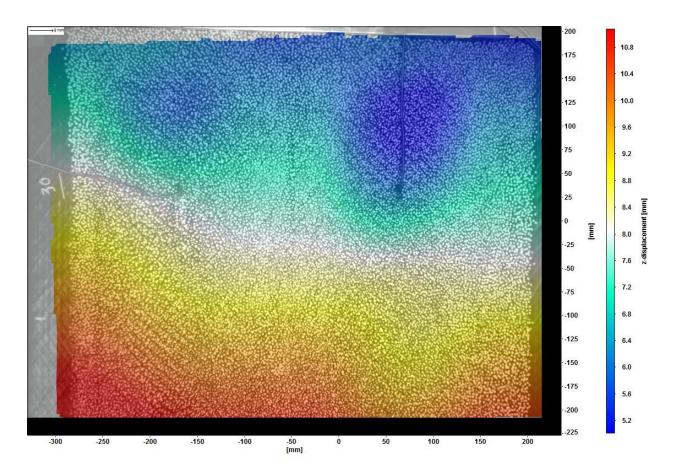
Figures 33 and 34 show the out-of-plane displacement contour maps of the top skin and side wall at maximum load (31 kN) measured by DIC cameras. The buckling mode shape, as well as the inward bump measured in the skin bay due to buckling, is in good agreement with the predictions made by the nonlinear Riks analysis performed by FE analysis (Fig. 9). It is worth noting that the out-of-plane displacements at the localized buckled area at the side wall, as predicted, are considerably smaller than those of the top skin.

Figure 33: DIC image of top skin showing the out-of-plane displacements at maximum load.

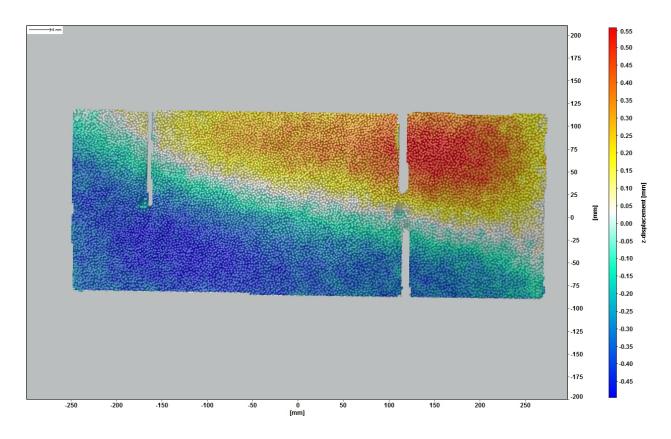
Figure 34: DIC image of side wall showing the out-of-plane displacements at maximum load.
