A pragmatic, performance-based approach to levee safety assessments

Rikkert, Stephan Johannes Hendrikus; Kok, Matthijs; Lendering, Kasper; Jongejan, Ruben

Journal of Flood Risk Management

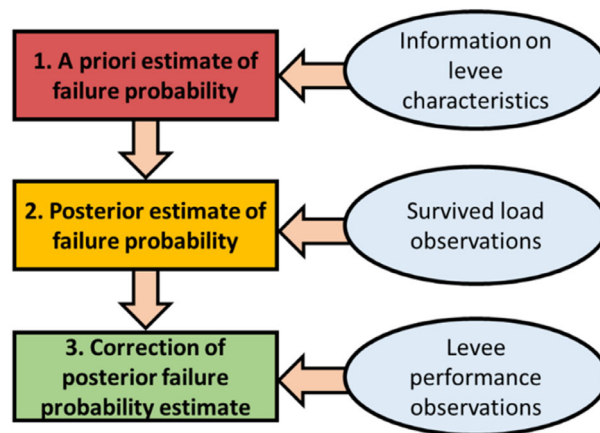
FIGURE 4 Schematization of the proposed method to estimate the failure probability, utilizing information on levee performance under critical conditions and levee inspection results

Figure 4 shows a schematization of the proposed approach. The first step of this method is to estimate the failure probability, based on levee specific load and strength parameters. In the two following steps, this estimation is improved by including observed levee behavior.

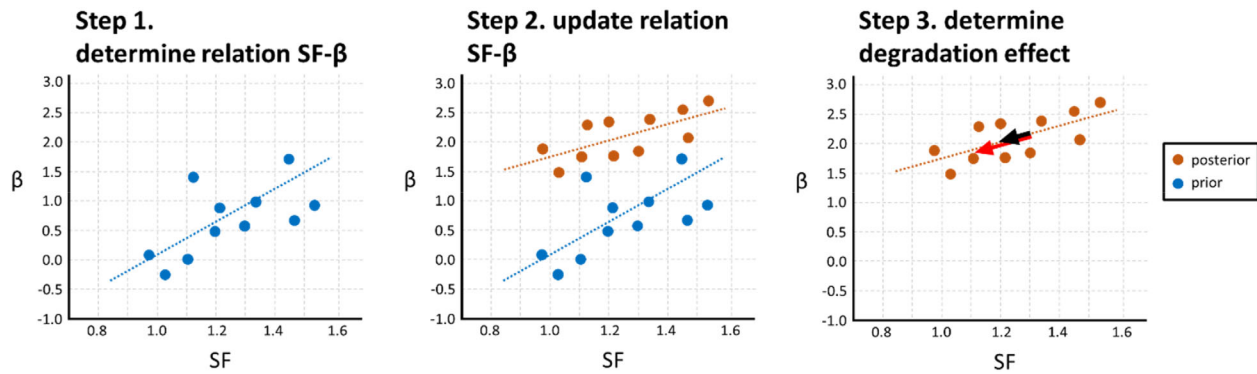
FIGURE 5 The approach explained through three steps. Step 1: Relation between safety factor SF and reliability index β for one levee type, based on probabilistic stability assessments. Step 2: Updating the prior relation between safety factor SF and reliability index β for one levee type, based on observations of survived hydraulic loads, with the prior relation in blue and the relation after updating in orange. Step 3: The arrows indicates how different degrees of degradation (black: light degradation; red: severe degradation) affect the stability factor, and hence the reliability index, of one levee type is influenced by levee degradation. The arrows are indicative, and effects on the stability factor depend on levee characteristics and degradation type

2. Observations of performance of the levee under various loading conditions can be included, using the approach described in Section 2.2.1 on reliability updating. The initial relation found in step 1 can be improved, by fitting a line through the points after reliability updating, as is shown in (see step 2 in Figure 5).

3. The final step is to correct the posterior failure probability by including results of levee inspections in the form of levee performance indicators, in addition to the survived loads from the previous step. These levee performance indicators contain information about the actual condition of the levee, and they influence the stability factor, and hence the probability of failure. Ideally, the same approach as in step 2 would be used here: including the effects of a certain performance observation, based on Bayes theorem. However, in this study a more pragmatic approach was used to limit the processing time of the study. Besides, discretization of the load and resistance in reliability updating makes it difficult to take into account gradual degradation. Therefore, we assumed that the effect of an observation (e.g., animal burrows) on the stability factor can be expressed as a reduction factor that is dependent of the levee type, the performance indicator and the level of severeness (see step 3 in Figure 5).

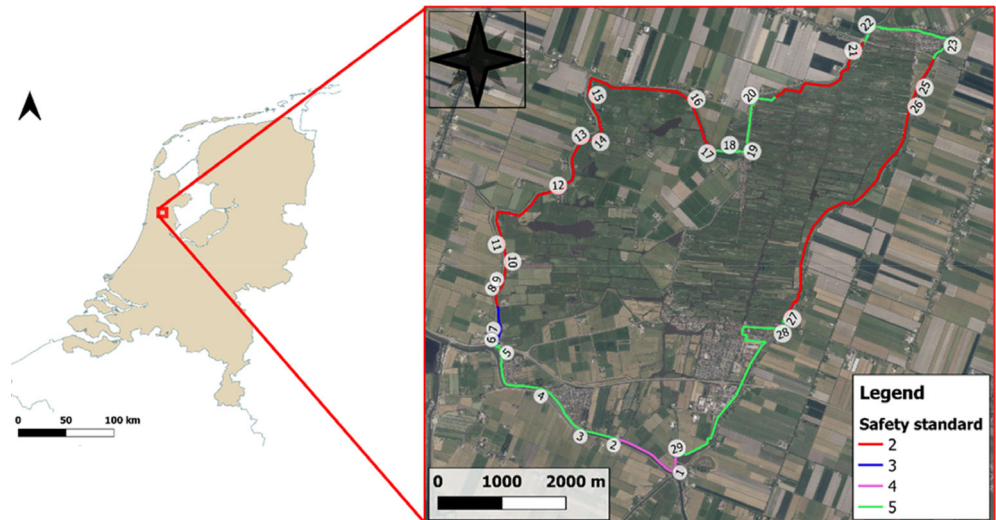
FIGURE 6 Left: Map of the Netherlands, with the location of the Eilandspolder. Right: Overview of levees protecting the Eilandspolder, the distinction into separate, numbered, levee sections, and their assigned flood protection standard

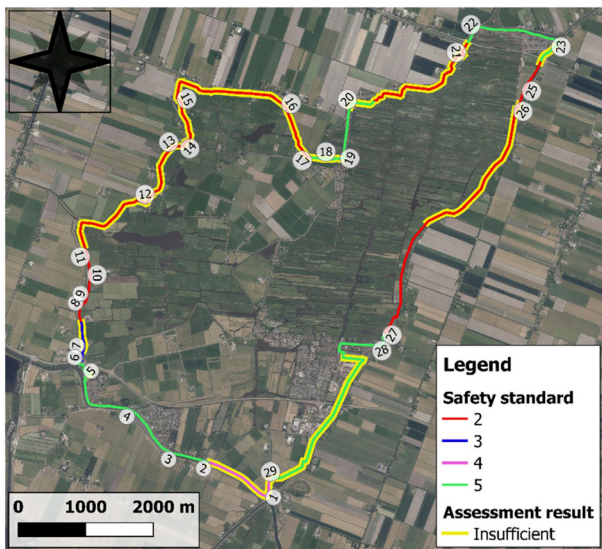
FIGURE 7 Overview of levees that do not meet the required safety standard for the failure mechanism macro-instability

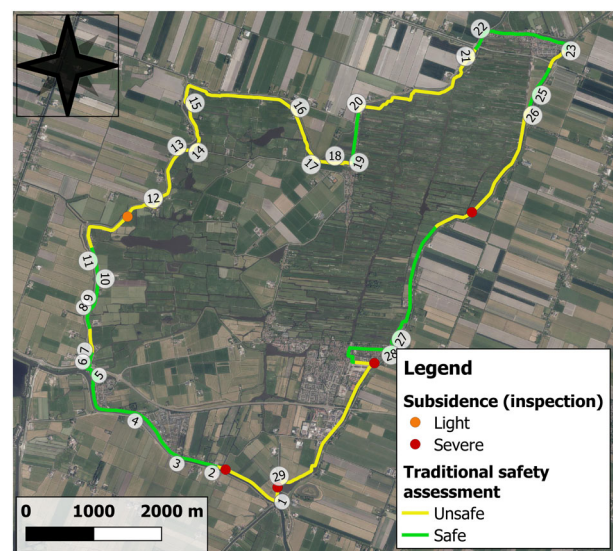
FIGURE 9 Map showing the subsidence observations from the levee inspection. Light subsidence is observed in section 4.5, and severe subsidence is observed in section 1 (on 2 locations), 8.2, and 9.2

Figure 9 shows the severity of levee subsidence per location, observed during levee inspections over a course of about 2 years (2016–2018). The figure only includes observations of levees that were unsafe according to the semi-probabilistic safety assessment. A distinction is made based on the degree of severity of subsidence:
