MBS Vehicle-Crossing Model for Crossing Structural Health Monitoring

MBS Vehicle–Crossing Model for Crossing Structural Health Monitoring

Abstract: This paper presents the development of a multi-body system (MBS) vehicle–crossing model and its application in the structural health monitoring (SHM) of railway crossings. The vehicle and track configurations in the model were adjusted to best match the real-life situation. By using the measurement results obtained from an instrumented crossing and the simulation results from a finite element (FE) model, the MBS model was validated and verified. The results showed that the main outputs of the MBS model correlated reasonably well with those from both the measurements and the FE model. The MBS and FE models formed the basis of an integrated analysis tool, which can be applied to thoroughly study the performance of railway crossings. As part of the SHM system for railway crossings developed at Delft University of Technology, the MBS model was applied to identify the condition stage of a monitored railway crossing. The numerical results confirmed the highly degraded crossing condition. By using the measured degradation as the input in the

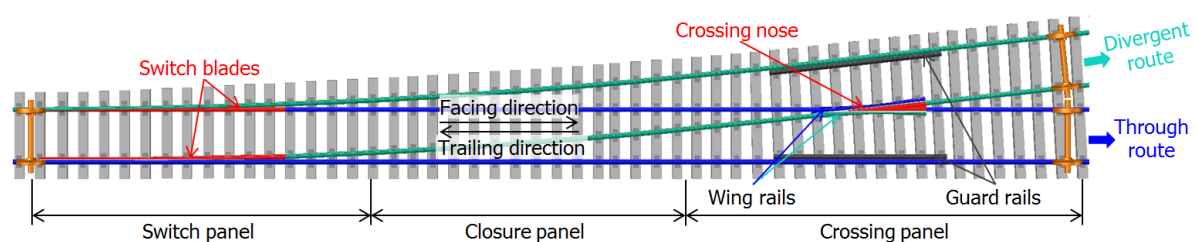
Figure 1. Standard left-hand railway turnout and the definition of the passing routes.

A sketch view of a standard left-hand turnout is shown in Figure 1.

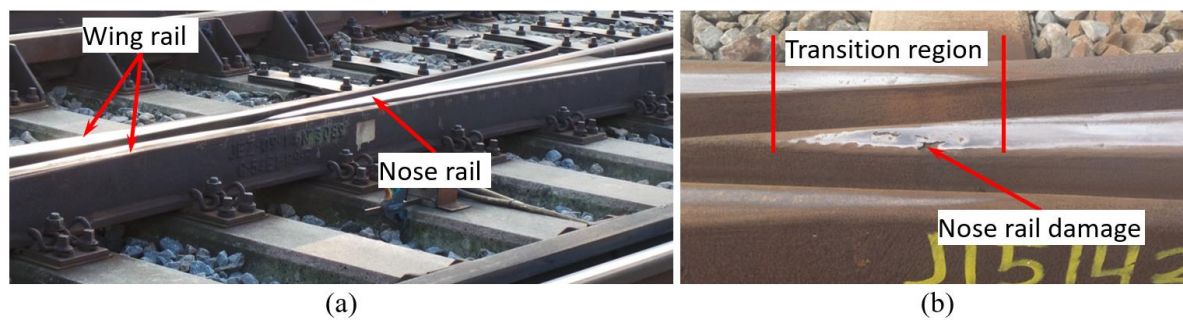
Figure 2. A 1:9 cast manganese steel crossing: (a) view of a wing rail and crossing nose rail, and (b) crossing nose rail damage in the transition region.

In the Netherlands, the most commonly used type of crossings is the cast crossing made of manganese steel with a crossing angle of 1:9 [37], as shown in Figure 2a. This type of crossing suffers greatly from severe plastic deformations and cracks, leading to spalling defects or even to sudden fracture of the crossing nose (Figure 2b). The service life of such crossings in the Netherlands has become prohibitively short, where in some cases, it is only 2–3 years [38]. To better understand the sources of their poor performance, the condition monitoring system based on instrumentation devices has been developed and implemented in this type of crossing, as described in Markine et al. [12]. The experimental data provided instant performance information about the monitored crossing, and together with the proposed condition indicators, they were used to assess the crossing condition and to describe the degradation process of the crossing. The indicators and related condition stages were determined experimentally. To verify them, as well as to extend the SHM system to other operational conditions (e.g., different types of crossings), a numerical model is necessary.

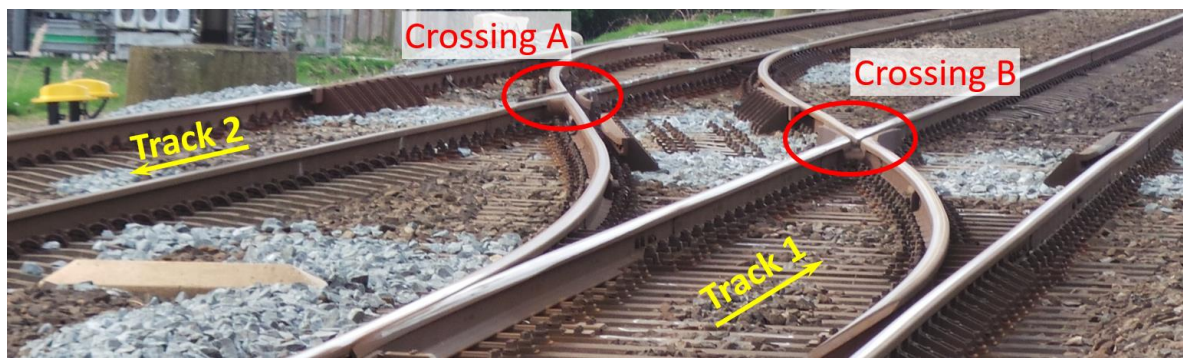
Figure 3. Typical crossover in the Dutch railway network.

In the railway track system, a crossover is a pair of turnouts that connects two parallel tracks and allows a train to pass over from one track to the other (Figure 3). Such a crossover is usually a part of a double crossover to allow all the trains to run on one track and gain more maintenance time for the other track. There are plenty of these crossovers on the Dutch railway network, and under normal operating conditions, the trains pass the crossings only in the through (facing or trailing) route (Figure 1). In the Dutch railway network, the presence of bridges, culverts, and level crossings limits the available space for the layout of the double crossovers. Therefore, the turnouts with the smallest crossing angle of 1:9, which requires a relatively short layout distance, are commonly used in crossovers.

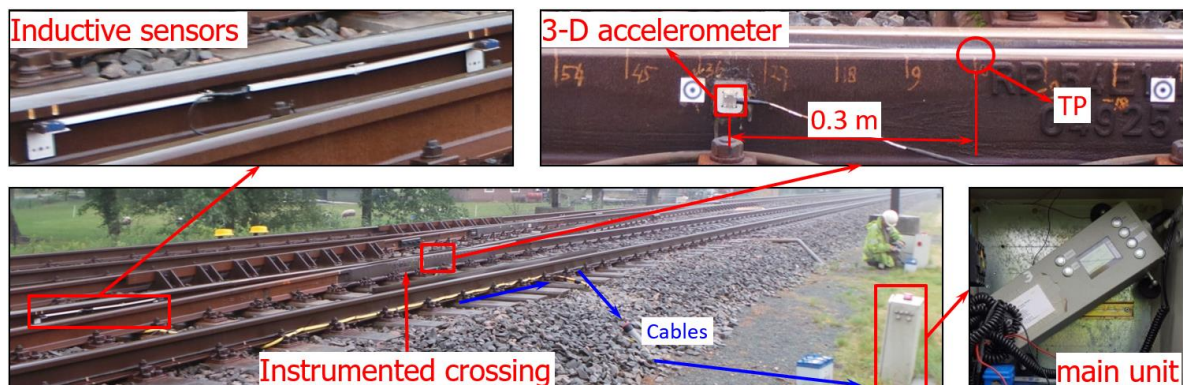
Figure 4. Overview of the crossing instrumentation. TP: Theoretical point.

As seen in Figure 4, the main components of this device are a 3-D accelerometer attached to the side of the crossing (0.3 m away from the theoretical point (TP)), a pair of inductive sensors attached in the closure panel, and the main unit installed near the track. The inductive sensors are used for train detection and train velocity calculations. All sensors are connected to the main unit for measurement control and data recording. The measurement range of the acceleration sensor is 500 g ($\approx 5000 \text{ m/s}^2$) and the sampling frequency is 10 kHz.

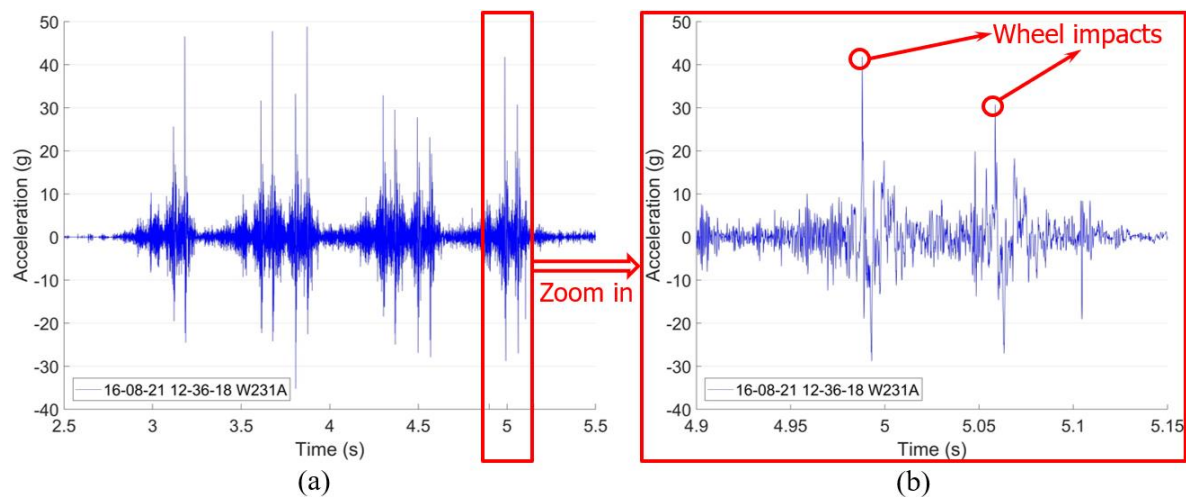
Figure 5. Measured crossing dynamic responses using the instrumentation: (a) vertical acceleration response of one train (12 wheelsets) and (b) examples used for wheel impacts extraction.

When a train passes through the crossing, the wheel–rail interaction is directly reflected in the vertical acceleration responses (Figure 5a). From these results, the impact due to each passing wheel can be extracted (Figure 5b). The statistical results of the impacts due to multiple passing wheels is considered to be a critical indicator for the crossing condition assessment [8].

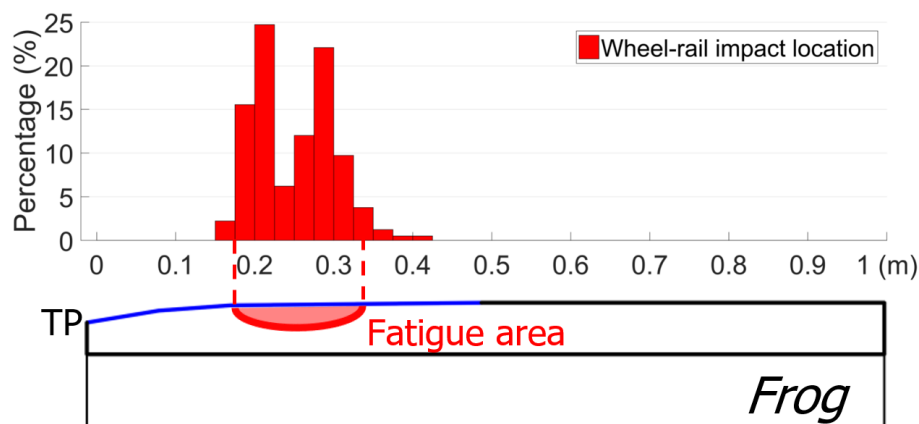
Figure 6. Example for the fatigue area detection.

Besides the wheel impacts, the impact location of each passing wheel could also be obtained, and the area where most of the wheel impacts were located was defined as the fatigue area, as shown in Figure 6. Practically, the fatigue area was simplified as the confidence interval of $[\mu - \sigma, \mu + \sigma]$, where μ is the mean value of the wheel–rail impact locations, and σ is the standard deviation. Theoretically, 68% of the wheel impacts are located in this region. Although discrepancies exist, such a simplification can reflect the development of the wheel–rail contact condition. It has already been demonstrated in a previous study [8] that the fatigue area is a good representation of the crossing rail damage observed in the railway network, which makes it an important indicator for assessing a crossing’s condition. The wheel impacts and the fatigue area are further discussed later, in combination with the developed MBS model.

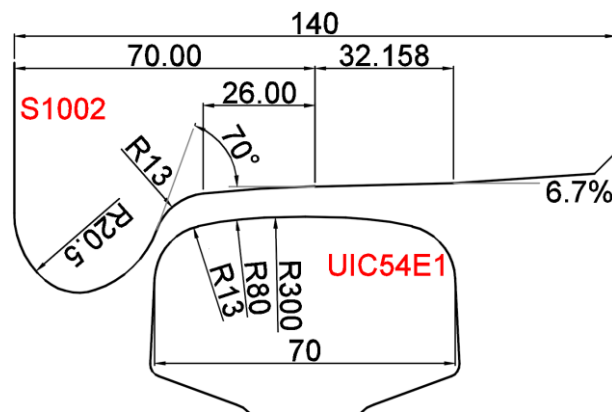
Figure 7. UIC54 E1 rail profile and S1002 wheel profile applied in the multi-body system (MBS) model (dimensions in mm).

In the MBS model, the vehicle model was developed based on the double-deck train VIRM [39], which is the most commonly used train type in the monitored track section. The wheel type used in the VIRM train is S1002, and the rail type used in the track is UIC54 E1. The main parameters of the S1002 wheel profile and UIC54 E1 rail profile are shown in Figure 7.

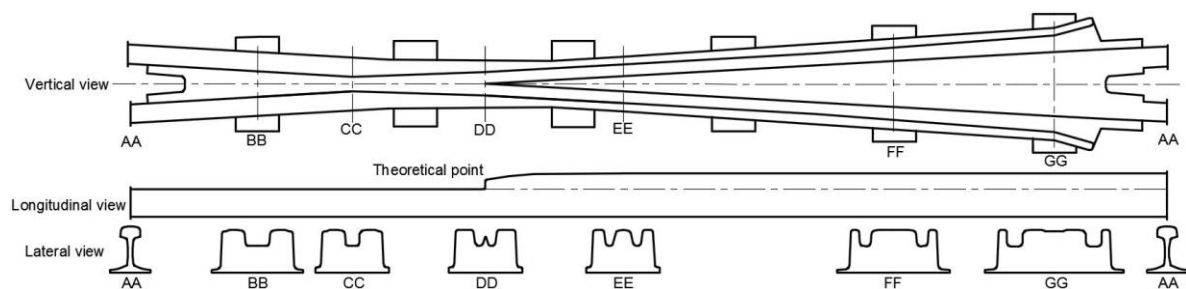
Figure 8. The geometry of the 1:9 cast crossing with defined critical cross-sections (drawing from Y. Ma).

The design drawing of the modeled 1:9 cast crossing is shown in Figure 8 (provided by the Dutch railway infrastructure manager ProRail). In this drawing, a group of critical cross-sections (from AA to GG) are defined to describe the crossing rail geometry. The total length of the crossing is approximately 3.7 m.

The crossing geometry is one of the critical components in the development of the MBS vehicle–crossing model. According to the design, the TP is located in the section DD, the change of the rail geometry is mainly from section CC (−0.50 m from the TP) to section FF (1.51 m from the TP). For the nose rail, the geometry is gradually developed from an arc ($r = 2$ mm) in the TP to the UIC54 E1 profile in the section of 0.63 m from the TP (between sections EE and FF). Some additional sections are added to precisely define the crossing geometry, which can help to control the curvature of the arcs in the rail profiles and the height of the nose rail. The additional control sections between DD and FF are shown in Figure 9.

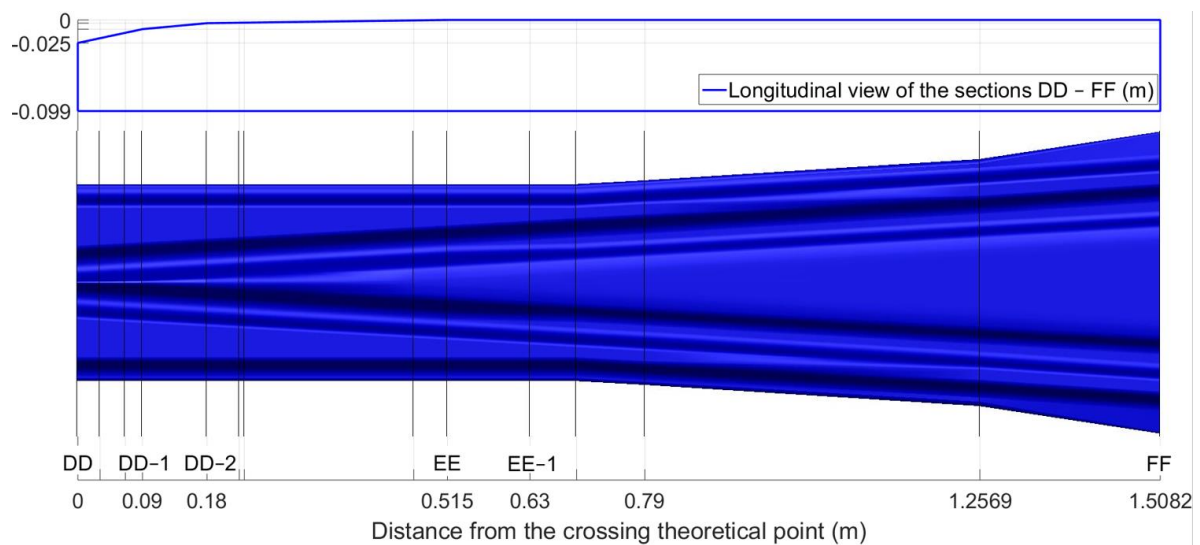
Figure 9. Additional cross-sections between DD and FF.

The height of the nose rail is defined by four control sections, namely section DD, two sections every 0.09 m (DD−1 and DD−2, Figure 9), and section EE that is 0.515 m from DD. Similarly, the profile of the nose rail is defined by five control sections from the TP (DD) to the section EE−1 with the UIC54 E1 profile (0.63 m from the TP). Together with some auxiliary sections, the crossing geometry is defined by 23 control sections, including AA, and the profiles between two control sections are automatically interpolated using the third-order spline curve.

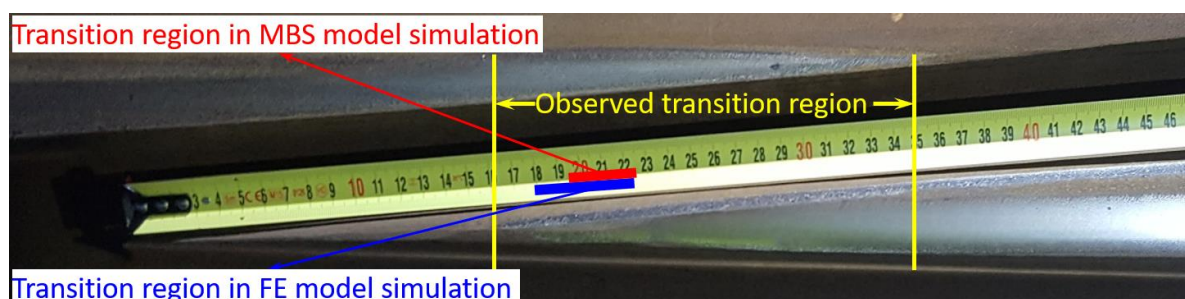
Figure 12. Transition regions obtained from the field observation and the numerical simulations. FE: finite element.

In real life, the transition region was obtained through inspection and recognized as the overlapping shining bands on both the wing rail and the crossing nose. For the monitored crossing, the observed transition region was around 0.16–0.35 m with a size of 0.19 m, as shown in Figure 12. It can be seen that the transition region in the MBS simulation was within the observed one but was much smaller with a size of only 0.031 m. Such a phenomenon can be explained by the ideal initial conditions (no lateral angle or displacement) of the wheels used in the simulations and the absence of the wheel or rail irregularities. Moreover, the actual crossing was not new and had a certain level of plastic deformations and wear. In reality, every wheel passed the crossing with a certain angle and lateral shift that resulted in earlier/later contact in the transition region. The fact that the simulated transition region was included in the transition region of the real crossing proved the correctness of the MBS simulation results.

The transition region in the FE model simulation [4] was 0.180–0.223 m with a size of 0.043 m, which was 30% larger than that obtained from the MBS simulation. Considering that in the MBS model,

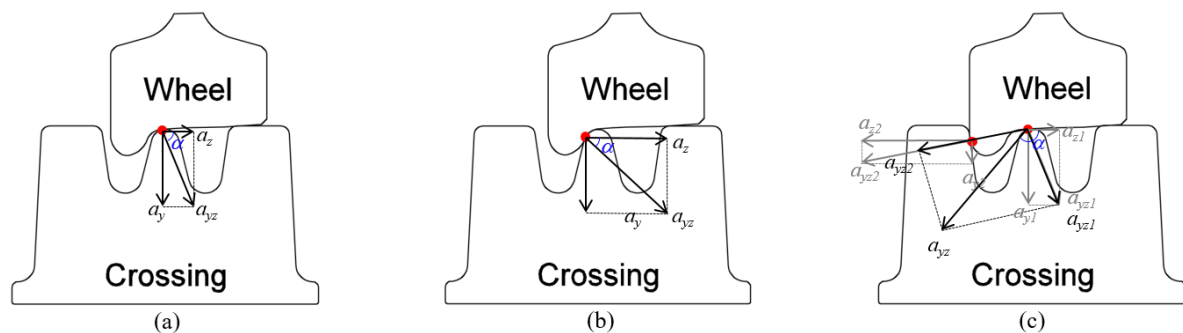
Figure 13. Wheel–rail contact situations: (a) regular contact, (b) irregular (positive) flange–nose rail contact, and (c) irregular (negative) flange–wing rail contact.

Due to the uncertainty of the wheel–rail contact situation, the measured impact accelerations of the passing wheels can vary a lot from one to another in terms of amplitude and impact angles [8], as shown in Figure 13. In extreme cases, such as the wheel flange impact on the rail (Figure 13b,c), the acceleration responses can be up to 10 times higher than that due to a normal passing wheel.

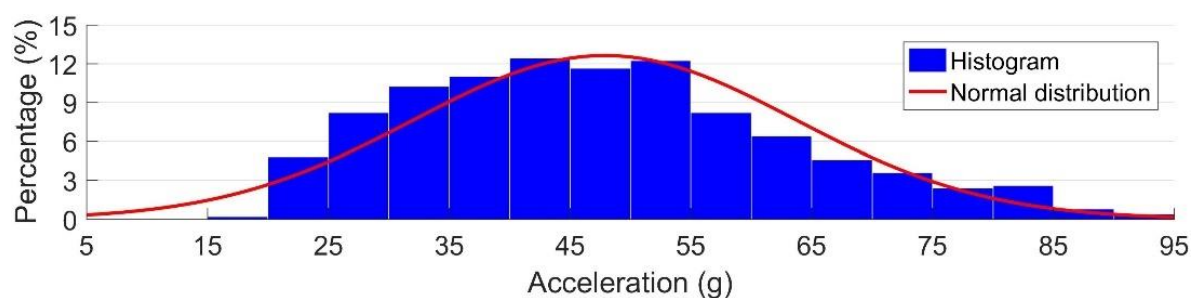
Figure 14. Histogram of the measured vertical accelerations used in the model validation.

The measured acceleration signals for the model validation contained more than 1000 wheels from 90 trains. In both numerical models, no track or rail irregularities were considered, which means that in the numerical simulations, the wheel (wheel-set) did not experience any additional disturbance when passing the crossing. As a result, the contact situation in these simulations was always regular (Figure 13a). Therefore in the model validation, only the measured signals with the regular contact ($|a_y| > |a_z|$) were used, which resulted in 500 selected passing wheels. The distribution of the impact accelerations due to these passing wheels is shown in Figure 14. The resulting histogram can be considered a normal distribution, with a mean value of $\mu = 47.15$ g and a standard deviation of $\sigma = 17.65$ g.

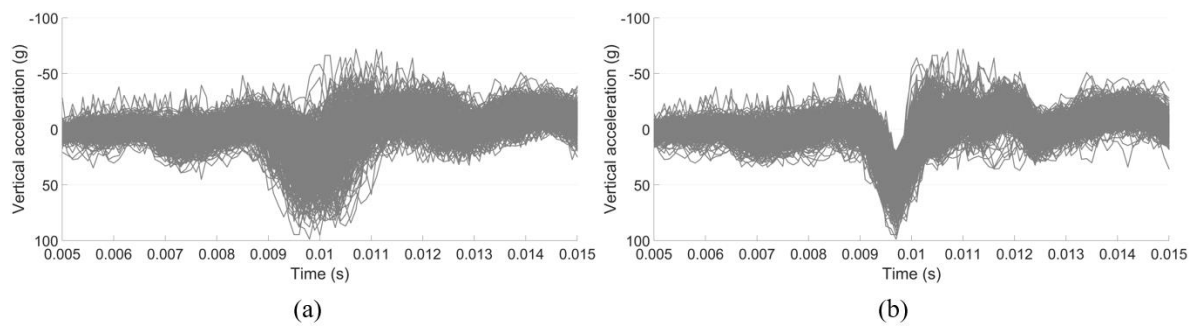
Figure 15. Measured acceleration responses: (a) original time–domain results and (b) modified results, with the time histories aligned horizontally with the impact point.

The time-domain representation of the selected measured acceleration responses used in Figure 14 is given in Figure 15a. For a better interpretation, the time histories were aligned horizontally with the wheel–rail impact point (Figure 15b), which were used for validation of the numerical model.

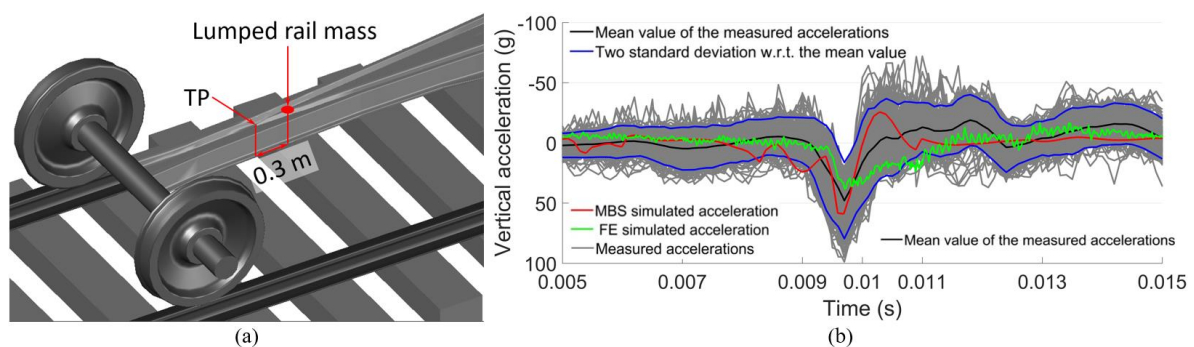
Figure 16. (a) Rail element for acceleration extraction in the MBS model. (b) Comparison of simulated accelerations with measured ones in time domain.

In the MBS model, the selected element used for the acceleration extraction was the rail with a lumped mass (Figure 16a) located 0.3 m from the TP, which was the same as the location of the accelerometer in the crossing instrumentation (Figure 4). The comparison of the MBS simulation results with the measured responses and the FE simulation results is shown in Figure 16b.

From Figure 16b, it can be seen that the amplitude of the MBS simulated vertical acceleration was higher than the mean value of the measured acceleration, as well as those from the FE simulation. It can also be noted that some of the measured accelerations had rebound after the impact (0.01–0.011 s). The MBS simulation also had such a rebound, while the FE simulation did not.

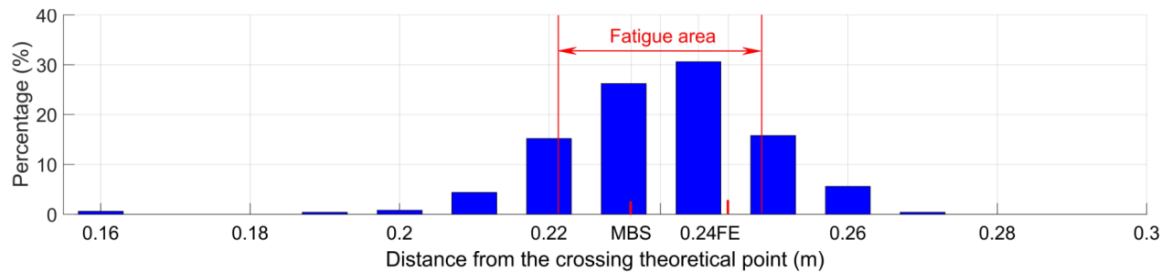
Figure 17. Distribution of wheel impact locations.

from field measurement represents the degree of concentration of the wheel impacts, while the impact location in the MBS simulation was only from one wheel passage. Even so, the close results proved the correctness of the MBS model.

By comparison, the impact location in the FE simulation was 0.244 m, which was within the fatigue area as well. The close impact locations obtained from the MBS and the FE simulations further proved the compatibility of these two models.

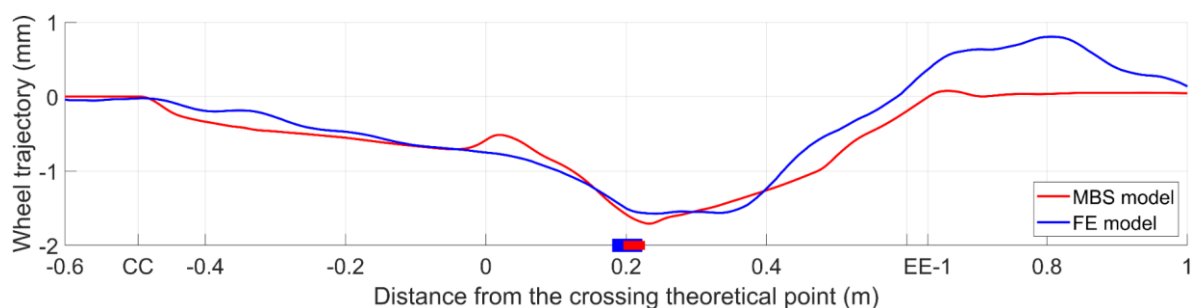
Figure 18. Wheel vertical trajectory comparison.

The vertical wheel trajectory is the vertical displacement of the wheel relative to the rail. The change of the trajectory reflects the smoothness of the wheel passing through the crossing [35]. The vertical trajectories of the wheel in the MBS and FE simulations are shown in Figure 18. To provide a better comparison, the initial points of all the simulations were shifted to zero.

It can be seen from Figure 18 that despite some slight differences near the TP and after the transition region, the trajectories of both simulations were very close to each other. The maximum

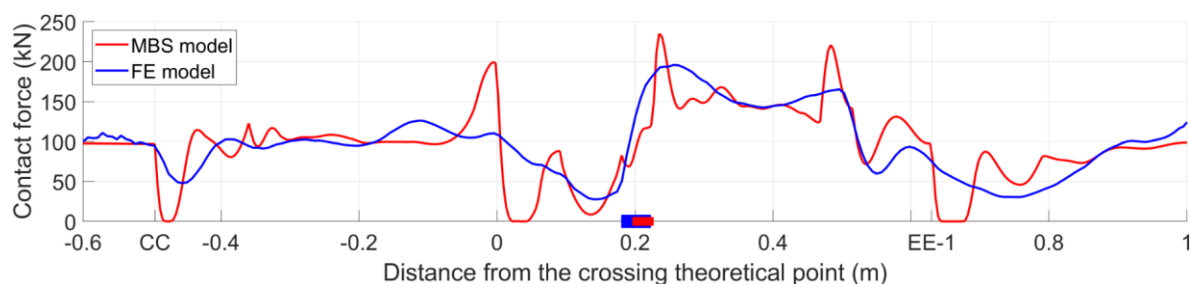
Figure 19. Comparison of the vertical wheel–rail contact forces.

Figure 19 shows the vertical wheel–rail contact forces obtained from the MBS and FE models. Similar to the wheel trajectory comparison, the contact forces of both models were close to each other. In the MBS simulation, loss of wheel–rail contact occurred near the sections of CC, DD, and EE-1, which were consistent with the locations where the wheel slightly rebounded (Figure 19). By comparison, the wheel–rail contact forces in the FE model developed smoother than those in the MBS models with less fluctuation.

The decrease in the contact forces of both models near section CC (Figure 19) indicated the beginning of the wing rail. At this point, the wheel–rail contact point on the wheel shifted farther from the wheel flange. In the MBS model, the sudden increase of the contact force near the TP reflected the effect of geometry change of the wing rail. It must be noted that the first peak values (after passing through the TP) of both models occurred after the respective transition regions. In the MBS simulation, the pick value was 235 kN, which was located at 0.235 m from the TP. Meanwhile, in the FE model, it was 196 kN at 0.256 m. The second peak values were 221 kN at 0.484 m in the MBS model and 165 kN at 0.496 m in the FE model.

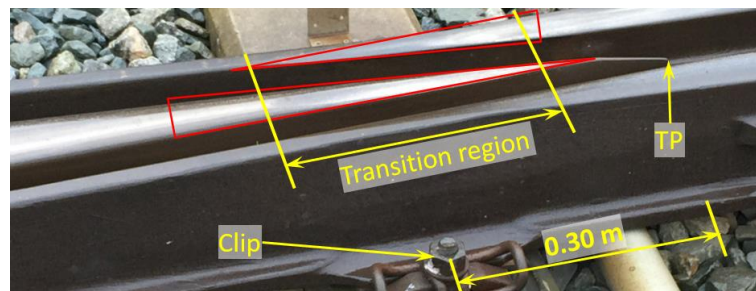
Figure 20. Transition region inspection of the monitored 1:9 trailing crossing.

To process the measured data, the transition region in the crossing was inspected, as shown in Figure 20. The transition region was recognized as the region with overlapping shining bands. Using the track dimensions (the sleeper width was 0.20 m, and the clip was located at 0.30 m from the TP), the transition region of this crossing was located between 0.15–0.40 m from the TP.

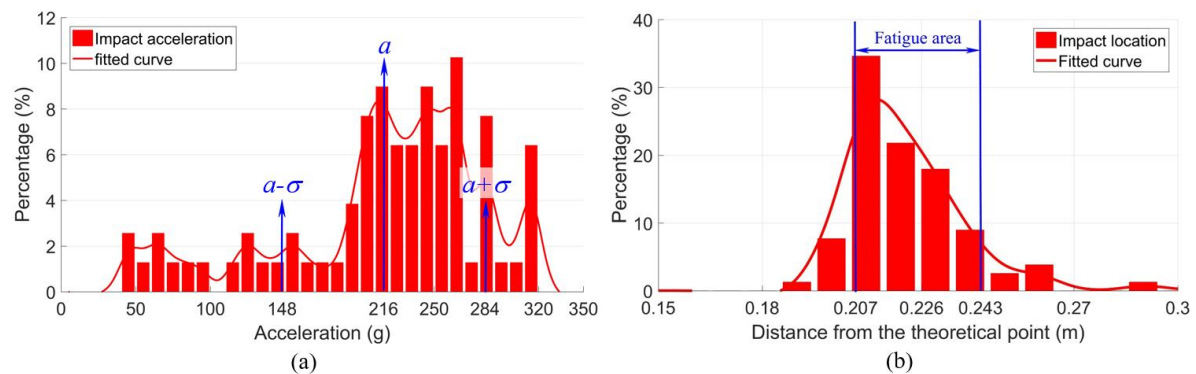
Figure 21. Measured dynamic responses: (a) wheel impact distribution and (b) impact location distribution.

The measurement data used for the crossing performance analysis consisted of the multiple wheel passages from one monitoring day. To be consistent with the numerical simulation, only the results from the VIRM trains with velocities of around 140 km/h, as used in the model, were selected, which resulted in a sample size of 78 passing wheels. The magnitude and location of the impacts due to these wheels were analyzed and the results are presented in Figure 21.

Figure 21a shows the magnitude distribution of the measured impact acceleration responses. The mean value was 216 g and the standard deviation was 68 g. The impact location distribution is shown in Figure 21b, from which it can be seen that the majority of the wheel impacts (the fatigue area) was located at a distance 0.207–0.243 m from the TP, resulting in a size of the fatigue area of 0.036 m.

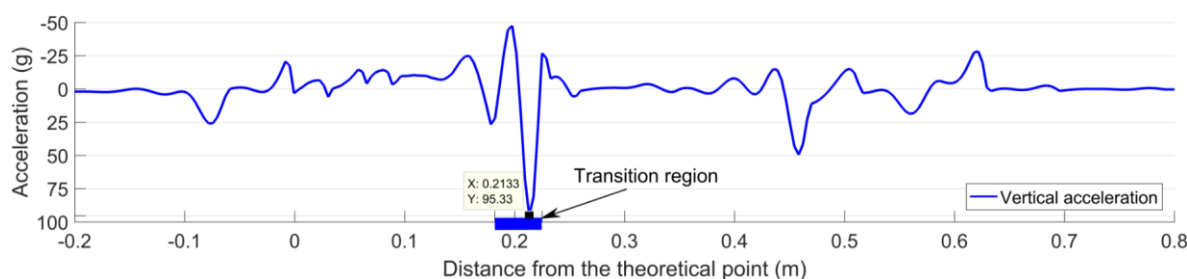
Figure 23. Rail vertical acceleration responses of a 1:9 trailing crossing in designed condition.

Figure 23 shows the vertical acceleration responses of the crossing rail due to the first passing wheel. It can be seen that the maximum acceleration (due to the wheel impact) was 95 g. This value was much lower than the mean value of the measured impact acceleration (216 g) shown in Figure 21a. Based on the significant difference (increase) between the measured and the simulated crossing accelerations (in the designed condition), it can be concluded that the monitored crossing was in a highly degraded condition. This conclusion was in agreement with the experimental results of a 1:15 crossing presented in [13], wherein the significant increase (68%) in the observed measured acceleration was correlated with the visible damage of the crossing rail.

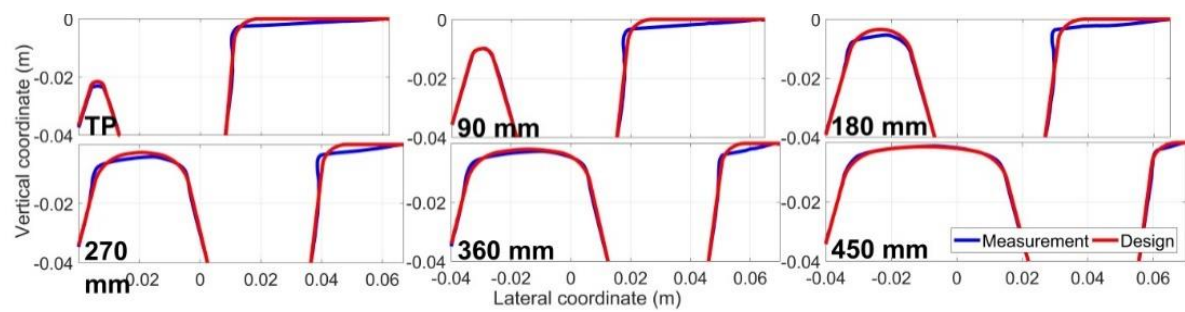
Figure 24. Measured crossing profiles in critical sections compared with the designed profiles.

For a regularly degraded railway crossing, one of the typical damage sources is rail wear and deformation. For the monitored crossing, the rail profiles in the critical sections were measured and compared with the designed profiles, as shown in Figure 24.

It can be seen from Figure 24 that the crossing rail was worn and deformed. The most severe material damage on both the wing rail and the nose rail occurred in the section of 0.18–0.27 m, which was consistent with the distribution of the wheel impact locations (0.207–0.243 m, Figure 21b). It can also be seen that the wear and deformation of the wing rail continued into the section of 0.00–0.18 m, meaning that the rail degradation extended out of the transition region. From this point of view, the crossing had been operating under a degraded condition for a significant period.

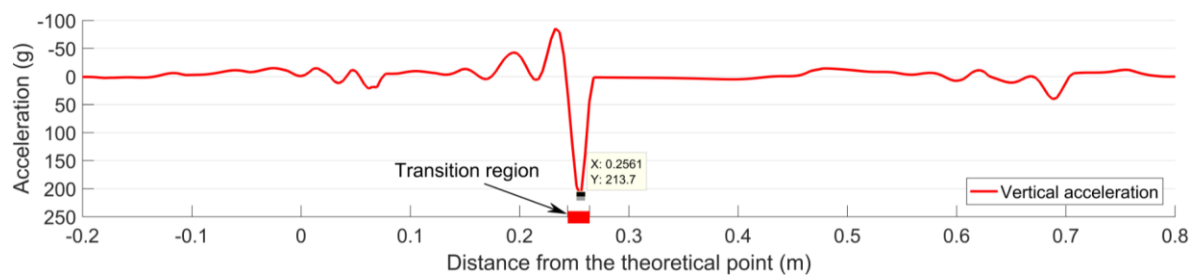
Figure 26. Simulation results of the 1:9 trailing crossing with rail wear and deformation taken into account.

The simulation results of the crossing acceleration due to the first passing wheel is shown in Figure 26. Compared with the designed condition (Figure 23), the crossing acceleration in the degraded condition was increased from 95 g to 214 g, and such a result was quite close to the mean value of the measured results (216 g, Figure 21a). These results indicated that the degraded rail geometry was the main cause of the increased accelerations.

It should be noted that the simulated wheel impact was located at 0.256 m from the TP, which was not consistent with the measured fatigue area (0.207–0.243 m, Figure 21b). Furthermore, this location was 0.043 m farther than the wheel impact in the designed condition (0.213 m, Figure 23). Such a result indicated that besides the degraded crossing rail geometry, there might also be some other degraded elements in the monitored crossing (e.g., uneven ballast settlement) that need to be further investigated in combination with displacement measurement results.

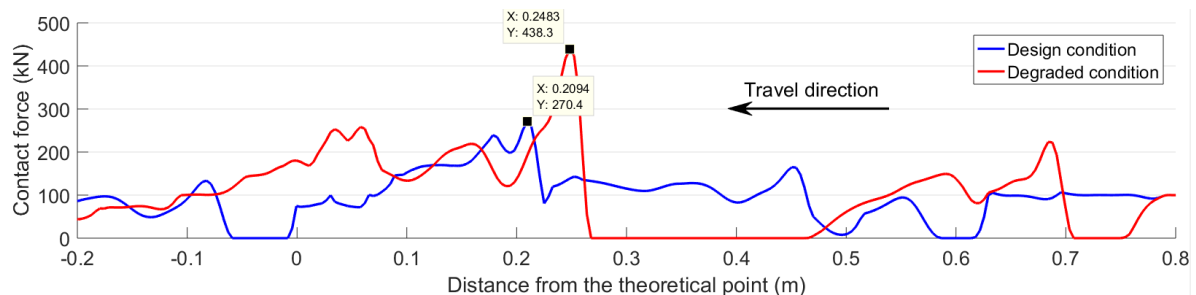
Figure 27. Wheel–rail contact forces in different rail conditions.

To analyze the developments in the wheel–rail interaction, the contact forces in both the designed and degraded conditions were also compared. The results are presented in Figure 27. Besides the dramatically increased impact force (438 kN in the degraded condition vs. 270 kN in the designed condition), the rail damage resulted in the loss of wheel–rail contact in the 0.27–0.46 m region. Such results show the influence of rail wear and deformation on the wheel’s behavior. Due to the interaction with the other wheel from the same wheelset, as well as the influence of the other wheelset within the same bogie, the wheel that was running through the crossing could not fully follow the damaged rail profile. Consequently, when the wheel resumed contact with the rail, the contact force was dramatically increased and the wheel load was sharply shifted from the crossing nose to the wing rail. Such a sharp transition of the wheel load led to a higher impact on the crossing.
