## Development of fragility curves for railway embankment and ballast scour due to overtopping flood flow

Natural Hazards and Earth System Sciences

# Development of fragility curves for railway embankment and ballast scour due to overtopping flood flow

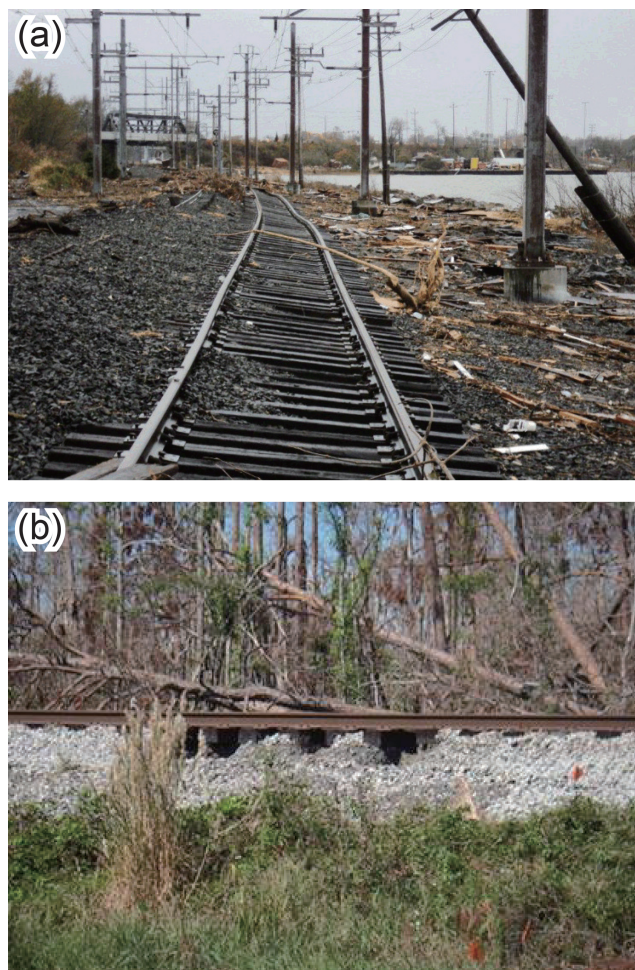
**Figure 1.** Railway ballast scour failures: (a) New Jersey Transit tracks in New Jersey, USA, after Hurricane Sandy in 2012; (b) CSX railroad tracks in Mississippi, USA, after Hurricane Katrina in 2005 (photo credits: New Jersey Transit, a).

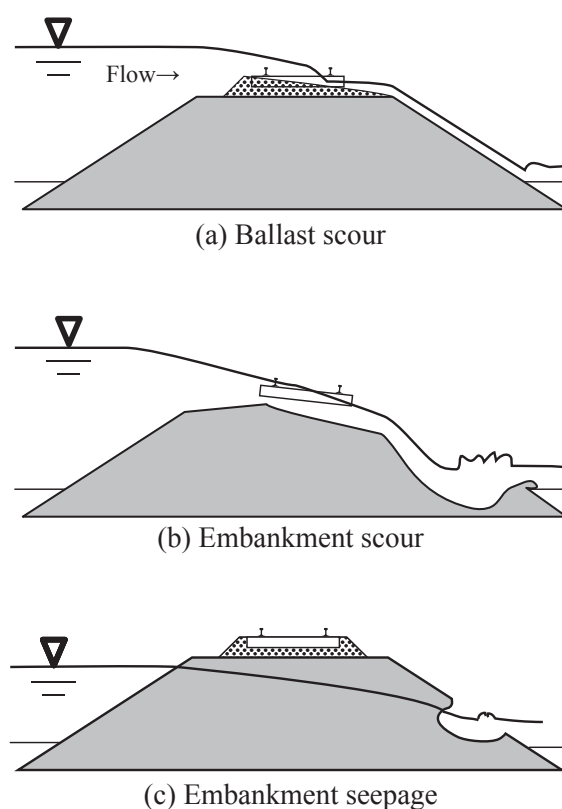
Figure 2. Railway embankment damage types.

ometrically similar to roadway embankments and levees, the structures atop railway embankments are very different from those atop these other embankments, as are the mechanisms by which overtopping can cause damage. As Fig. 2 shows, floods can cause damage to railway embankments via three processes: (a) scour of ballast induced by overtopping, (b) scour of both ballast and embankment fill by overtopping, and (c) piping/seepage failure of embankment fill. Though piping/seepage failure of fill is more likely to occur in high (and wide) embankments, most railway embankments are relatively low, and most observed railway embankment failures appear to have been the result of overtopping-induced scour of embankment fill and/or ballast (Kaneko, 2010; Tsubaki et al., 2012a; Onoda and Hayano, 2015). Ballast scour is a damage mode unique to railway embankments. In the cases of ballast scour only, repair of the ballast layer is relatively straightforward, but in cases of embankment fill scour, repairs can be costly and take a long time. Repair of damage to an embankment is less expensive than repair of damage to bridges and other facilities (see Table 1), but ballast and embankment damage occurs much more frequently than bridge damage. Furthermore, river floods or tsunamis large enough to damage bridges usually also cause extensive flooding which leads very long sections of an embankment to wash out (e.g., Shimozono and Sato, 2016). Therefore, the development of fragility curves for scour of railway ballast and embankments is crucial for the assessment of railway vulnerability and resilience.

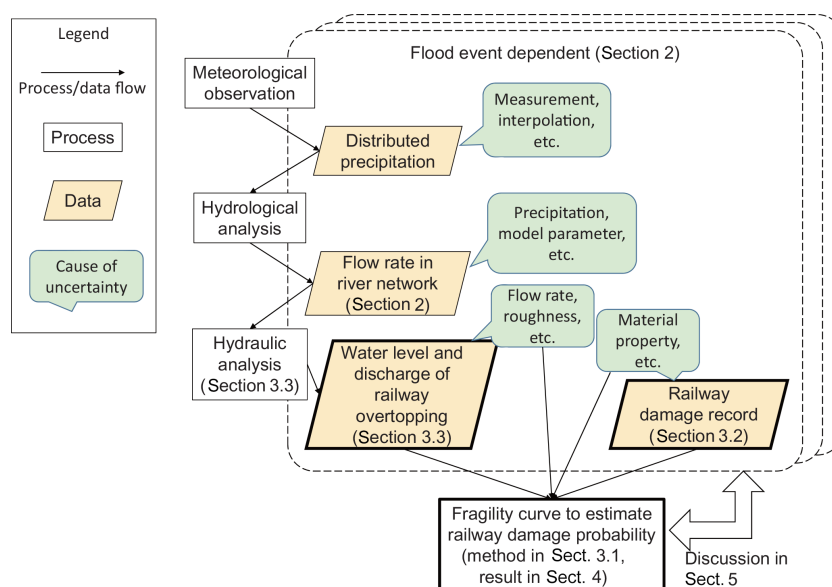
**Figure 3.** Relationship between processes and data within the structure of this paper.

Figure 3 shows the relationship between the processes and data used in this study. The two flood events for which damage records exist, as well as the estimated flow rates in the river networks during these events, are described in Sect. 2. Section 3 is devoted to the methods used in this study. Fragility curves are introduced in Sect. 3.1. Railway damage recorded for the two flood events is described in Sect. 3.2. The method of hydraulic analysis and uncertainty in the estimated water depth are both described in Sect. 3.3. Based on the results of Sects. 3.2 and 3.3, the fragility curves are developed in Sect. 4. Discussions including the comparison between the estimated damage probability and recorded damage types are reported in Sect. 5. Section 6 highlights the conclusions of this study.

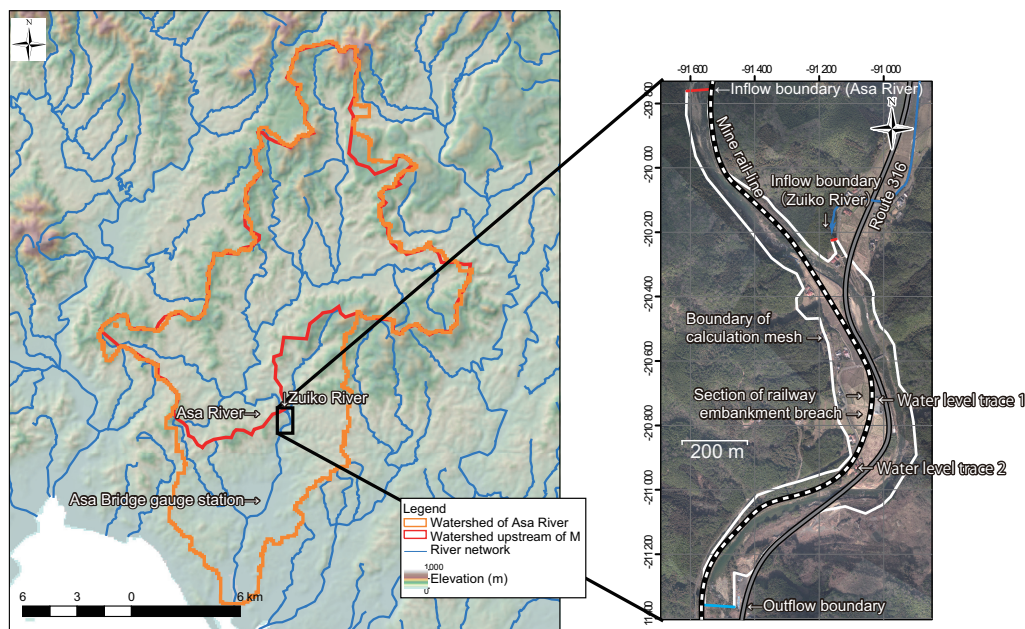
**Figure 4.** Watershed of the Asa River (left) and aerial photo taken in 2011 of section M (right). (Source: National Land Numerical Information download service, Ministry of Land, Infrastructure, Transport and Tourism, Japan, for digital elevation model, watersheds, and river network.)

In June 2010, a large flood occurred along section M (see Fig. 4) of the Asa River and caused inundation of homes and a factory, as well as washout of a railway embankment (Yamasaki et al., 2010; Tsubaki et al., 2014). The left-hand map in Fig. 4 outlines the watershed upstream of section M of the Asa River in red, while the watershed of the entire reach of the Asa River is outlined in orange. A storage function model, with parameters calibrated to previous major events, was used to calculate an event-dependent model parameter  $R_{sa}$  (a saturation criterion to start runoff), which was determined via best fit to the discharge hydrograph measured at the Asa Bridge gauge station (location indicated in the left panel of Fig. 4) based on four error criteria (Ube Construction Office, 2012). The estimated maximum flow rate in the Asa River was  $811 \text{ m}^3 \text{ s}^{-1}$  (Ube Construction Office, 2012), while the inflow from the Zuiko River was  $110 \text{ m}^3 \text{ s}^{-1}$ . Though it is possible that the peak flow in each river would reach their confluence at slightly different times, the same hydrologic model showed that the maximum flow at a point 3 km downstream of the confluence was

Water levels hindcast by the flood simulation are compared with measured water level traces from two locations depicted in the right panel of Fig. 4. Steady flow boundary conditions were used for model inflow and outflow, though the presence of vortices (circulatory flow) over the floodplain and near the riverbanks caused a complex velocity field and prevented perfectly steady flow from forming (Tsubaki and Kawahara, 2013). Due to these fluctuations, modeled water levels were assessed via both 20 min running averages representing each minute of model output, as well as maximum water levels during these same intervals. Flood elevation trace no. 1, on the inner wall of the factory, was measured to be 25.98 m (in Tokyo datum, hereafter). The average modeled flood elevation here was 25.79 m, and the maximum modeled flood elevation at this location was 25.90 m. At location no. 2,

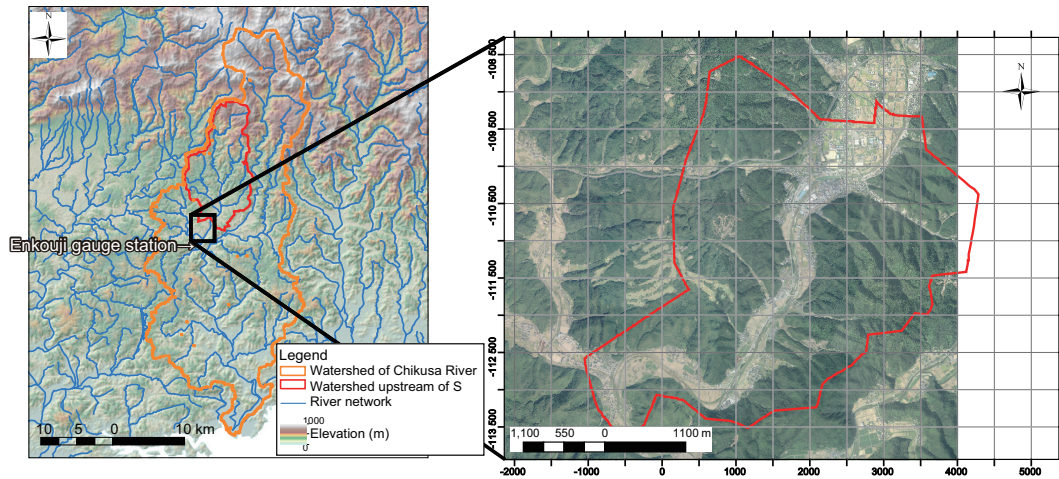
**Figure 5.** Watershed of Chikusa River (left) and hydraulic flood model domain in section S of Sayo River (right). (Source: National Land Numerical Information download service, Ministry of Land, Infrastructure, Transport and Tourism, Japan, for digital elevation model, watersheds, and river network and Kinki Regional Development Bureau, Ministry of Land, Infrastructure, Transport and Tourism Japan for the aerial photo taken in 2010.)

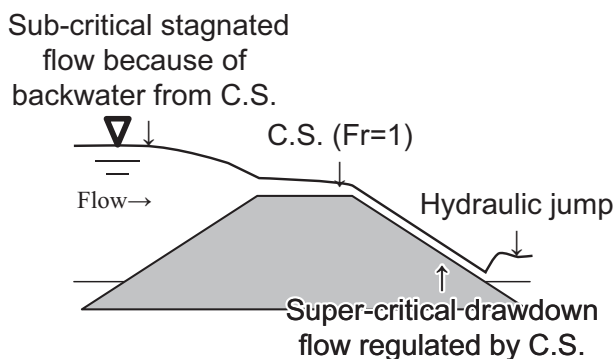
**Figure 6.** Schematic diagram of one-dimensional flow over embankment. C.S. in figure corresponds to the critical section where the flow is critical.

In this paper, we use upstream flood water level (overtopping surcharge) as a variable explanatory for railway overtopping failures. As schematically depicted in Fig. 6, under the situation of water overtopping an embankment, critical flow occurs on the embankment (C.S. in Fig. 6) and the upstream water level correlates almost directly to the overtopping discharge (Chow, 1959; Dawson et al., 2005; Apel et al., 2009). The upstream water has less velocity head and the surface is relatively flat, whereas the overtopping flow atop the embankment is rapidly varied flow and quite sensitive to small differences and uncertainty in the local elevation of the em-

bankment crest. The flow on the lee side of embankment is supercritical and the water level is regulated by the C.S. The local flow rate over the embankment crest estimated by the embankment-resolving fine-resolution inundation simulation (e.g., Tsubaki and Kawahara, 2013) has non-negligible uncertainty because of high sensitivity to the embankment shape and height represented by the undulation of the calculation grid based on the digital elevation model and land cover data. This is because exchange between kinetic and potential energies is actively occurring in this area (Chow, 1959), leading to a two-dimensionally undulating water surface profile and inhomogeneous velocity distribution (Tsubaki and Kawahara, 2013). For these reasons we use the upstream water level as a hazard level to explain the probability of railway failure.

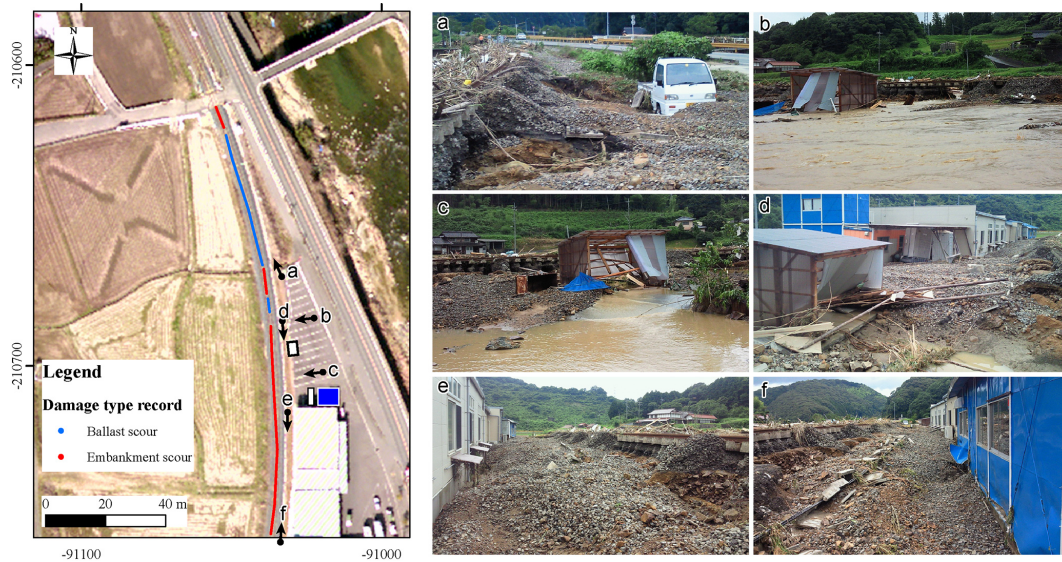
**Figure 7.** Example of the photos showing the status of the railway ballast–embankment scour just after the flood. Shooting location and direction of each photo are both plotted in the left orthorectified aerial photo taken in February 2012 (photo source: M. Kikunaga).

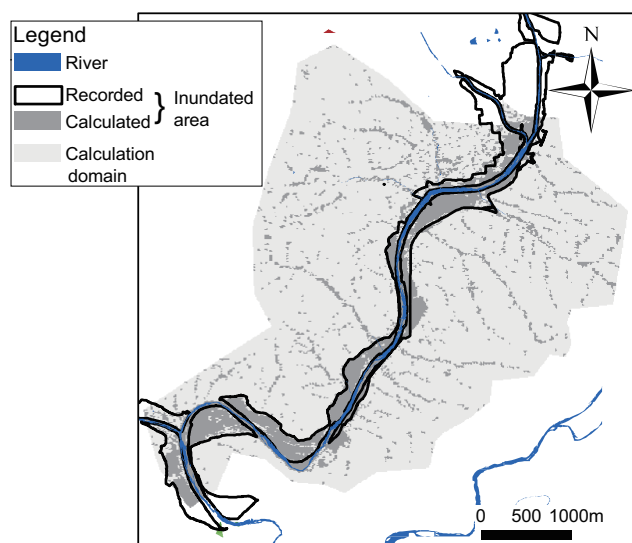
**Figure 8.** Comparison of calculated and recorded inundation areas (Tsubaki et al., 2012a).

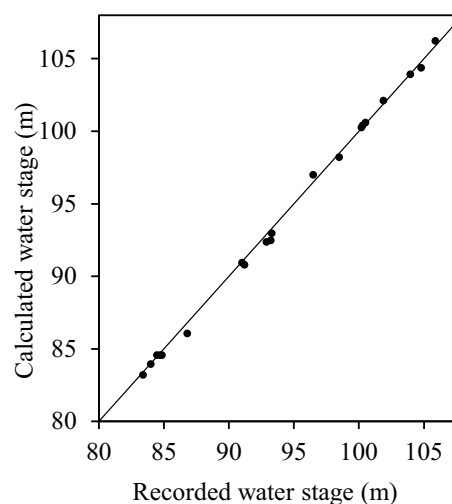
**Figure 9.** Comparison of calculated and recorded flood stages in Tokyo datum. The straight line shows the perfect-agreement line, i.e., recorded water stage = calculated water stage (Tsubaki et al., 2012a).

cover on the embankment slope. Moreover, there is a difference in the definitions of calculated and recorded water depths, namely the calculated water depth is a cell-averaged quantity but the recorded water depth denotes the local water depth around obstacles; this caused an underestimation of the calculated water depth as reported in Sect. 3.3.2a for the Asa River and shown in Fig. 9 for the Sayo River.

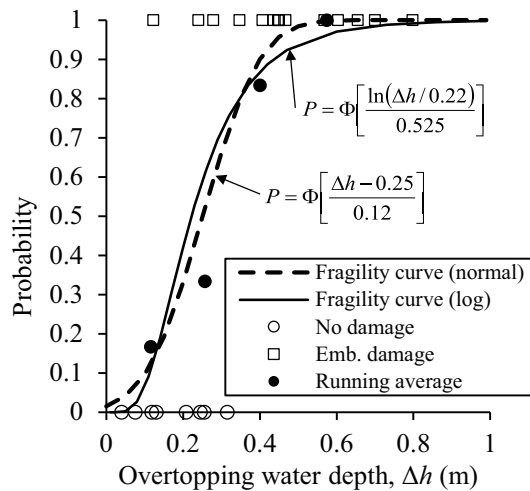
**Figure 10.** Fragility curves for embankment scour damage described by normal and log-normal distributions.

Figure 10 displays the fragility curves for the embankment scour using the normal distribution (depicted by the dashed line with log-likelihood  $\ln(L) = -7.3$ ) and the log-normal distribution (the solid line with log-likelihood  $\ln(L) = -7.9$ ) resulting from data points at which either no damage (the number of samples was  $n = 8$ ) or embankment scour ( $n = 16$ ) was observed at two flood events. In Fig. 10, open symbols represent individual data points, while filled figures represent overtopping water depth and damage data which have been put through a five-point running average after ordering by overtopping water depth. Though both normal and log-normal distribution models (solid and dashed lines, respectively) represent well the trend of damage probability based on the field record (filled circles), the normal distribution has a slightly better fit.

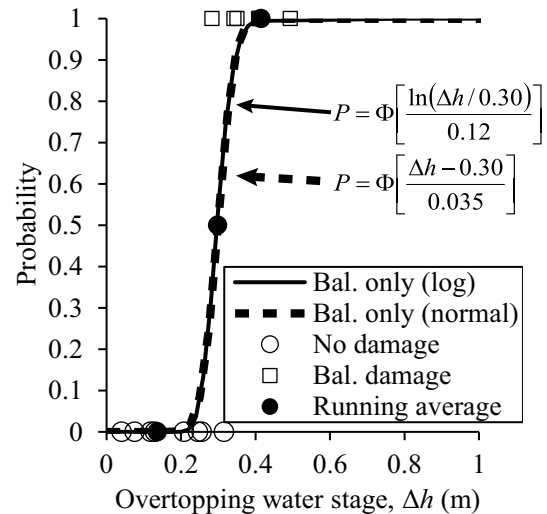
**Figure 11.** Fragility curves for ballast scour damage described by normal and log-normal distributions.

Figure 11 shows the fragility curves for the ballast scour using the normal distribution (depicted by the dashed line with log-likelihood  $\ln(L) = -2.6$ ) and the log-normal distribution (the solid line with log-likelihood  $\ln(L) = -2.6$ ) resulting from data points at which either no damage (the number of samples was  $n = 8$ ) or ballast scour ( $n = 7$ ) were observed during the two flood events. The normal and log-normal curves were almost identical.

In Fig. 11, the fragility curve for ballast scour has a median overtopping water depth of  $\Delta h = 0.30 \text{ m}$ , and its variance  $\sigma = 0.035 \text{ m}$  is smaller than those of the fragility curves for the embankment scour and combined ballast and embankment scour. It must be kept in mind that the lidar topography used in the flood model has an RMSE on the order of  $0.1 \text{ m}$ , and the uncertainty in hindcast flood levels was on the order of  $0.2 \text{ m}$ , so the standard deviation  $\sigma = 0.035 \text{ m}$  of the ballast scour model is very small compared with expected uncertainty in the estimated overtopping water level. The experiment of Tsubaki et al. (2012b) showed ballast scour to begin at  $q_c = 0.045 \text{ m}^2 \text{ s}^{-1}$ , which is an order of magnitude smaller than the median ( $q = 0.4 \text{ m}^2 \text{ s}^{-1}$ ) or lower limit ( $q = 0.25 \text{ m}^2 \text{ s}^{-1}$ ) of the fragility curve for ballast scour shown in Fig. 13. Therefore, it appears the calculated fragility curve for ballast scour in this study may overestimate the condition experimentally evaluated in Tsubaki et al. (2012b). This

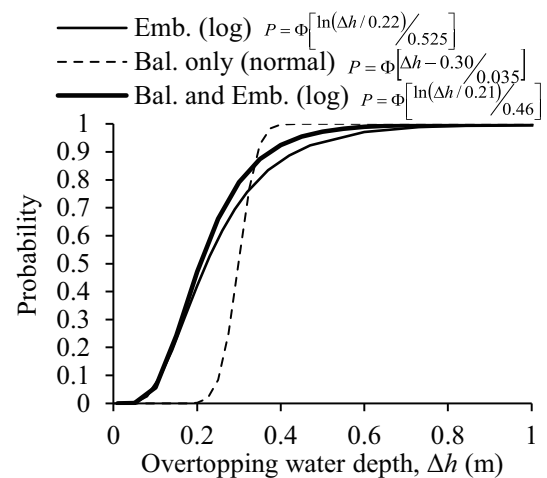
**Figure 12.** Fragility curves for ballast scour (Bal. only), embankment scour (Emb.), and ballast and embankment scour (Bal. and Emb.)

Figure 12 compares the normal fragility curve for ballast scour (dashed line) and a log-normal curve for the combination of ballast scour and embankment scour (thick line, log-likelihood  $\ln(L) = -8.9$ ). The fragility curve for ballast scour has a larger mean and smaller standard deviation compared with the curve for embankment scour and the curve for combined ballast scour and embankment scour. The damage probability at medium overtopping water depth  $0.2 \text{ m} < \Delta h < 0.6 \text{ m}$  for the combined ballast and embankment scour is slightly larger than the probability for embankment scour only.

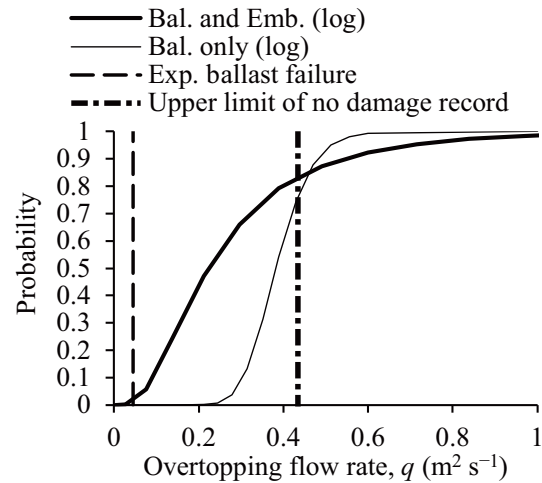
**Figure 13.** Fragility curve for ballast failure using overtopping flow rate per unit length. The dashed line indicates the experimental bound at which the onset of ballast scour occurs (Tsubaki et al., 2012b). The double line corresponds to the upper limit of the flow condition where no damage was observed.

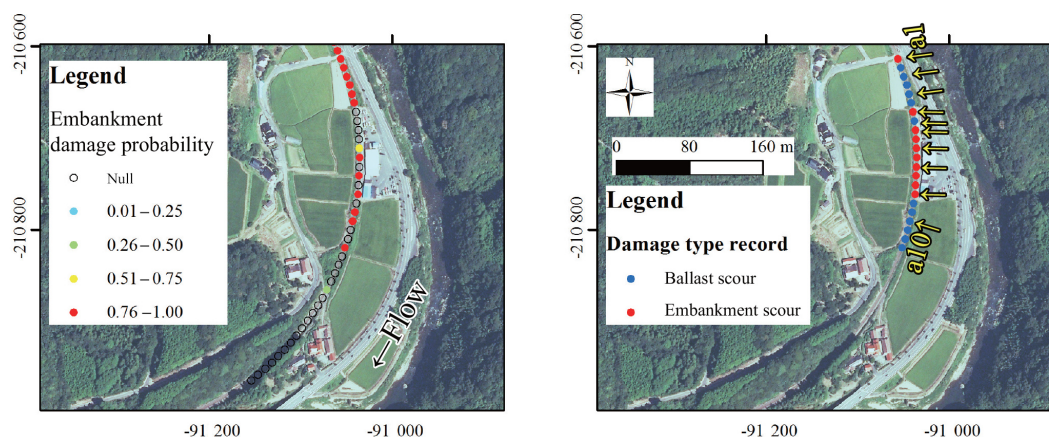
**Figure 14.** Estimated damage probability (left) and damage type record (right) at Asa River section M. The yellow symbols in the right map depict data points listed in Table A1.

A validation of the combined damage fragility curve, of which feasibility was discussed above, was conducted by comparing its calculated probabilities to the actual damage record. The normal distribution for combined ballast and embankment scour was determined to be the most feasible model based on the discussion in Sects. 5.1–5.3. Via the model, the damage probability along the rail track in the Asa River floodplain at 10 m intervals was calculated and plotted in Fig. 14 (left). Thirty-one of the data points, used in Sect. 4 and listed in Tables A1 and A2 to obtain the fragility curves, were selected where the damage type record was confident (e.g., not marginally at the border of two damage types), but a point array at 10 m intervals was used for the validation here. Damage probability in Fig. 14 (left) is calculated without regard to the types of failure (ballast or embankment scour), but it is calculated with the fragility curve for ballast and embankment scour; however, the actual damage record of the right figure distinguishes the type of damage. In Fig. 14, there is variability in the calculated result, but the area where the

ballast and embankment scours were observed is predicted as a high damage probability area. The points at which no damage was calculated are points at which the flood model calculated either a very shallow overtopping water depth, or no overtopping at all. The railway crest in this section is almost horizontal. Since the crest of the railway embankment consists of both rail and railway ties (sleepers), the  $1\text{ m}^2$  resolution lidar data cannot resolve this, and the  $1.7\text{ m}^2$  triangular mesh carries forward this variation, leading to an unavoidable difference between modeled and actual topography. Since actual railway crest elevation does not experience spurious variations at 10 m intervals, topography based on lidar data of limited resolution and accuracy might be improved by application of a spatial filter along the railway.

**Table A1.** Point-wise estimated overtopping water depth  $\Delta h$  and damage types for the Asa River flood. In damage types row, emb. is embankment scour, bal. is ballast scour, and no is no damage. Location of each point is indicated in Fig. 14.

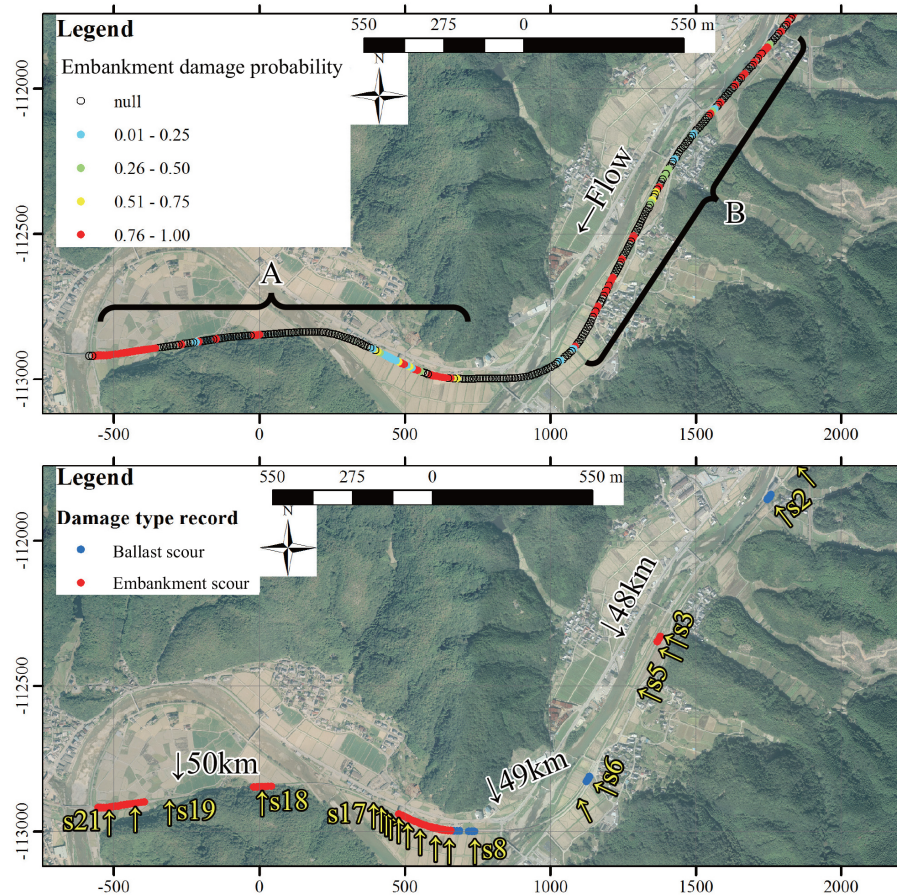
**Figure 15.** Estimated damage probability (top) and damage type record (bottom) at Sayo River section S. The yellow symbols in the bottom figure depict data points listed in Table A2. (Source: Kinki Regional Development Bureau, Ministry of Land, Infrastructure, Transport and Tourism Japan for the aerial photo taken in 2010.)

Figure 15 shows calculated and observed damage to the railway along the Sayo River. The domain is decomposed into two segments (A and B) in the discussion below. Continuous damage was recorded along a portion of Segment A, and this damage was reproduced well in the fragility curve calculation. In this segment, damage occurred in locations at which relatively steep slopes existed in the railway crest elevation profile (Fig. 16). Since the locations of railway embankment overtopping were governed by a longitudinal slope of the railway and large-scale topography in this segment A, the flood model was able to simulate actual overtopping location and flow rate with higher accuracy, and damage probability resulting from the fragility curve matched recorded damage well. In Segment B, estimated damage probability was high at points that experienced actual damage, but many other points estimated to have high damage probability experienced no actual damage. In regions such as this, where spatially sporadic damage is calculated, fragility curves are still useful for predicting whether damage will occur, but they cannot predict the specific locations at which the damage should be expected. In this segment, elevation of the railway embankment crest was very smooth, with no steep slopes in

crest elevation (Fig. 16). Therefore, the entire segment was overtopped with shallow surcharge. However, small errors in topography at the size of each model grid cell caused large difference in the overtopping water depth, resulting in erroneous damage probabilities at the 10 m intervals at which damage was assessed. The fragility curve concept can also account for uncertainty in hazard level (overtopping water depth in this paper) by adjusting the deviation parameters  $\sigma$  or  $\zeta$  in Eq. (1) or (2) (Mander, 1999); in segments within which sporadic damage is predicted, the level of damage can be estimated by averaging the damage predicted for points within the segment. However, the reason damage in Segment B of Fig. 15 was not evaluated as such an average is that the error in grid-scale model topography was too large to just cause variations in overtopping water depth; rather, the error caused many points within the segment to not experience any overtopping at all. Therefore, the model predicted scattered damage for Segment B.

**Table A2.** Point-wise estimated overtopping water depth  $\Delta h$  and damage types for the Sayo River flood. Location of each point is indicated in Fig. 15.

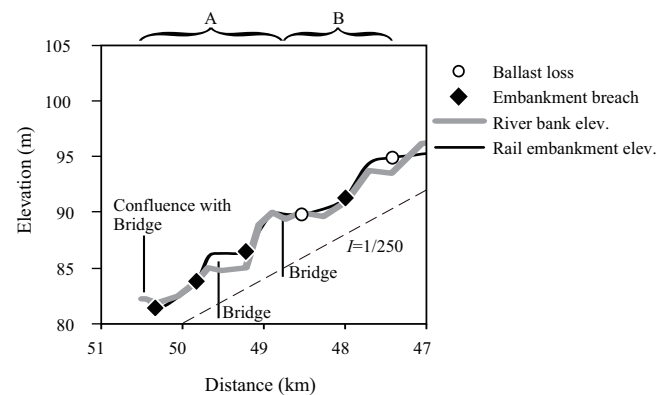
**Figure 16.** Longitudinal profiles of railway and riverbank elevation. The cross sections where the river and railway intersect are indicated as “bridge” (Tsubaki et al., 2012a).
