## Facade refurbishment for energy saving in tube houses a case study in Hanoi, Vietnam

# Facade Refurbishment For Energy Saving In Tube Houses

## A case study in Hanoi, Vietnam

*Phan Anh Nguyen<sup>1,\*</sup>, Regina Bokel<sup>1</sup>, and Andy van den Dobbelaer<sup>1</sup>*

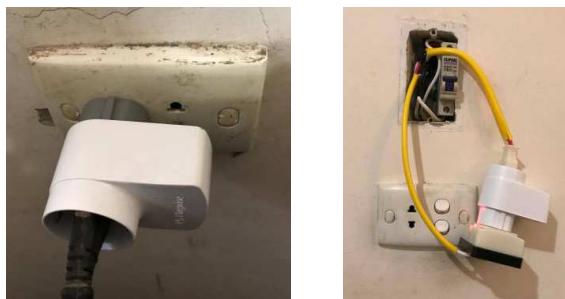
**Fig. 2.** Plug-wise unit installed for energy measurement  
Fig. 3 shows the location of the measurement units in the house. Currently, there are only 2 occupants living in the house and they mostly occupy the lowest two floors. The ground floor is mainly equipped with kitchen appliances such as induction cooker, refrigerator, microwave oven. Both the living room and bedroom on the first floor are equipped with air-conditioners that are capable of both heating and cooling. A water boiler is located in the bathroom on the first floor for daily showering. Most of pluggable electrical equipment was measured. The lighting system could not be measured because the cables are inside the walls. A washing machine on the top floor is out of range of the monitoring system hence is also not measured. However, it is rarely in use and can

The building performance was monitored for 2 months, December 2017 and January 2018. Outdoor and indoor temperature and energy consumption were measured by Sense and Source, monitoring equipment that was developed by the Plugwise company, see fig. 2.
