decommissioned TCDD suburban train wagon as found on site · 1:50

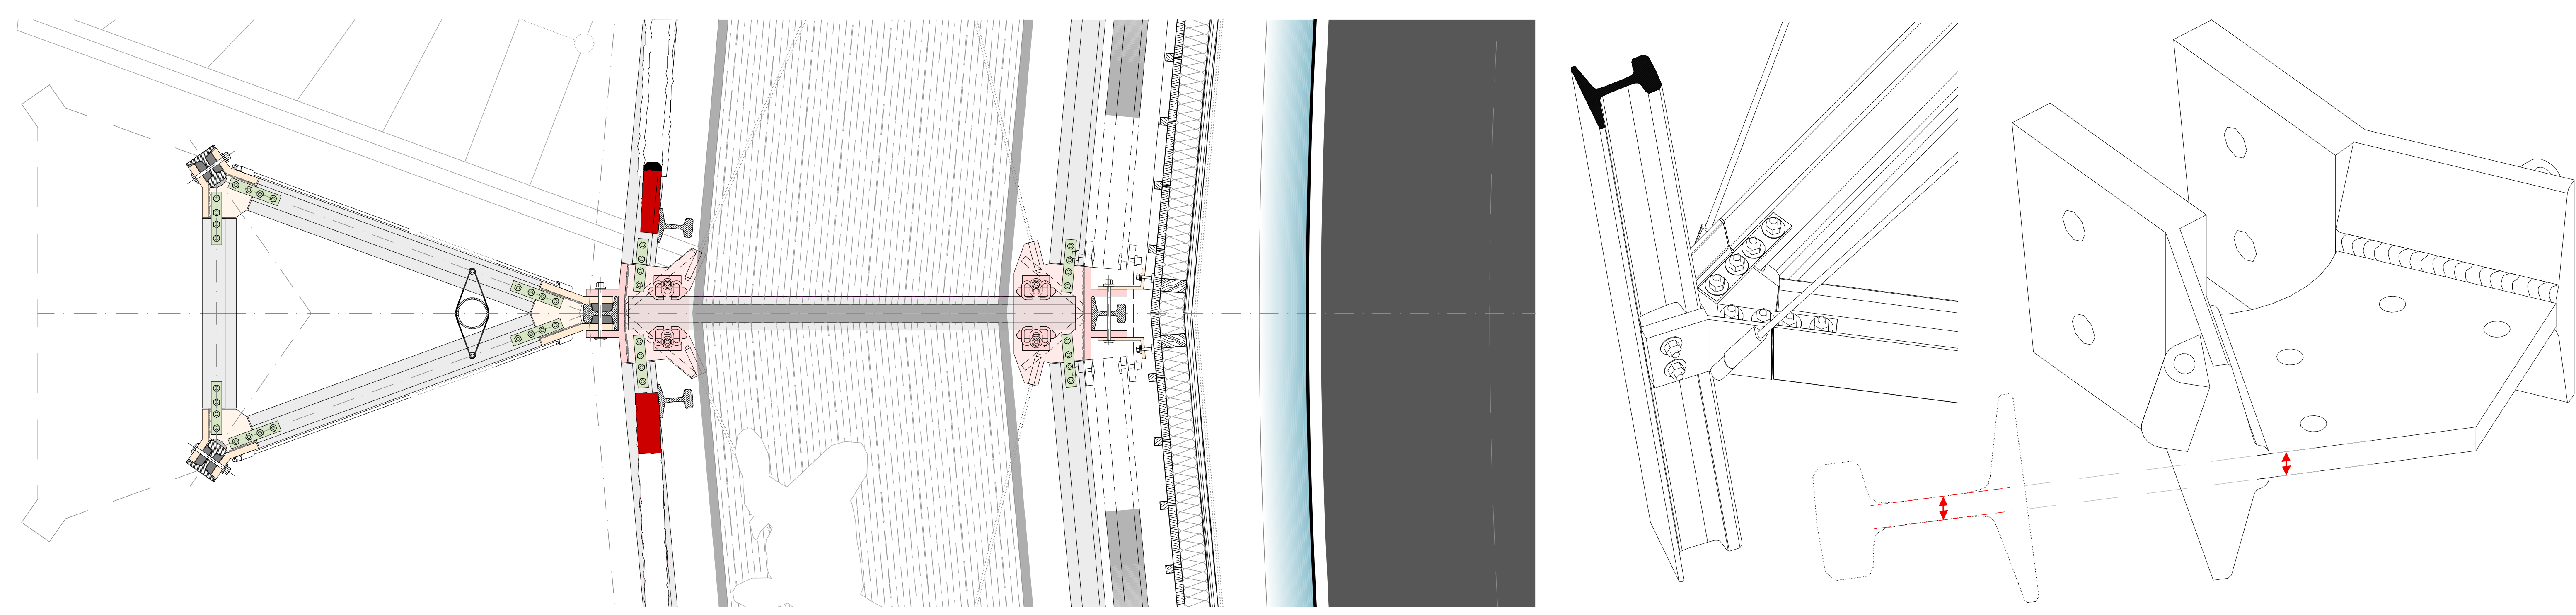
horizontal facade section with joints · 1:10

2-axis joint axonometry · 1:10

track connection shoe · 1:2.5

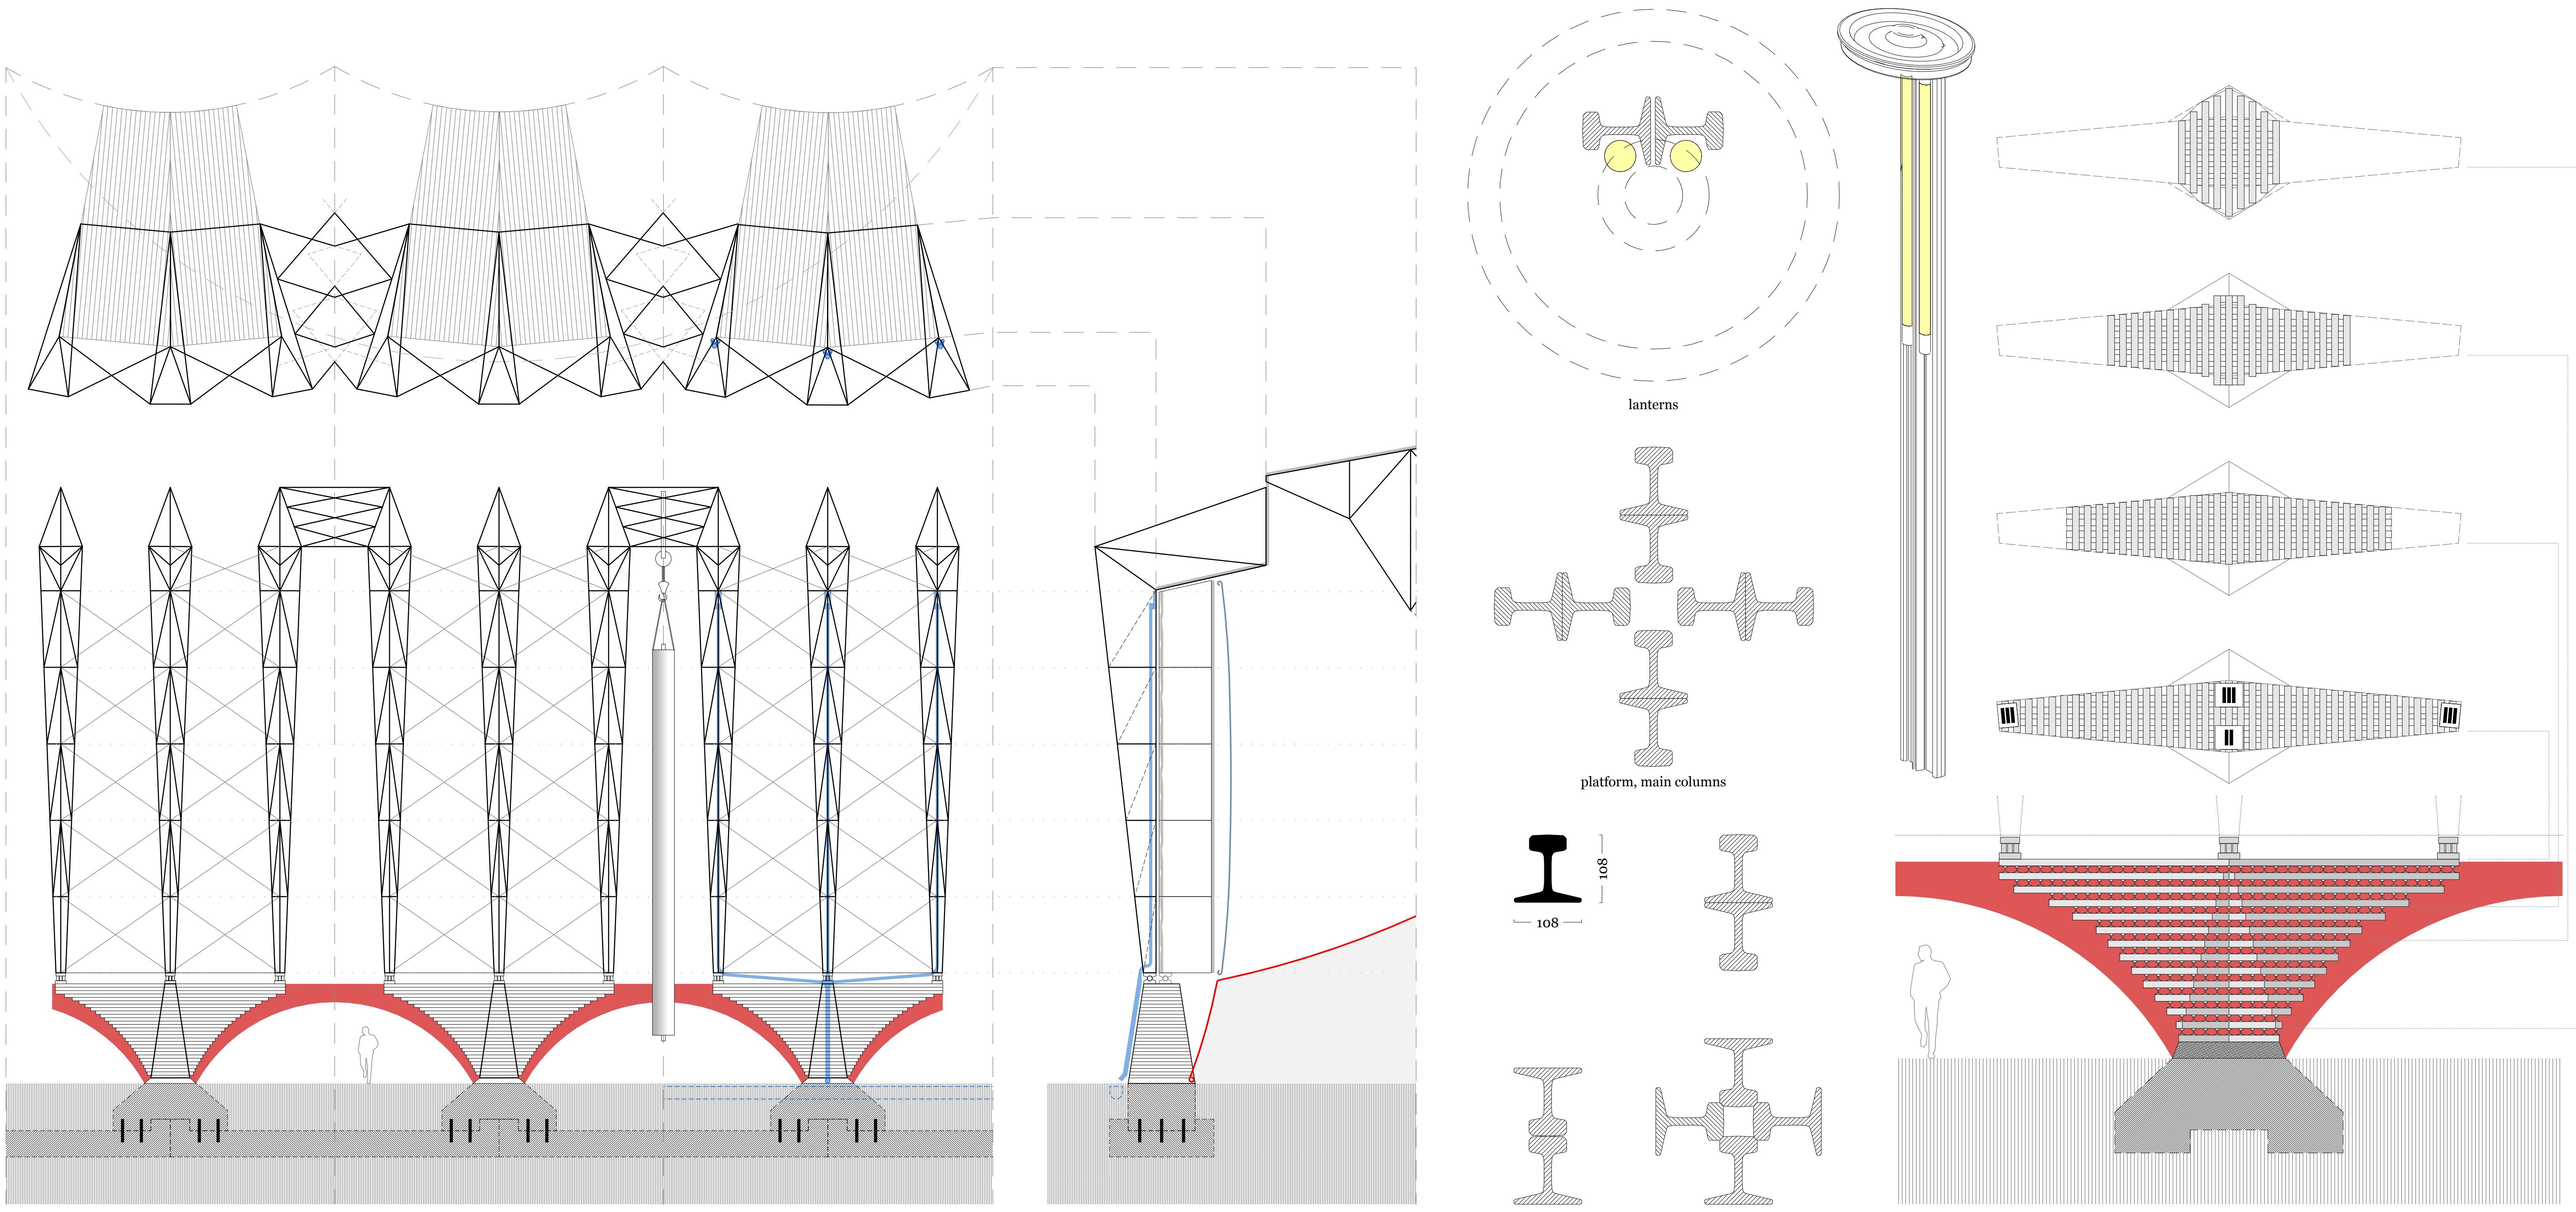
segmentation scheme · 1:100

railway track configurations · 1:5

base detail · 1:50
