## Measuring Wave Run-Up, Overtopping And Damage Of Rubble-Mound Breakwaters In Scale Model Tests

Proceedings of the HYDRALAB+ Joint User Meeting

## MEASURING WAVE RUN-UP, OVERTOPPING AND DAMAGE OF RUBBLE-MOUND BREAKWATERS IN SCALE MODEL TESTS

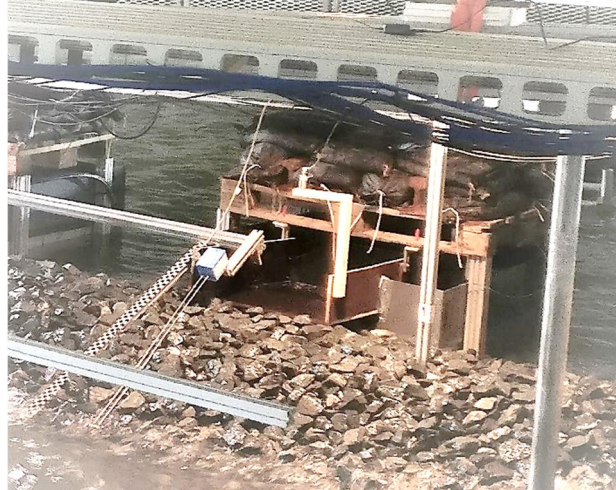
Fig. 3 there is a picture from the entrance of the overtopping reservoir at the breakwater root. In addition to the chute, the acoustic wave gauge to identify overtopping events and the graduated staff deployed in front of that reservoir can be seen. During the tests, a video camera recorded the free-surface on the graduated staff. It is expected that run-up parameters can be extracted from such videos using the methodology of Bornschein et al. (2014).

Figure 3. General layout at the entrance of an overtopping reservoir (run-up wave gauge, acoustic wave gauge to identify overtopping events, graduated staff).

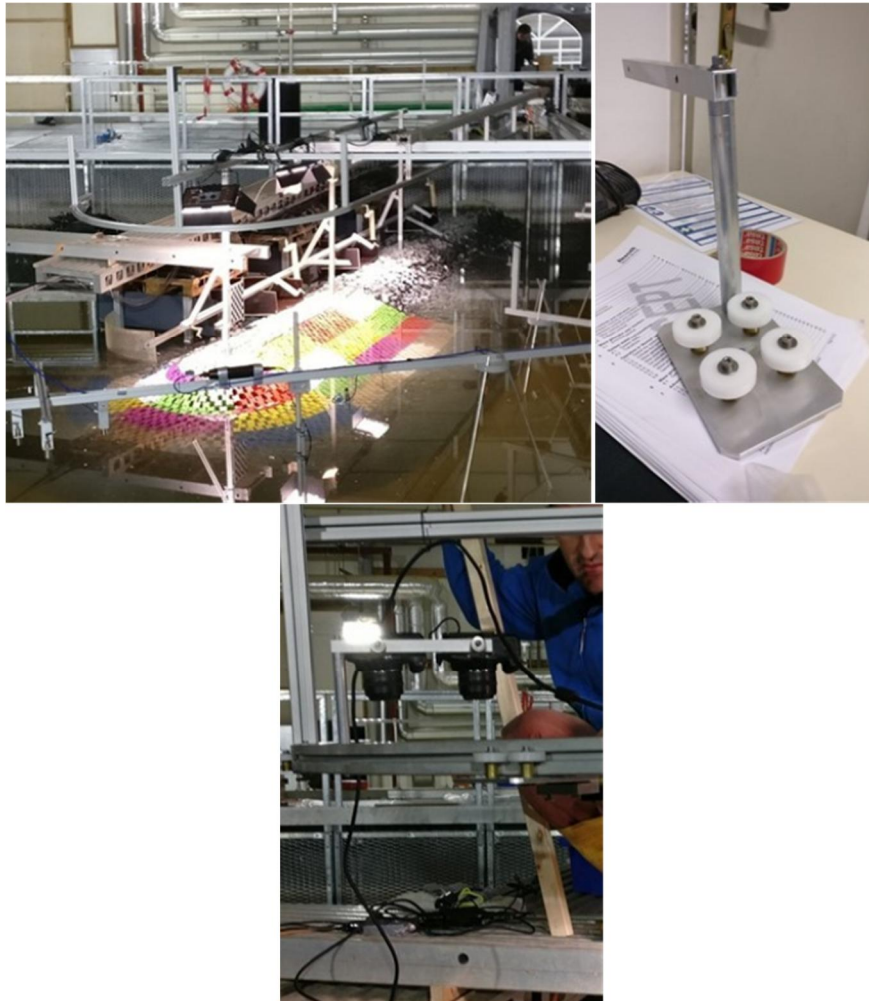
Since these two techniques implied the movement of the measuring equipment above the study region, an aluminium rail made of a straight stretch 7.85 m long and of a semi-circumference stretch with a diameter of 1.80 m was hung 2.00 m above the wave basin bottom. Fig. 4 shows the rail assembly as well as the special wagon that was moved along the rail and where the cameras ensemble or the Kinect motion sensor were hung.

Figure 4. Left: rail to support the photographic cameras and the Kinect motion sensor; Middle: wagon to carry those cameras; Right: wagon on the rail with two cameras.
