Proceedings of the 21st European Conference on Composite Materials

A STUDY ON FATIGUE RESISTANCE AND STRUCTURAL INTEGRITY IN WEB-CORE COMPOSITE BRIDGE DECK PANELS

Keywords: GFRP, Web-to-Flange Junctions, fatigue, experiments

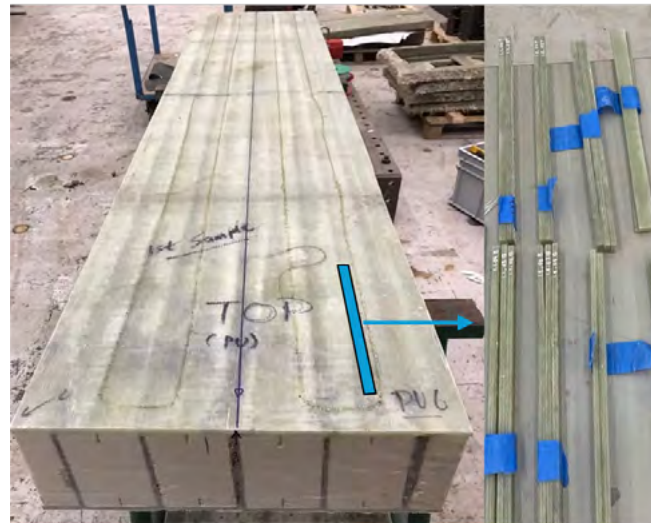
Figure 1. Coupons cut out from the sandwich panel.

The coupons and the components (WFJs) are cut out of the GFRP bridge decks, as shown in Figure 1 and Figure 2. The bridge deck is manufactured with vacuum-infused GFRP panels and polyurethane resin that has a core of polyurethane (PU) foam. The deck laminate consists of a Z-shaped layering approach and integrates three types of fibre fabrics. Surrounding the foam blocks are layers of E-glass fabric angled at $[+/-45 \text{ degrees}]$. Along the length, three layers of UD E-glass fabrics are laid, with overlaps of two blocks at the top and bottom. The Z-shaped configuration also includes two additional

The coupons are cut out from the top and bottom facings of the sandwich panels of the deck as shown in Figure 1. The coupons are extracted from a scaled deck by a factor of 0.5 and the thickness of the coupon specimens is twice as low compared to the thickness of the tests on the WFJs.

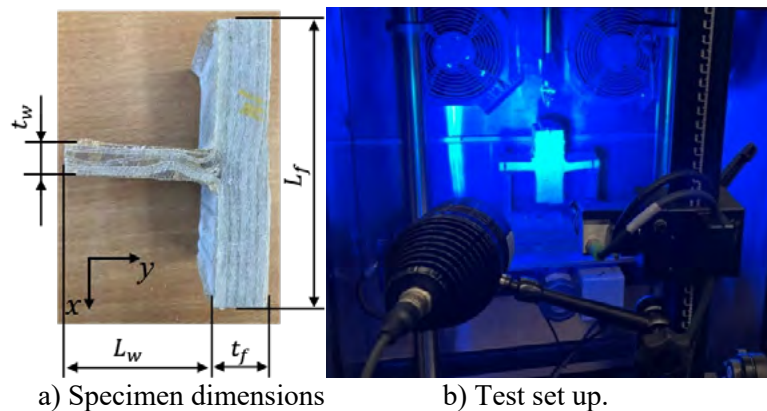
Figure 5. Component tests.

Figure 5a shows the specimens' average dimensions, including a width of $50.02 \pm 0.53 \text{ mm}$, flange length and thickness ($L_f = 140 \pm 9.16 \text{ mm}$, $t_f = 26.22 \pm 2.25 \text{ mm}$), and web length and thickness ($L_w = 72.45 \pm 3.65 \text{ mm}$, $t_w = 12.86 \pm 2.16 \text{ mm}$).

For testing, a universal testing machine equipped with a 15kN load cell and a total span of 175 mm is used (see Figure 5b). A DIC system featuring a 50.6 MPa camera and polarized blue LED lights captures full-field displacements on the specimens' side surfaces during tests, synchronizing photos with load and displacement data.

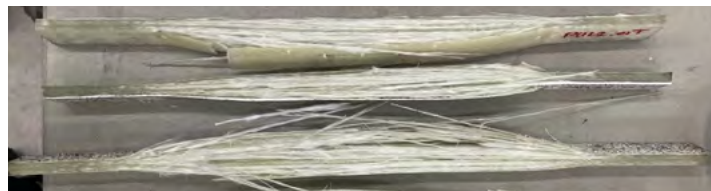
Figure 6. Delamination and fibre failure. Static material tests.

Prior to fatigue tests, static tests are conducted on a set of three specimens to determine the failure loads and stresses. The failure modes are visually inspected, which included delamination and fibre breakage, and consistent across all tests and are shown in Figure 6. The analysis of the specimens is detailed in Figure 7, where the average failure load, displacement and stress are $F_{max} = 137.68 \text{ kN}$, $w_{max} = 11.89 \text{ mm}$ and $\sigma_{max} = 577.75 \text{ MPa}$, respectively. The tensile stress is calculated by dividing the applied

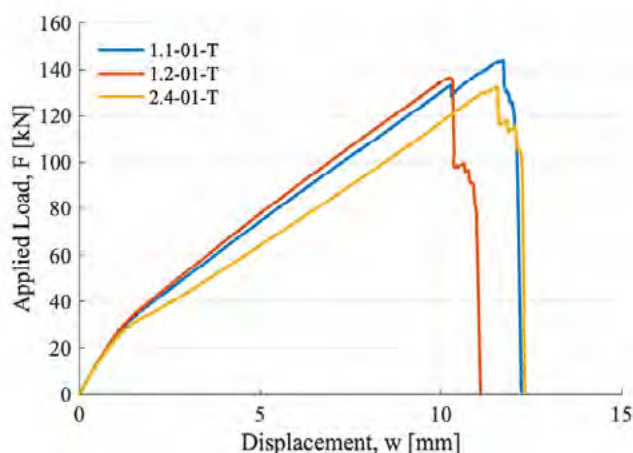
Figure 7. Load-Displacement curves. Static material tests.

load by the initial cross-sectional area at the failure region of the specimen. All three tests show a linear relationship between the applied load and displacement.

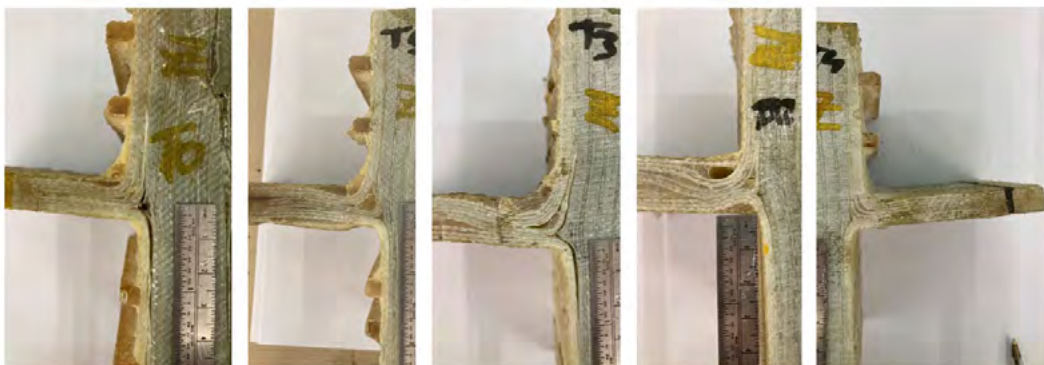
Figure 10. Failure initiation and delamination. Static component tests.

Static tests are conducted on 5 pairs of WFJ, in which one out of two connected together WFJ failed during each test. The failure modes are visually inspected, shown in Figure 10, which are similar across all the tests with the delamination between the 'Wrap' and 'UD'-layer of the WFJ. The Force-Displacement plots of the specimens are shown in Figure 11 indicating an average failure load, displacement and nominal bending stress are $F_{max}=2.04\text{kN}$, $w_{max} = 1.90\text{mm}$ and $\sigma_{max} = 50.90\text{MPa}$, respectively. The nominal bending stress is determined by multiplying the reaction force from the support by the distance from the support to the beginning of the radius to obtain the bending moment. This is then divided by the elastic section modulus of the web just before the junction. All five tests show a linear relationship between the applied load and displacement.
