A multi-layered safety perspective on the tsunami disaster in Tohoku, Japan

ABSTRACT: This paper presents an assessment of the multi-layered safety system in Tohoku, Japan based on the tsunami disaster of March 2011. The performed analysis has been based on data provided by local researchers and field observations. First an overview of the tsunami behaviour along the affected coastline of Tohoku is presented, which shows clearly that the disaster has site-specific features. The assessment that follows has a descriptive character and it is divided in two parts. First the performance of each safety layer in Tohoku is separately assessed, and conclusions are drawn for the efficiency of the system. The second part points out some implications of this disaster for the use of multi-layered safety in flood risk management.

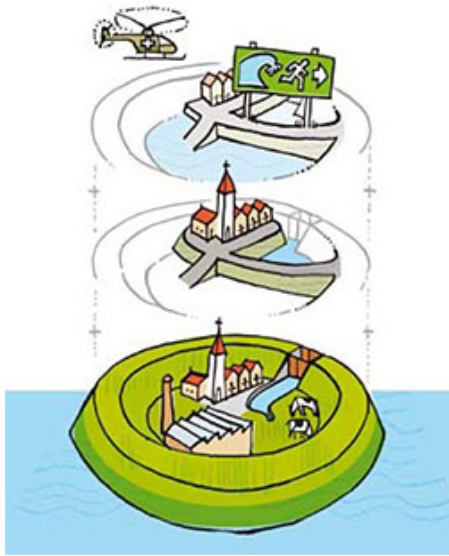
Figure 1: Graphical representation of multi-layered safety (Kolen et al. 2010)

- Layer 1 - Prevention: Prevention is defined as preventing river and seawater from inundating areas that are usually dry. This is done by building flood defenses or preventing high river discharges.
- Layer 2 - Spatial Solutions: Spatial solutions mean using spatial planning and adaptation of buildings to decrease the loss if a flood occurs.

- Layer 3 - Emergency Management: This layer focuses on the organizational preparation for floods such as disaster plans, risk maps, early-warning systems, evacuation, temporary physical measures such as sandbags, and medical help.

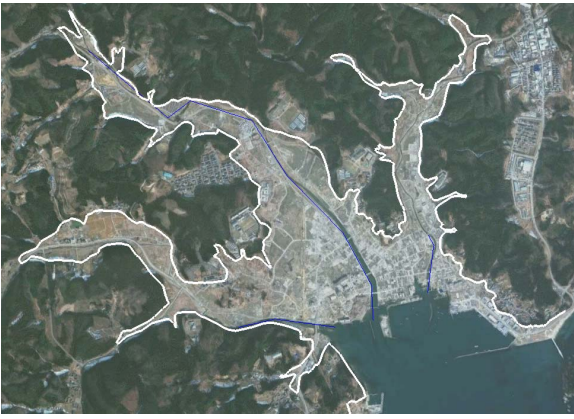
Figure 3. Inundation area in Minamisanriku, rias

The rias coast extends along Iwate prefecture and the northern half of Miyagi prefecture. Rias are fjord-like shaped coastal inlets formed by the submergence of former river valleys. The rias coasts are therefore extremely irregular and indented in places, forming narrow and steep bays. At this type of coast, due to bathymetry focusing effects, the tsunami height increases. The narrow bays are surrounded by high grounds that face the ocean with steep cliffs, and relatively deep sea in the front. The basin created by the high grounds obstructs the intrusion of seawater far inland, which, combined with the increased tsunami height, resulted in large inundation and run-up heights.

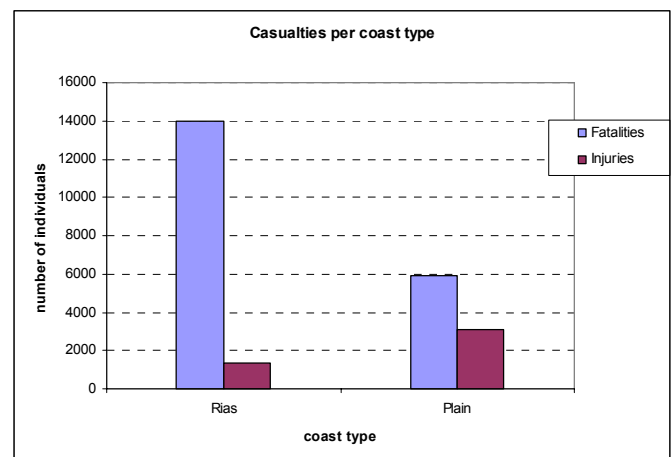
Figure 6. Recorded casualties in the rias and in the plain region (November 2011)

Despite the degree of preparedness for evacuation among population, the death toll was much higher in the areas where inundation heights were very high. According to casualties’ records available in November 2011, the fatalities in the plain region was 0.32% of the total population, whereas in the rias it reached 2.15%, which is about 7 times higher. The following graph, which is based on the same records, shows that fatalities in the rias outnumber fatalities in the plain region, while the rate of injuries over fatalities is lower. The inundation of evacuation centres can be one of the reasons for the much higher fatalities in the rias. The higher rate of injuries over fatalities in the plain implies that most people exposed to the tsunami flow in the rias died, while in the plain many of them survived.
