Causes of long-term bed degradation in rivers

Setup of research

Causes of long-term bed degradation in rivers: setup of research

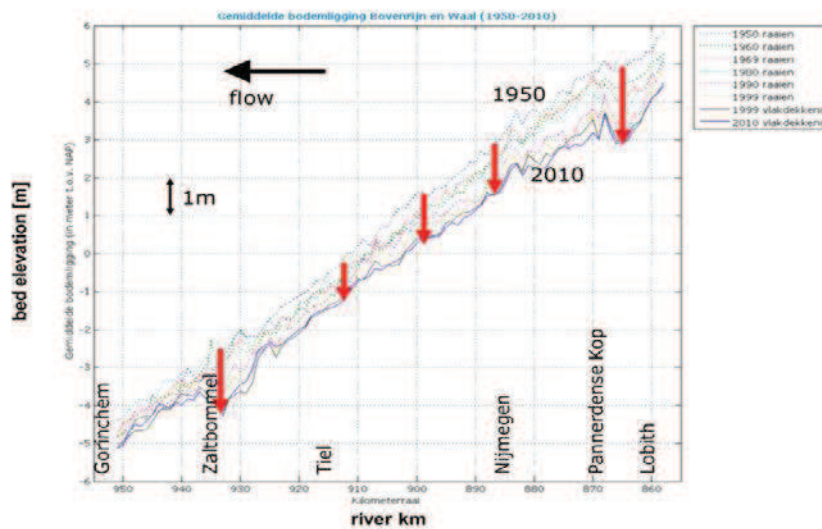
Figure 1: Bed degradation in the Upper Rhine and Waal in the last 60 Years (Blom 2016; data courtesy: Rijkswaterstaat)

The degradation in the Dutch Rhine (Fig. 1) has various causes: the 19th and 20th century large-scale river training, extensive dredging in the past, coarsening of the sediment supply from Germany, and construction of dams in its tributaries (Blom 2016). However, their relative contribution is still unclear. To minimize the negative effects of bed degradation and for optimal design of future mitigation measures, it is crucial to understand the causes of bed degradation processes and their relative contributions.

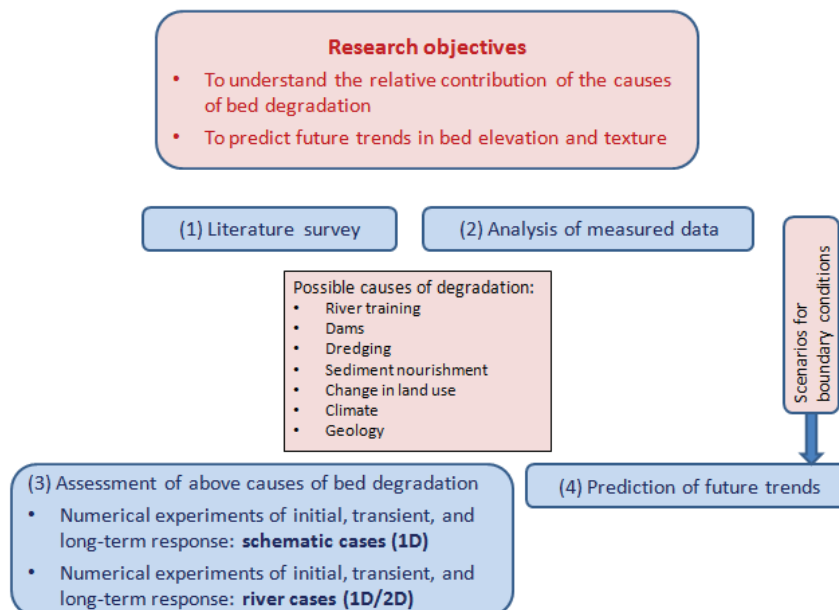
Figure 2. Approach of research (numbers indicate chronology of the research)

The research will proceed by coupling literature survey, analysis of measured datasets and numerical modelling. Fig. 2 presents the approach of the research. The relative effects of the causes of bed degradation will be first assessed using a 1D numerical research code, for quick insight on the effects of measures. The code solves the flow (1D shallow water equations or the backwater equation), bed level and bed surface texture (using the Exner and Hirano equations). The numerical modelling will involve schematic cases and river cases and will distinguish initial, transient and long-term responses. In dealing with prediction of future trends, the effects of climate change, for example on discharge and sediment supply and sea level change will be accounted for by developing scenarios. In a later stage, 2D numerical model will be setup to properly account for the presence of two river bifurcations (Pannerdens Kop and IJsselkop) and the effects of bend sorting.
