## Effect of moisture on the adhesion of CFRP-to-steel bonded joints using peel tests

Moreira Arouche, M.; Budhe, S.; Alves, L. A.; Teixeira de Freitas, S.; Banea, M.D.; de Barros, S.

Brazilian Society of Mechanical Sciences and Engineering. Journal

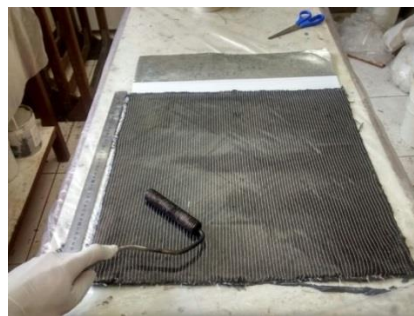
**Fig. 1** Carbon fiber lamination process

The composite-to-metal bonded joint test specimens were manufactured by the same process used in composite patch repairs of oil and gas production platforms [29-30]. The carbon steel plate was blasted with G-40 steel shot and then degreased using acetone. The final surface roughness measured was 12.26  $\mu\text{m}$  root mean square deviation (Rq) and 76.12  $\mu\text{m}$  total height of the roughness profile (Rt). The epoxy resin NVT201E® was then applied over the treated steel plate surface. Afterwards, the lamination process started by alternating application of carbon fiber fabric layers and the impregnation resin PIPEFIX®, as shown in Figure 1. Six plies of carbon fiber were used to produce the composite with a

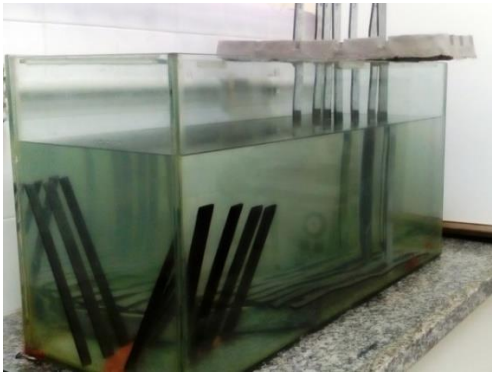
33 **Fig. 3** Specimens in salt water tank

The salt water ageing process was employed in order to evaluate the long-term effect of environmental exposure on the joint. The specimens were kept inside the salt water

1 tank (5% NaCl) at room temperature for 40 days and 150 days. The ageing process  
2 simulates the effect of environmental conditions wherein the bonded repairs are exposed  
3 to marine environment. Specimens were exposed to ageing in two different conditions:  
4 partially immersed in salt water, i.e. 50% of bonding length was in salt water and  
5 remaining in atmospheric conditions; and fully immersed in salt water. Some reference  
6 specimens were tested without any ageing. Figure 3 shows the specimens in the salt water  
7 tank and Table 1 provides the ageing conditions tested and the number of specimens for  
8 each condition.  
9  
10  
11  
12  
13  
14  
15  
16  
17  
18  
19  
20  
21  
22  
23  
24  
25  
26  
27  
28  
29  
30  
31  
32

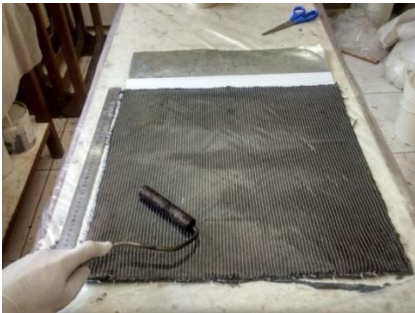
Fig. 1 Carbon fiber lamination process

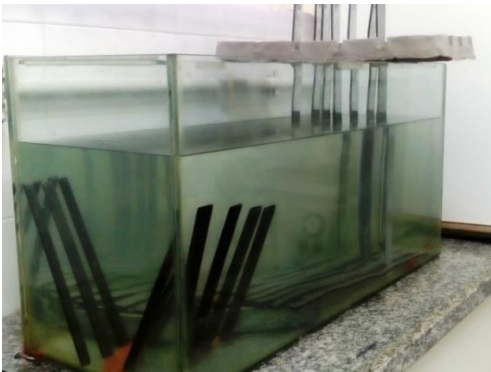
Fig. 3 Specimens in salt water tank

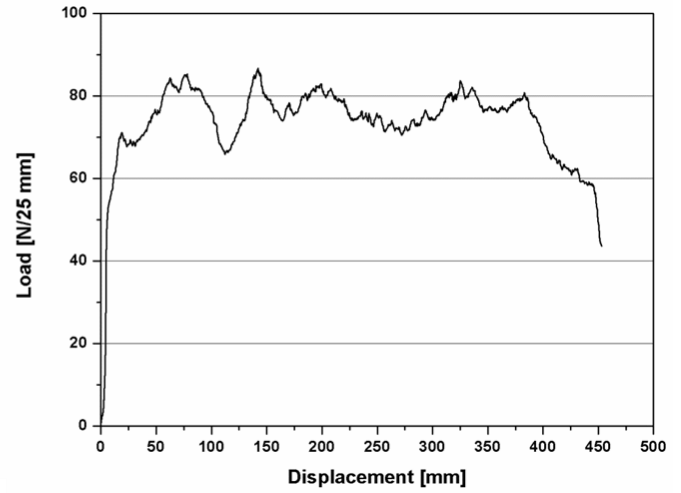
**Fig. 7** Representative curves of dry specimens with: a) 250 mm length; and b) 500 mm length
