Wood and Bamboo for Rural Water Supply a Tanzanian Initiative for Self-Reliance

Delft University Press / 1981

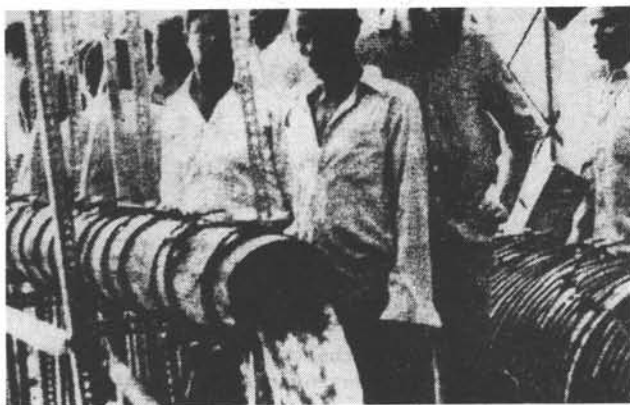
figure 2, Tests

The introduction of the woodstaves in Tanzania seems less problematic at least the stages of testing and demonstration of the constructions. (fig. 2).

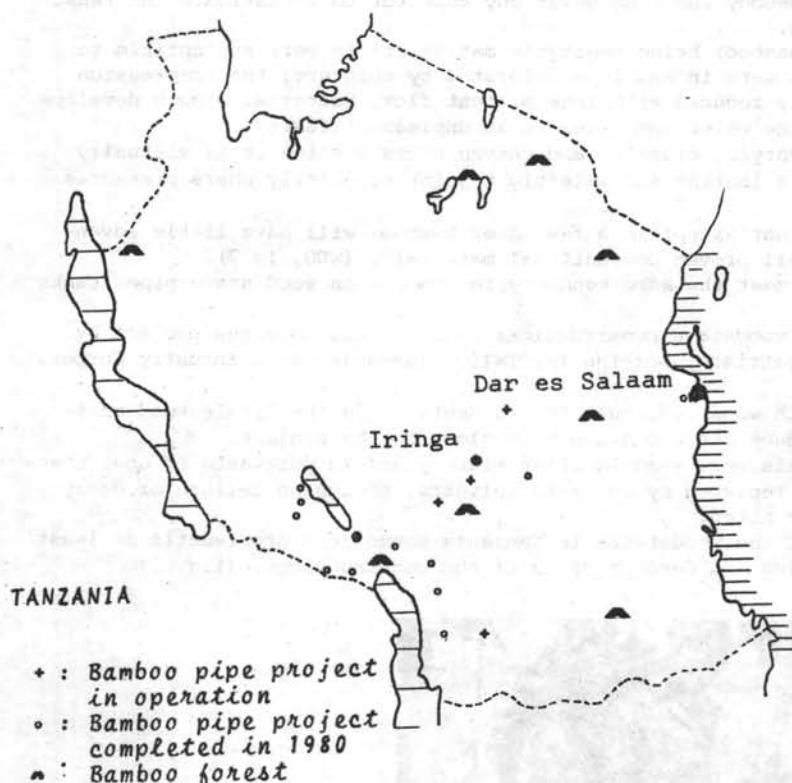
figure 3. Bamboo areas and bamboo water pipe villages.

In the meantime the bamboo pipe system spread in 1978 four projects were constructed at villages in Iringa, Rukwa and Ruvuma Region.

Four projects were completed in 1979, some of the villages are Ujamaa Vijiji. (fig. 3).

About 14000 people in Tanzania tap their water from a bamboo pipe distribution system, the total length of which is now 30 km. According to Lipangile (Daily news, December 1979) the costs of these nine water supplies were 3.030.000/-TSH; the costs of conventional material like PVC or Polythene would have been three times more.

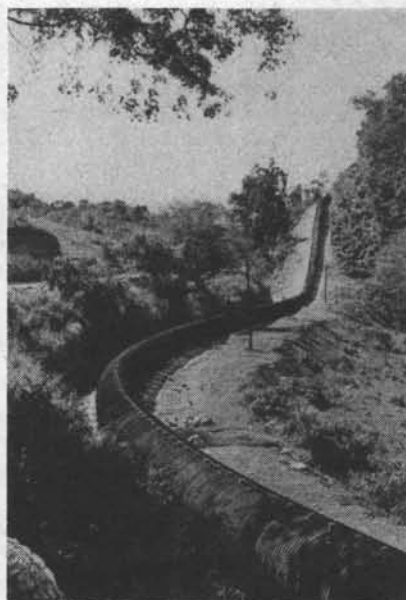
figure 5, Woodstave pipe in Jamaica

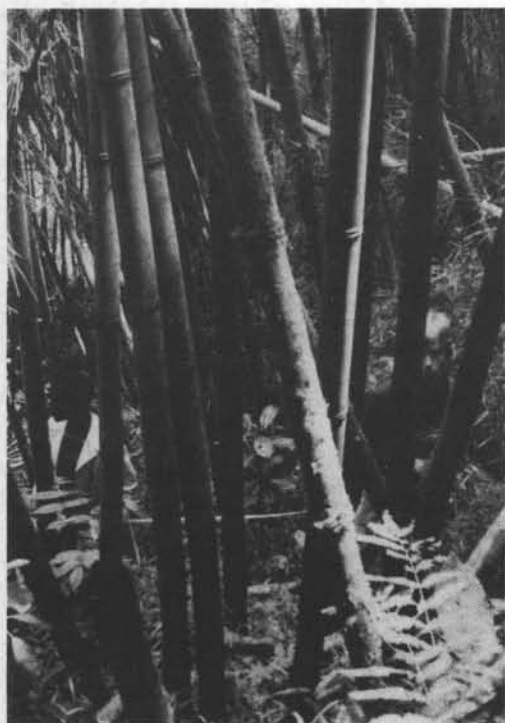
figure 8. *Arundinaria Alpina*, Rungwe Mountain.

The stem grows no more in height or thickness after the first season. Every bamboo plant spreads by the underground extension of its rhizomes from which the aerial culms or bamboos spring. The early tight formation of the clump becomes lost as the older culms at its centre die and disappear. They are replaced by new culms which spring from the extensions of the old rhizomes, but these new culms are more widely spaced and the continuation of this process over a long period tends to obscure the clump effect and give a homogenous appearance to a forest of this species. (fig. 8).

The locations of the mountain bamboo forest in Tanzania which should be investigated are: (see fig.8)

- Mbulu District, on the Oldeani volcano between Lake Manyara and Lake Eyasi and Nou Hills (Mlowe, 1979)
- Arusha District, on Mt. Meru South slope,
- Mbeya District, Igali Pass,
- Morogoro, Uluguru Mountains, Lukwangule plateau (This bamboo in the Uluguru is probably an *Arundinaria Alpina*)

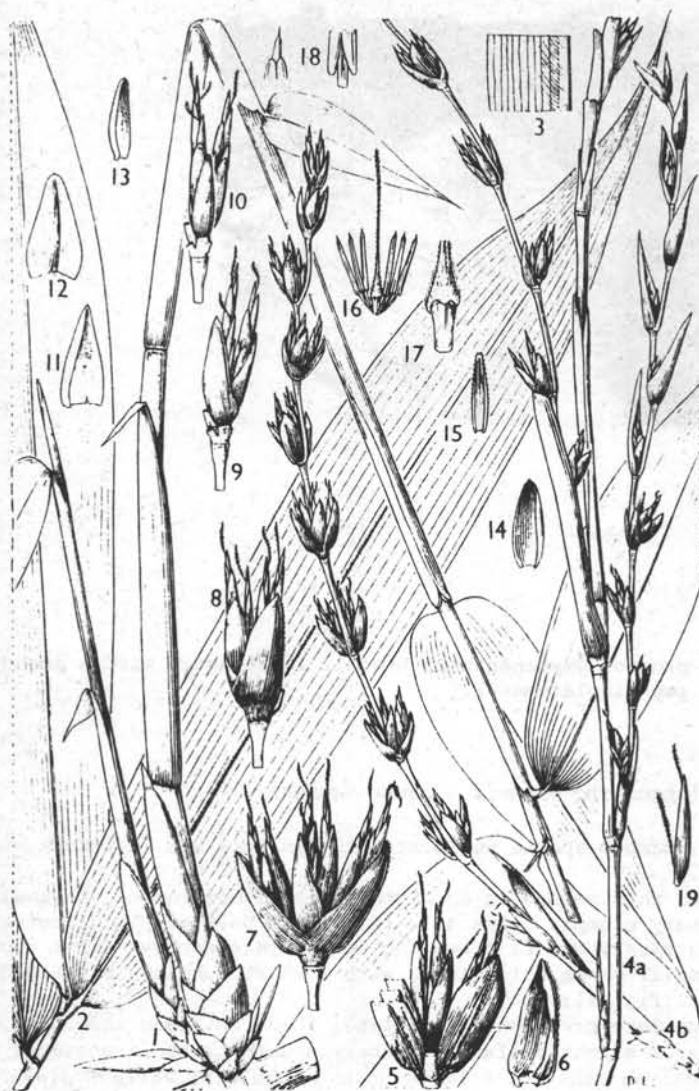
figure 11. *Oreobambos Buchwaldii* 1. leaf branchlet; 2. leaves; 3. part of dorsal surface of blade showing tessellate venation; 4a, 4b, flowering branchlets; 5. spikelet cluster; 6. bract; 7. spikelet cluster (Clayton, 1972).

Clayton describes this bamboo as *Oreobambos buchwaldii* bamboo, in small dense patches or solitary clumps, culms 4.5.-18 m. high 5-10 cm. in diameter spreading or drooping rarely erect, green, hollow, culm sheaths at first clothed with appressed stiff brown hair tipped with a short subulate blade and fimbriate shoulders (fig. 11).

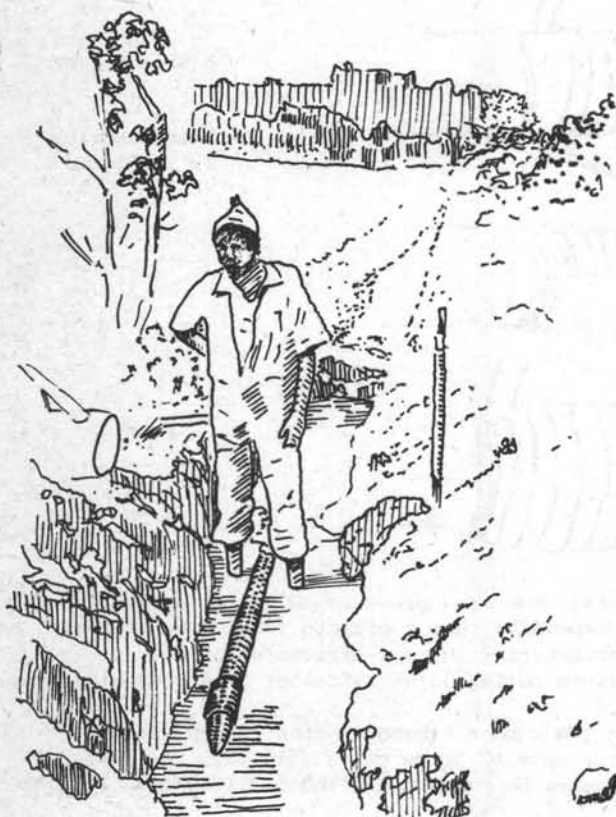
figure 21. Repair of bamboo pipeline.

For repairs it is possible to use the rubber + bamboo joint to replace the current method involving the disturbance of three pipes (fig.21). The rubber + bamboo repair joint can, in some cases be connected without disturbance of the pipeline.

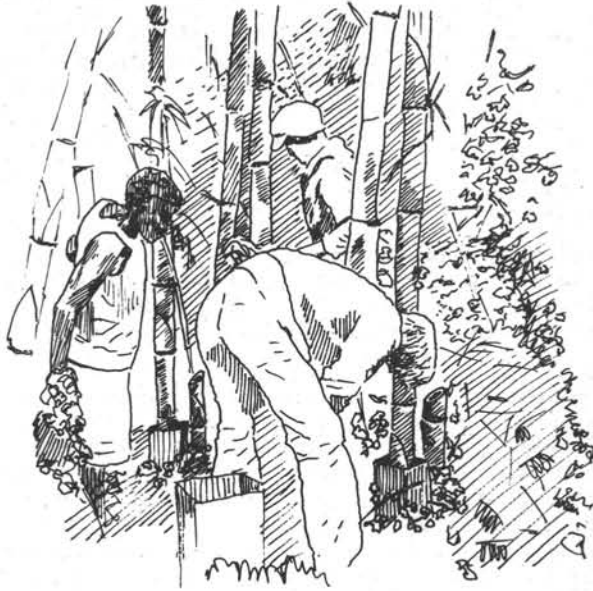
figure 23
the sapdisplacement method

The upper nodes filled with the preservative should be filled again and again. (indian building 1960).

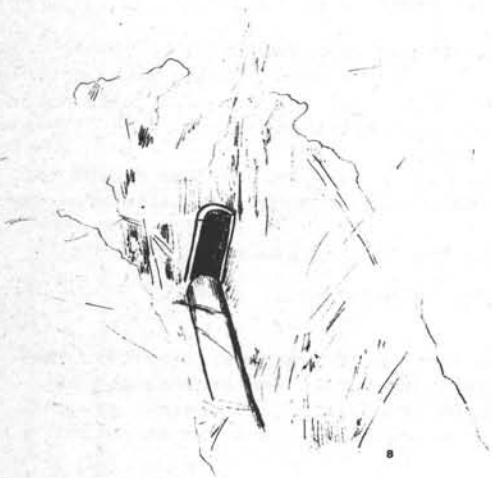
figure 29.
Installation of the "hole type"
drain

- 1) The bamboo is split in two unequal parts.
- 2) The diaphragms are removed either by a hammer or a chisel with a bended end.
- 3) Notches, 2 cm wide each, are cut in the edge of the bigger bamboo part, every 10 to 15 cm.
- 4) Connection of the two parts in their original relation, secured by three iron wires.
- 5) The bottom of the drain trench is covered with gravel or trash material forming the filter envelope for the drainage pipe.

- 6) The smaller bamboos are selected from the upstream end of the drain and the bigger once for the downstream end.
- 7) The drains are placed in the trench with the holes below the horizontal. the advantage of this system is the uptake of relative clean water because the sediments are most of the time not transported upwards. Blocking of the perforation by soil dropping from above is also avoided. (Key 1960)
- 8) The first bamboo drain pipe is closed at the upstream end with a piece of bamboo.
- 9) The joint with the second pipe is established by a two-piece bamboo collar.

- 10) The installed bamboos are secured against movement during installation at the joints.

- 11) After a last check on the installed drain, the filter material is applied on the uncovered pipe section.
- 12) Back-filling of the trench.
