## Managing erosion of mangrove-mud coasts with permeable dams – lessons learned

2020

Ecological Engineering

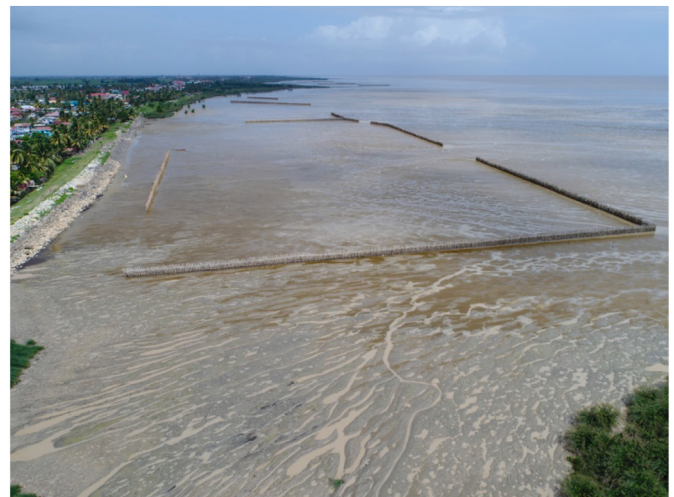
Fig. 4. Mangrove recolonization along Guyana coast, east of Georgetown, 2019.

was similar to the descriptions in Section 4. Figure 4 shows an aerial photo of some of the dams erected near Georgetown. The dams near Georgetown did not have durable results. However, along the left bank of the Essequibo River (Anna Regina and Devonshire Castle, west of Georgetown) 1.5 – 2 m siltation was monitored behind a 100 m long dam between 2013 and 2016. The higher siltation rate yielded bed levels a bit higher than the optima for mangrove rehabilitation. Part of the mangrove planting took place on these deposits.

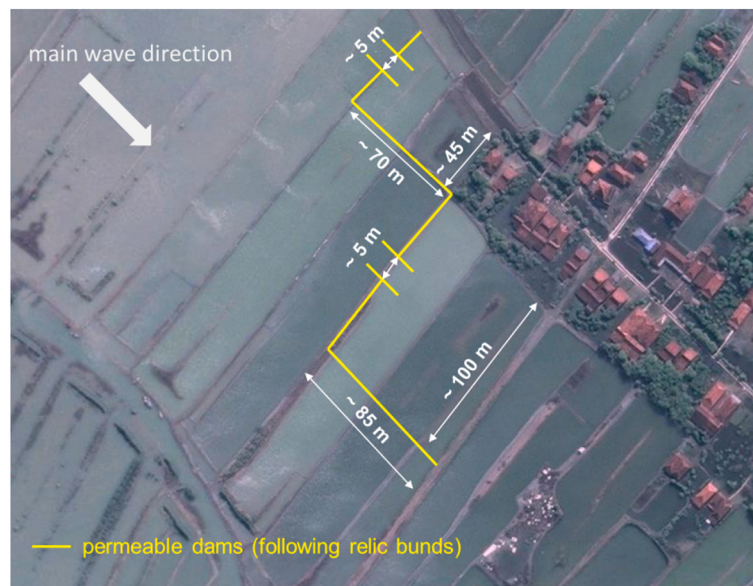
Fig. 5. First permeable dam pilot project in Indonesia in 2013, Bogorame, Demak.

Two sedimentation basins were created by erecting permeable dams on the lost lands at the head of Bogorame, as this part of the village was severely at risk to erosion and flooding. Fig. 5 shows the remnants of the bunds previously forming the now-lost aquaculture ponds. The

permeable dams were placed on top of these remnants, as they form a stable underground, reducing the risks of local scour. Construction of the dams was finished in November 2013. Fig. 6 presents the measured sedimentation volumes in the two sedimentation basins, showing a mean sedimentation rate of about 0.5 m in the four most dynamic months, whereas elsewhere erosion continued. Based on these promising results, many more dams were constructed in Demak coastal area with a total length of more about 13.5 km, built and funded by various partners, with slightly modified designs, while still based on best engineering practices. Simultaneously, an extensive monitoring and basic research program was set up, in conjunction with a socio-economic development program with the local stakeholders (see Section 5).

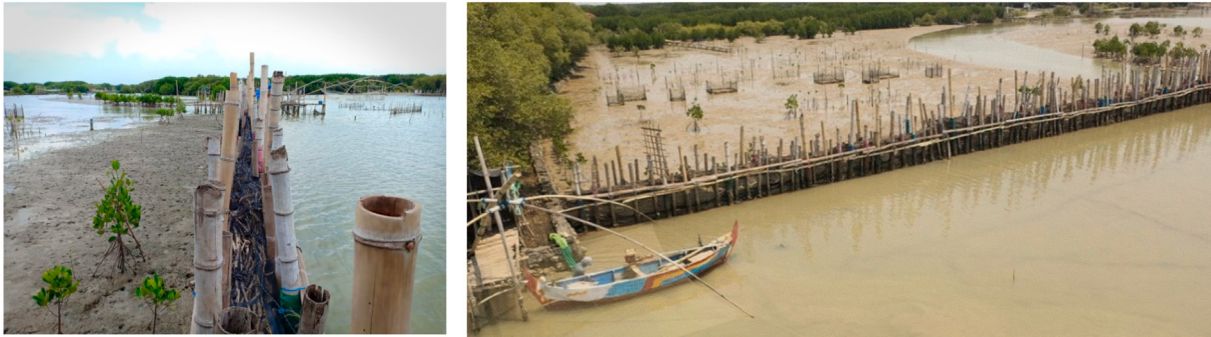
Fig. 7. 2019 sedimentation patterns, Bogorame, Demak, Java, Indonesia, photos December 2019 and January 2020.

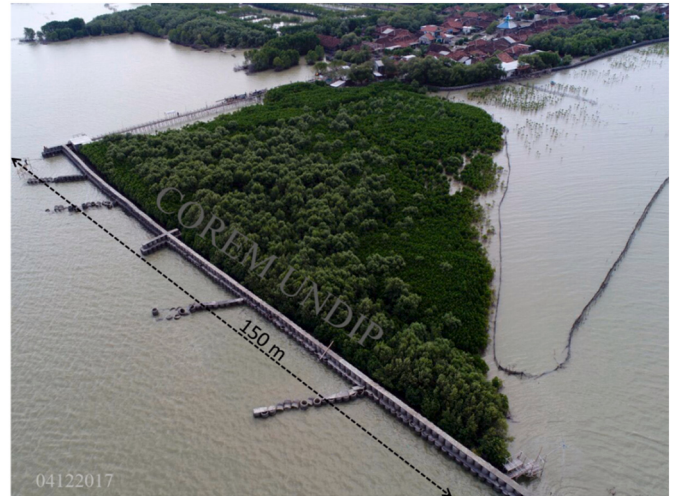
Fig. 9. APO, concrete seawall at Timbul Sloko, Demak, Indonesia (courtesy COREM-UNDIP) with natural colonization by *Avicennia* (high vegetation) and planted *Rhizophora* (low vegetation).

Prior to the construction of permeable structures, a 150 m long seawall was built in Timbul Sloko using concrete cylinders. This seawall is locally known as the APO (Fig. 9), located along the original, pre-erosion coastline. Sedimentation behind the APO up to MSL took place in about two years, and one year later the first *Avicennia* seedlings were

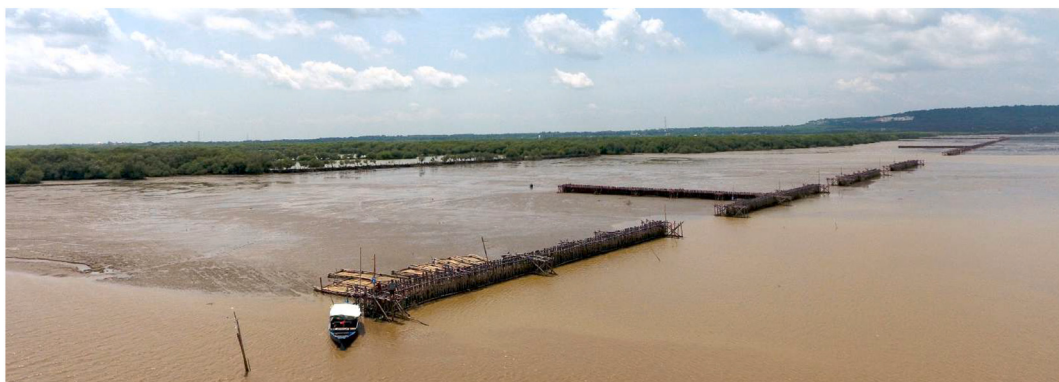
Fig. 8. Example of permeable dams in Gresik Regency, close to Solo River, Java, Indonesia (photo by MMAF early 2019).

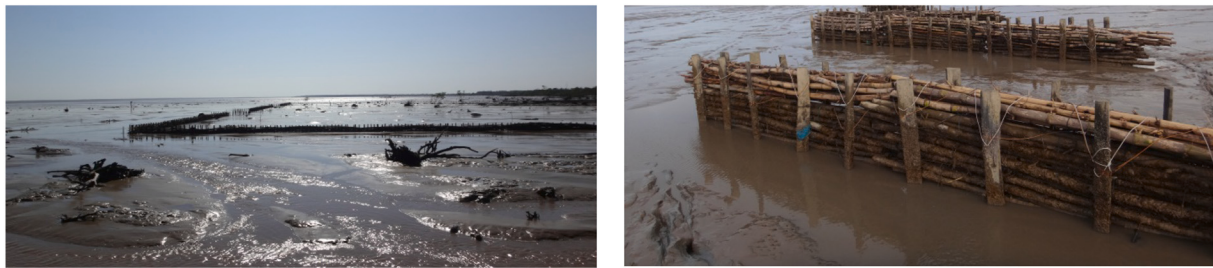
Fig. 11. Permeable dams constructed near Weg naar Zee, north of Paramaribo, Suriname (photos by E. Van Lavieren).

series of permeable dams were constructed, as shown in Fig. 11, the locations of which are indicated in Fig. 10. Next to these constructions, a small-scale mangrove replanting program was executed in 2018. This work was mainly aimed at involving local stakeholders in mangrove rehabilitation efforts, and no systematic monitoring program was executed.

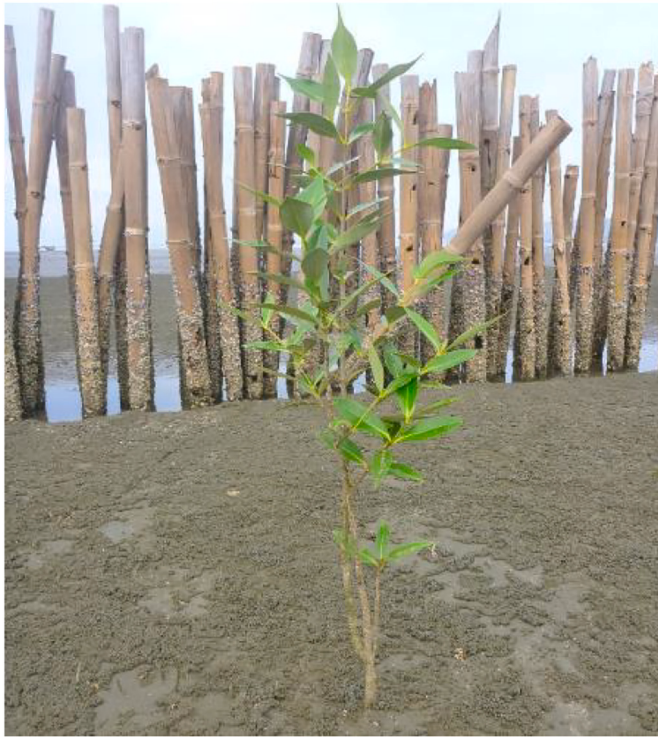
Fig. 14. Sedimentation and *Avicennia marina* behind the bamboo fence on Klang Island, Thailand.

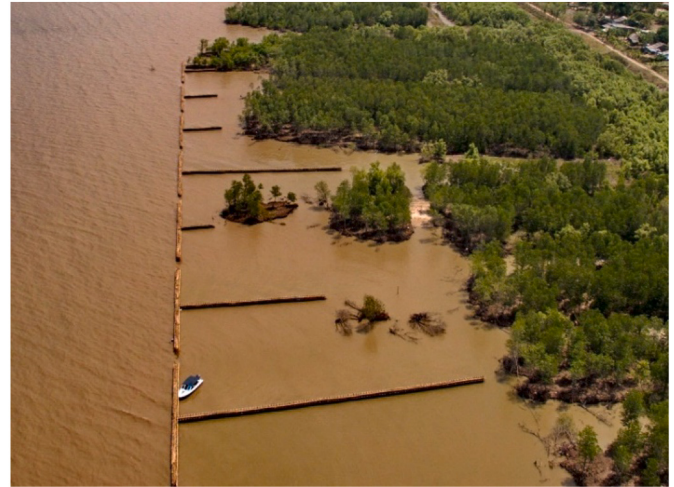
Fig. 16. Wave dampening effect of bamboo T-dams in Ca Mau Province, Viet Nam (courtesy R. Sorgenfrei, 2016).

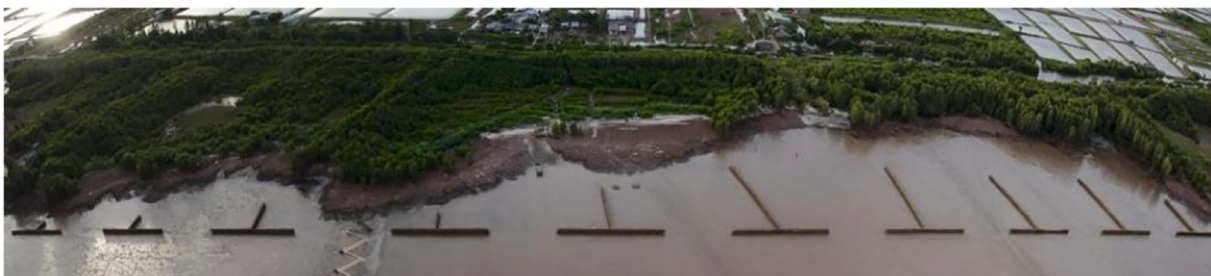
Fig. 15. Placement of T-dams in Bac Lieu Province, Viet Nam (courtesy Cong Ly and G.E. Wind, 2013).

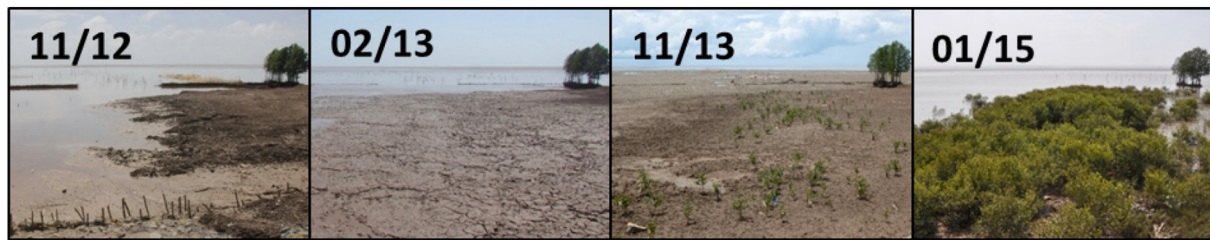
Fig. 17. Natural regeneration of *Avicennia* on restored floodplains in Soc Trang Province from the construction of the T-fences in October 2012 until January 2015 (Photos: GIZ Soc Trang, R. Sorgenfrei).

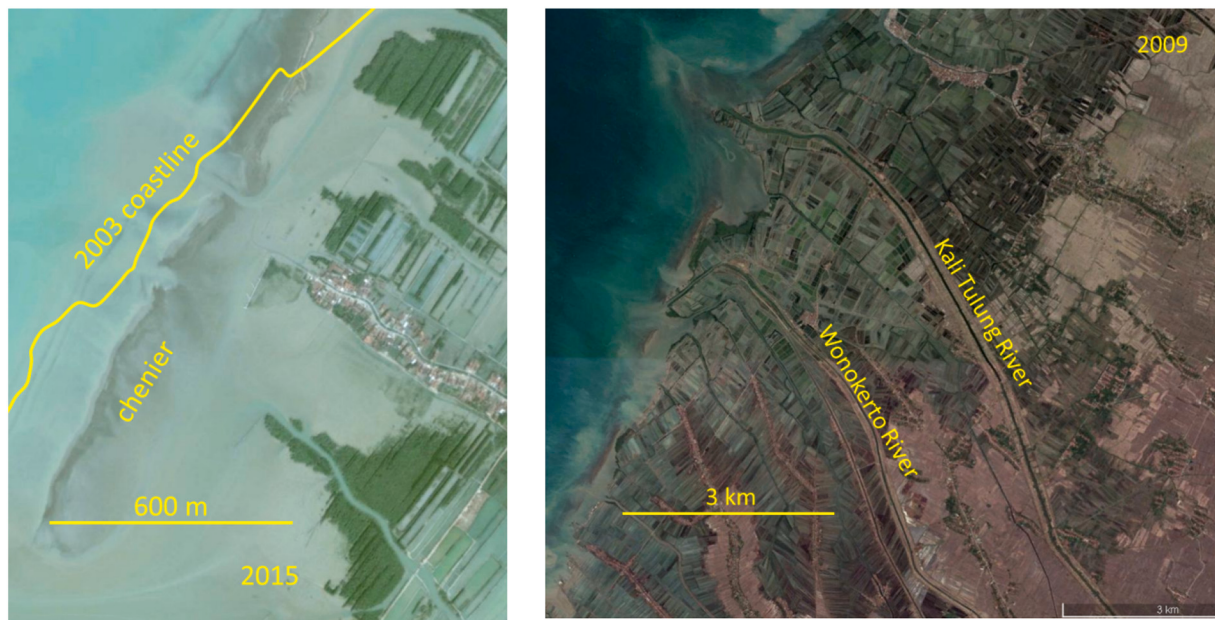
**Fig. 26.** Example of chenier formation Demak, Indonesia (Google Earth image) by (a) self-organization of eroded coastal sediment and (b) riverine sand input.

The formation and dynamics of cheniers and their migration are largely unknown. Tas et al. (2020) collected data on chenier dynamics, mainly under quiet hydrodynamic conditions (0.2 m waves). They tested some hypotheses with mathematical models, and it is postulated that the large tidal volume behind this chenier presumably augments its dynamics largely. However, no data could be collected during storm conditions. Fig. 27 exhibits the importance of such storm conditions, showing how a cheniers moved about 100 m onshore within one to two weeks. Likely, its further migration is blocked by the permeable dam.

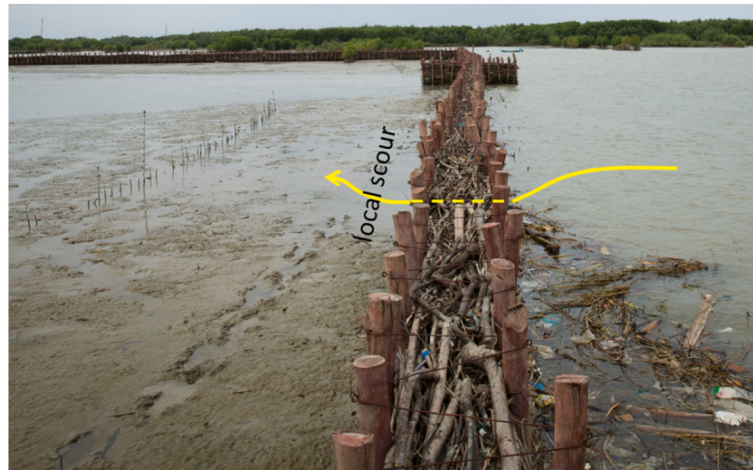
Fig. 29. Example of local scour by near-bed currents underneath loose brushwood, coastal restoration works in Bogorame, Demak, Indonesia.

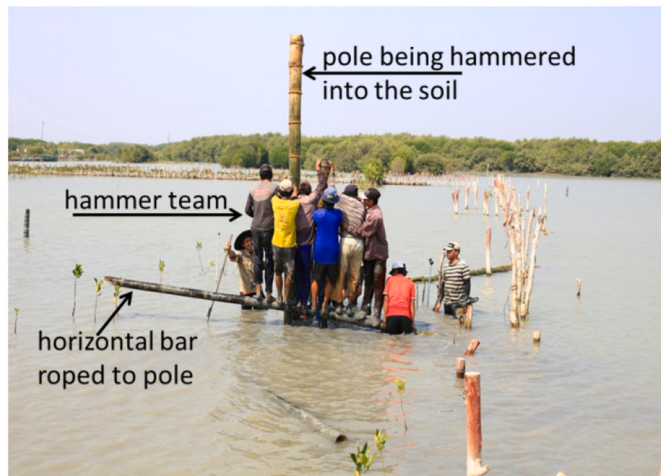
Fig. 32. Hammer team at work to place bamboo pole, Bogorame, Demak, Indonesia.

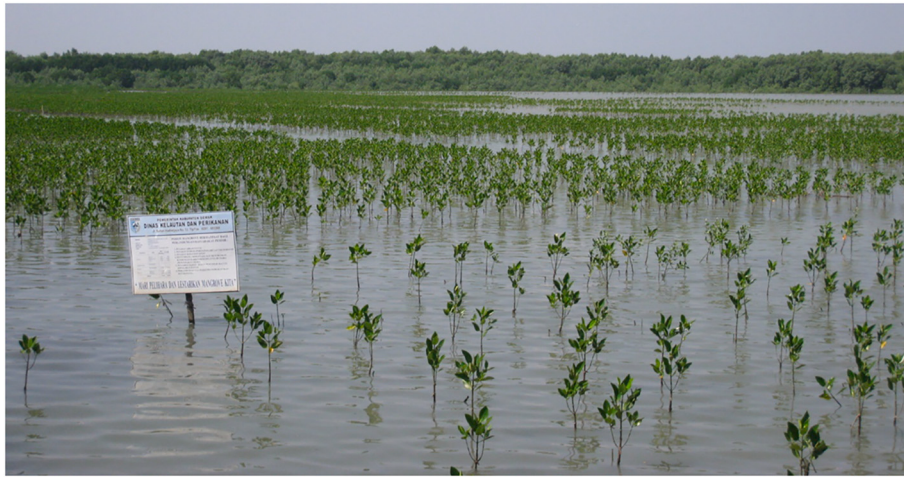
Fig. 33. *Rhizophora* planted on mud flat.

Overall, mangrove replanting is often done with red mangrove propagules, irrespective of habitat suitability (Fig. 33). As a

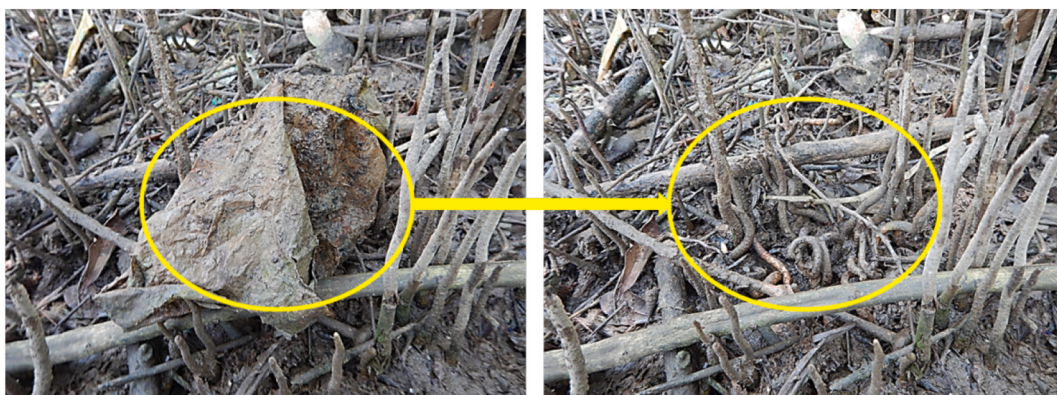
Fig. 34. Example of root degeneration/deformation in response to suffocation by plastic (Demak, photo C. Van Bijsterveldt).
