## Dielectric Coatings for High Voltage Gas Insulated Switchgear

van der Born, D. (2017). *Dielectric Coatings for High Voltage Gas Insulated Switchgear*. [Dissertation (TU Delft), Delft University of Technology]. <https://doi.org/10.4233/uuid:4f1b06bc-3d01-4107-8c85-21c0e278c4bd>

This research was financially supported by GE Grid Solutions  
(Villeurbanne, France)

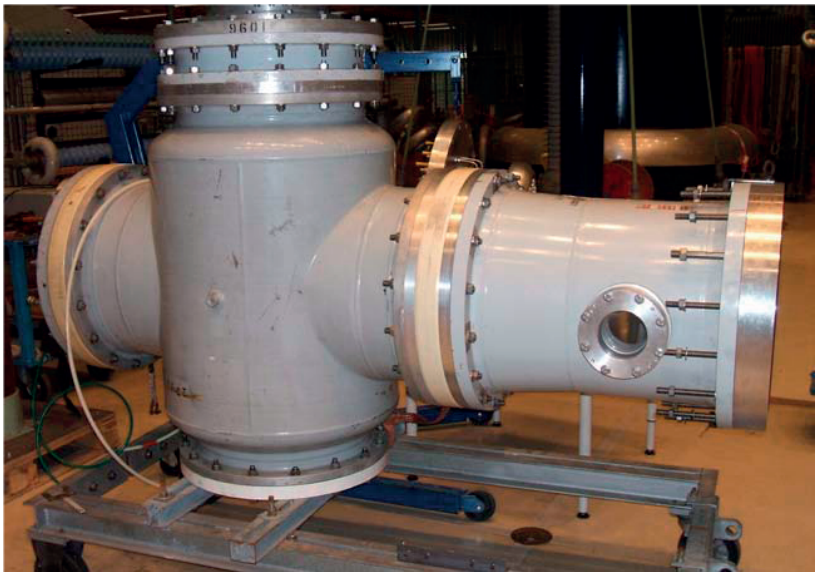
**Figure 3.1:** Picture of test setup GIS enclosure

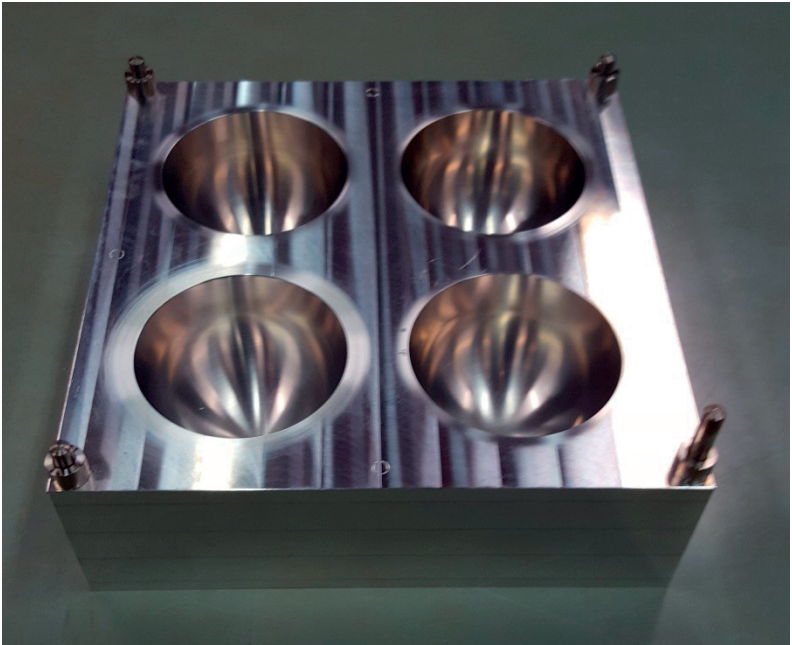
**Figure 3.21:** Mould for large size electrodes, bottom part.

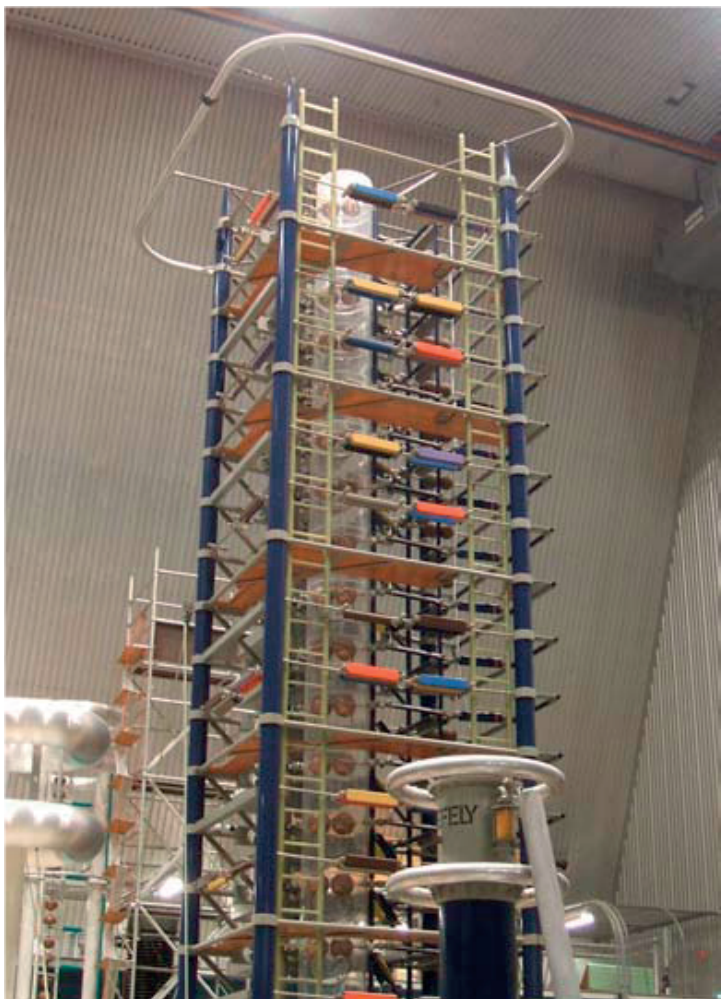
**Figure 3.29:** 20-stage Haefely impulse voltage generator.
