**Project Summary A3 - Dike reliability analysis**  
**Better methods for the assessment and design of dike systems**

## A3 - Dike reliability analysis

*Better methods for the assessment and design of dike systems*

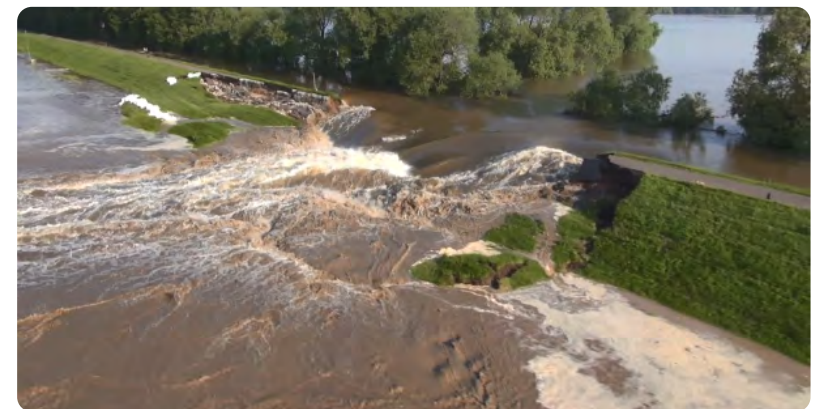
Figure 1: Dike failure in Breitenhagen, Germany. Photo by [Weichel \(2013\)](#).

modelling of failure mechanisms via the structured deduction of failure scenarios from before and after data. We tested this approach to find the most likely cause of the failure of the Breitenhagen dike in Germany (Figure 1). The method is generically applicable to other locations.

For a detailed description of each finding, please **see the key project outputs on the next page**. The analysis of the 2013 failure on the Breitenhagen dike in Germany shows that the slope instability most likely occurred as the result of an old breach. This old breach probably eroded the soil in front of the reconstructed dike, creating a direct connection between river and aquifer, thereby increasing pore water pressures.

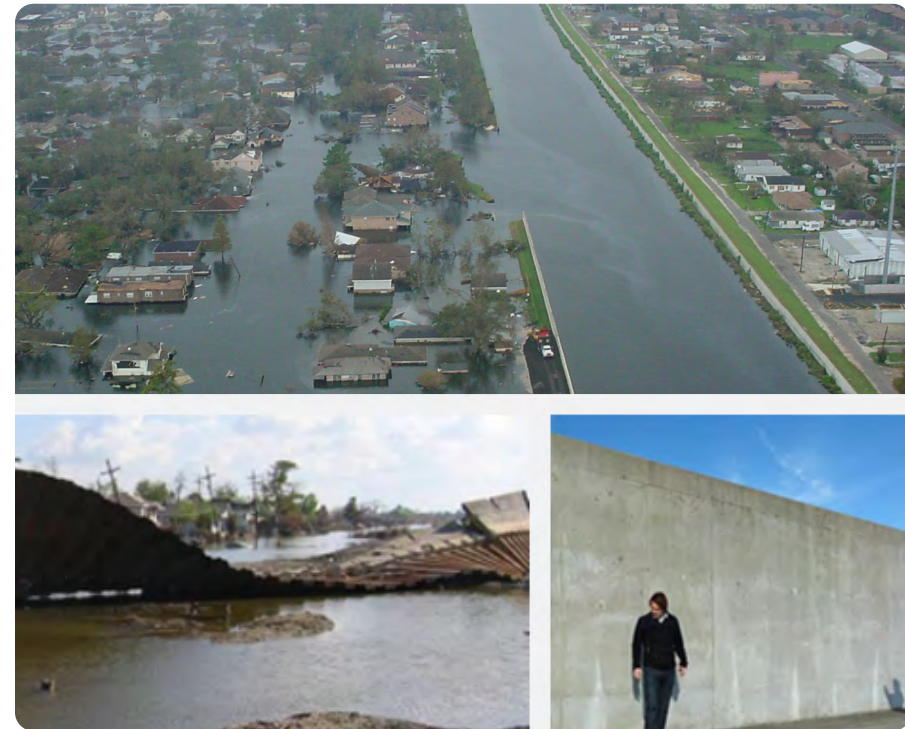
Figure 2: **Top and bottom-left:** Floodwall failure on 17<sup>th</sup> Street Canal from Hurricane Katrina in New Orleans (photos by U.S. Army Corps of Engineers and [IPET, 2005](#)). **Bottom-right:** Rebuilt New Orleans floodwall in 2013 (Photo by Bianca Hardeman).

Seeing the aftermath of the New Orleans flood in 2005 motivated me to work on dike reliability modelling (**Figure 2, bottom-right photo**). The flood consequences were grave and very impressive (**Figure 2, top and bottom-left photo**). That event made me realise the difficulties in predicting dike reliability first-hand and the need to reduce modelling uncertainties abroad and in the Netherlands.

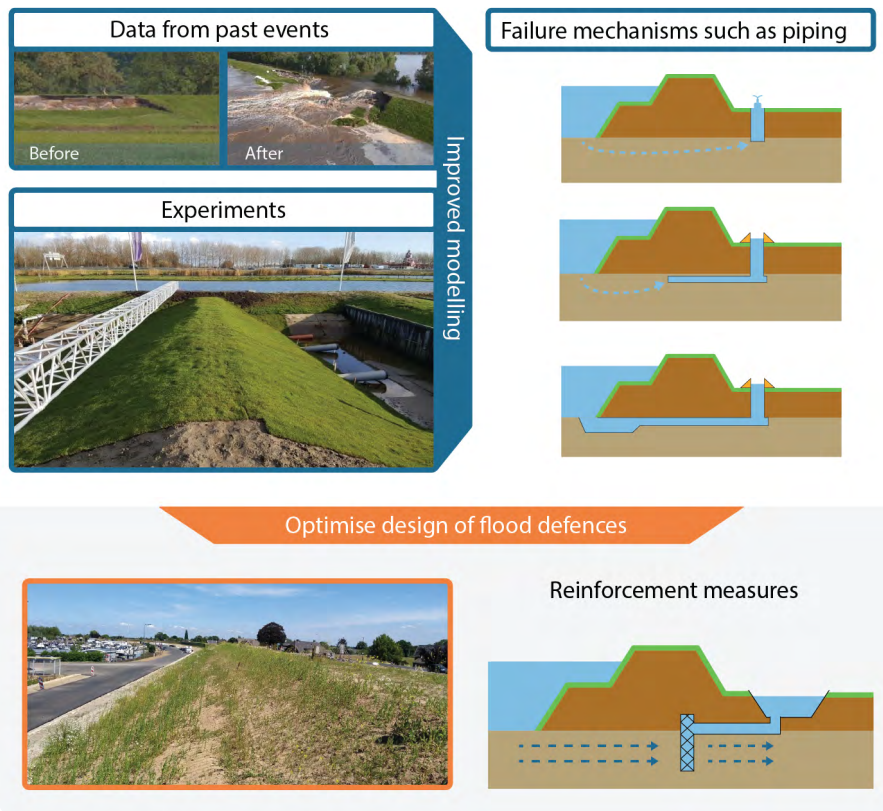
Figure 3: Components include data from **top**: the dike failure in Breitenhagen, Germany (source: [Weichel, 2013](#)); **middle**: the Flood Proof Holland backward erosion piping experiment (source: [Pol, Kanning & Jonkman, 2021](#)), and **bottom**: reconstructions around Kinderdijk in South Holland (source: [TU Delft \[SAFELevee\], 2021](#)). The piping and reinforcement schemes were adapted from [van Beek \(2015\)](#).

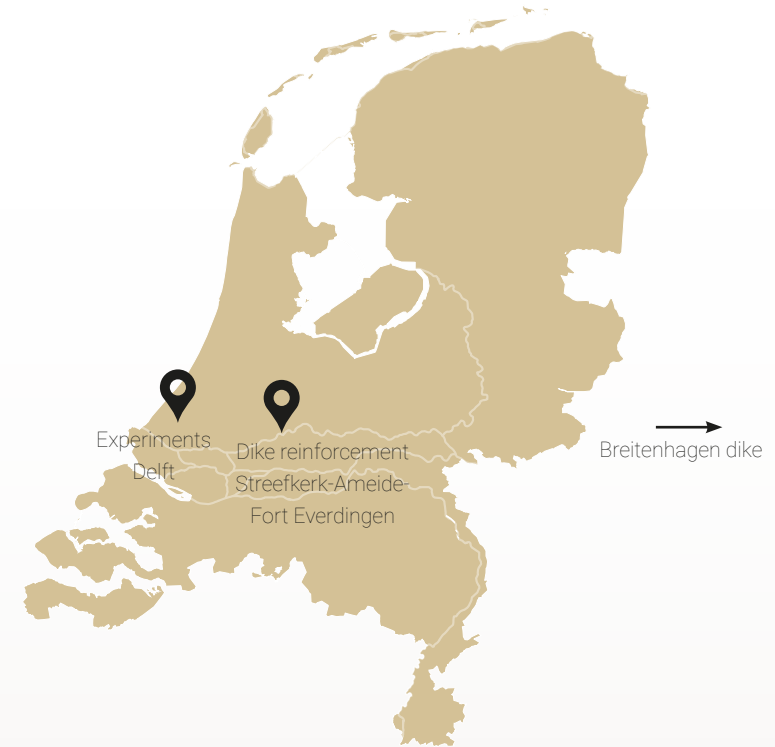
The research include key locations in the Netherlands and abroad to use data from past events and experiments in the optimisation of flood defences.
