## Morphodynamic trends of the Ribb River, Ethiopia, prior to dam construction

Geosciences (Switzerland)

# Morphodynamic Trends of the Ribb River, Ethiopia, Prior to Dam Construction

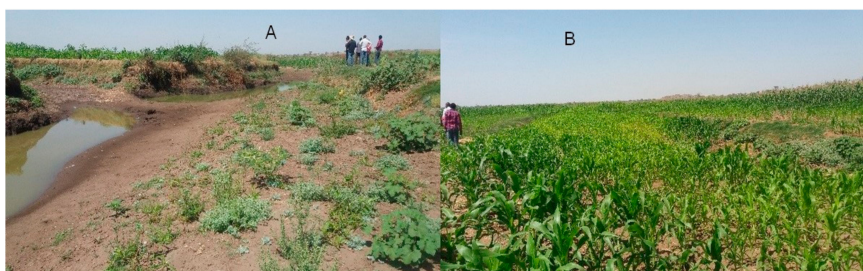
**Figure 5.** Lower Ribb River reach. (A) the point where the river loses its channel; (B) maize plantation using residual moisture along the river channel downstream of location A.

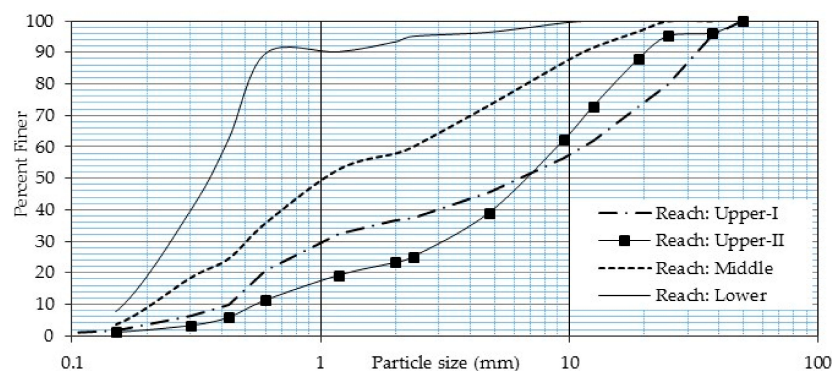
**Figure 7.** Grain size distribution of Ribb River bed material downstream of the Ribb Dam site, upstream and downstream of the weir site and upstream of the Ribb Bridge, at Universal Transverse Mercator (UTM) coordinates 37P 0388475, 1332080, 1872 m a.s.l.; 37P 0373692, 1329576, 1819 m a.s.l.; 37P 0368803, 1330762, 1804 m a.s.l. and 37P 0359808, 1326196, 1795 m a.s.l., respectively (Samples were collected in March 2016).

The granulometric curves of the bed material (Figure 7) show that the Ribb River sediment becomes finer in the downstream direction [13,24].

The riverbed near the dam site is dominated by a mixture of gravel (65%) and sand (35%). The bed material gradually changes to sand near the weir site (60% sand and 40% gravel). Further downstream, the riverbed is composed of 90% sand. The median grain size,  $D_{50}$ , is 7 mm in the Upper I and Upper II reaches and decreases to 0.65 mm in the Middle (the Upper and the Lower) reaches and 0.35 mm in the Lower reaches. Historical data on sediment grain size are lacking and this does not allow for assessing their temporal evolution.

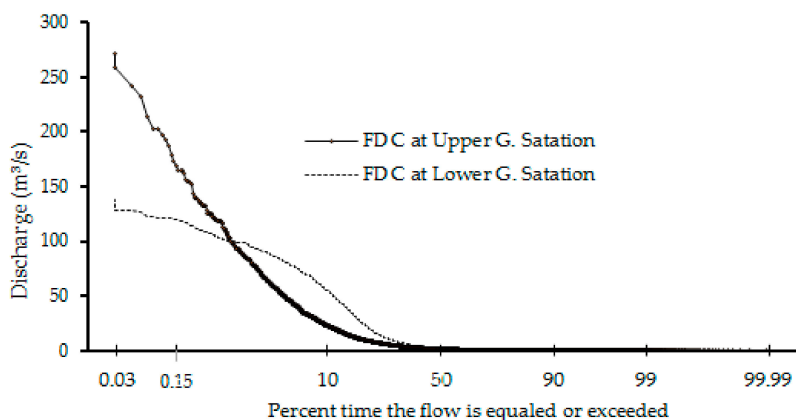
**Figure 11.** Flow duration curves at the Lower and Upper gauging stations (data source: Ministry of Water, Irrigation and Energy).

The FDCs derived for the gauging stations are shown in Figure 11. It is evident that the peak discharge at the Upper gauging station is substantially greater than the one at the Lower gauging station. This is likely due to overbank flow reducing the discharge exceeding the bankfull by as much as 71% at the Lower gauging station [21].
