Concrete Flow in Diaphragm Wall Panels: A Full-Scale In-Situ Test

Jan H. DALEN VAN^{a,b}, Johan W. BOSCH^b, ir. Wout BROERE^b

^b *Geo Engineering, Civil Engineering, Delft University of Technology, the Netherlands*

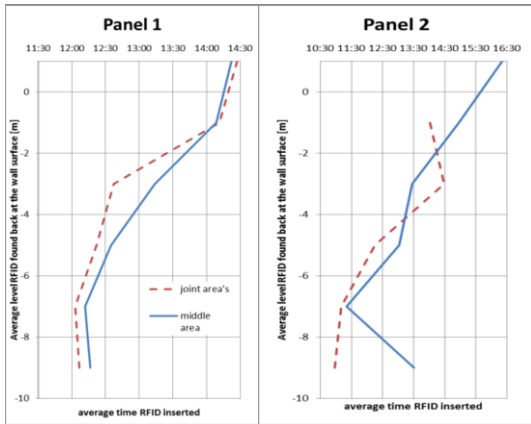
Figure 3. Relation between scanned level of RFIDs, averaged per 2 m height and time of insertion.

In the case of panel 1 is observed that for deeper levels the average time of insertion of

RFID's found near the joint is about 6 minutes earlier than those found in the middle area of the panel (see Figure 3). In this amount of time on average about 3.5 m³ of concrete will have passed the tremie pipe. For levels, higher than halfway the depth of the panel, the time difference diminishes to about zero at surface level. For Panel 2 this is completely different; in this case the difference in insertion time between RFIDs near the joint and in the middle of the panel is much more extreme for deeper levels: several hours. This supports the observation from Figure 2 that the early concrete in the middle area was pushed up by concrete poured in after the interruption.

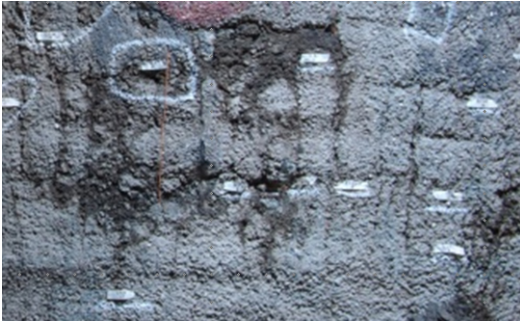
Figure 6. Location of reinforcement bars visible in Panel 2

In Panel 2 at several locations (totally about 50% of the panel) an effect as shown in Figure 6

is observed. Clearly visible at the surface is the location of reinforcement bars. This indicates that those bars influence the horizontal flow of concrete perpendicular to the net of bars. Also it indicates that on those locations, in the space between reinforcement bars and surrounding soil no flow of importance parallel to the plane through the reinforcement net takes place.

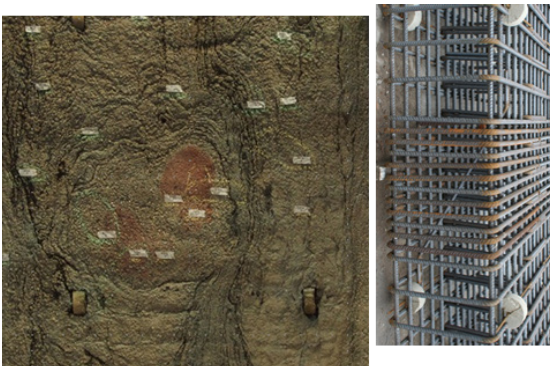
Figure 7. Pattern visible at locations with a strong reinforcement concentration

Another pattern is observed in locations with an extreme amount of reinforcement, see Figure 7. The red concrete, visible in the middle area originates from the last truckload, the grey concrete surrounding it from the first truckload. During the first truckload the level of the tremie pipe was 3.5 m deeper than this location, during part of the last truckload this level was 0.5 m under the reinforcement concentration.

A plausible explanation for what is seen here, might be the fact that during the first truckloads, this area was not completely filled with concrete,

due to the reinforcement concentration. From simulations this was also expected. During the last truckload, however the pressure in the concrete near the outlet of the tremie pipe must have reached much higher values, since the overall concrete level in the trench was higher. Probably with that pressure, the gap in the concrete was filled from underneath, suppressing the (grey) concrete present at the edges of the formerly non filled area. The latter would explain the circular lines of grey concrete which are alternated with lines of dark grey bentonite, surrounding the circular red area. Area's similar to this one are found at 3 different locations in the panel, all where concentrations of reinforcement are present.
