## Experimental study on driftwood accumulation at submerged culverts

Proceedings of the 10th International Symposium on Hydraulic Structures (ISHS 2024)

**Abstract:** This study investigates the effect of driftwood on submerged culverts through scale experiments, focusing on their accumulation and the hydrodynamic processes occurring underneath. Examining temporal evolution and velocity measurements, this research delves into the implications of driftwood accumulation, including its geometry, hydraulic conditions and associated backwater rise. Findings reveal that accumulation shape is strongly influenced by hydraulic conditions, with higher Froude numbers pulling logs toward the bottom and thus yielding more compact accumulations. This effect holds implications for submerged culverts, where the opening near the bottom diminishes the importance of surface flow resistance. Accurate prediction of accumulation lengths is achieved using wood volume and initial flow velocity. The study also provides valuable data for developing quantitative design equations for backwater rise from driftwood accumulation at culverts. Additionally, detailed measurements of velocity profiles and Reynold

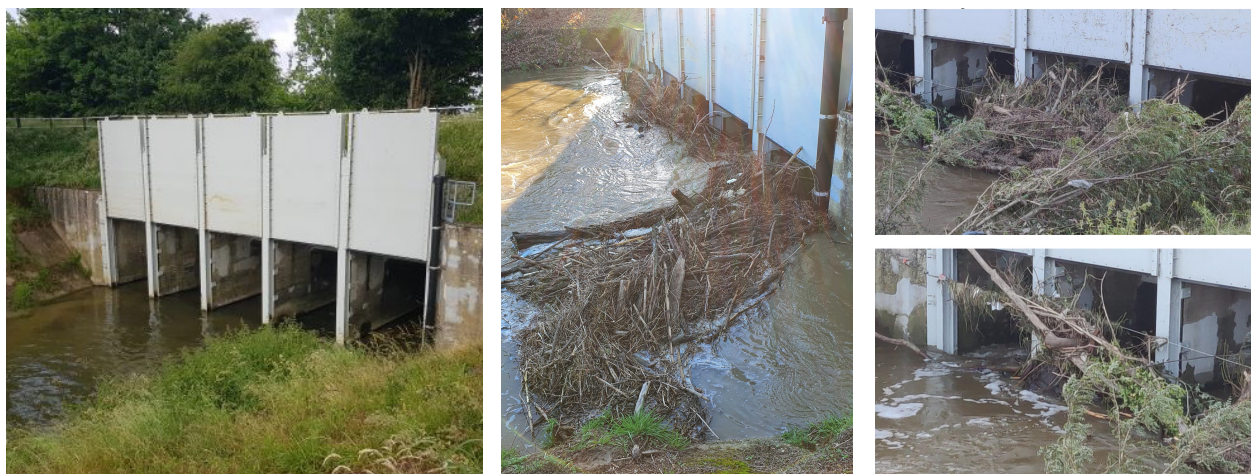
**Figure 1.** Inverted siphon near Bunde (the Netherlands), affected by driftwood accumulation during the summer 2021 flood.  
Credit rightmost photos Waterschap Limburg.

The accumulation of driftwood at critical infrastructure has often been overlooked in the realm of flood management, despite representing a critical aspect that can yield catastrophic consequences if not adequately addressed. The mishandling of strategies and an insufficient comprehension of the processes leading to large wood accumulation can significantly hamper the functionality of hydraulic structures in flood-prone areas. The 2021 floods in Belgium, Germany, and the Netherlands served as a reminder of this issue, as numerous bridges and hydraulic structures sustained severe damage due to driftwood accumulation and subsequent clogging (Korswagen et al. 2022; Erpicum et al. 2023). In the Netherlands, several culverts and inverted siphons fell victim of large driftwood accumulation, resulting in a reduced conveyance capacity and exacerbating upstream flooding (Ronckers 2023a). The village of Bunde, situated near Maastricht in the Limburg province of the Netherlands, became a prime example of this phenomenon. Large wood accumulations obstructed the entrance of an inverted syphon (Figure 1), preventing floodwaters to flow from the Geul river to the Maas, intensifying overflow along the Juliana Canal and inundating multiple nearby villages. As a consequence, additional damage was induced by the reduced capacity of these critical hydraulic structures, pointing out the need for more efficient debris management strategies.

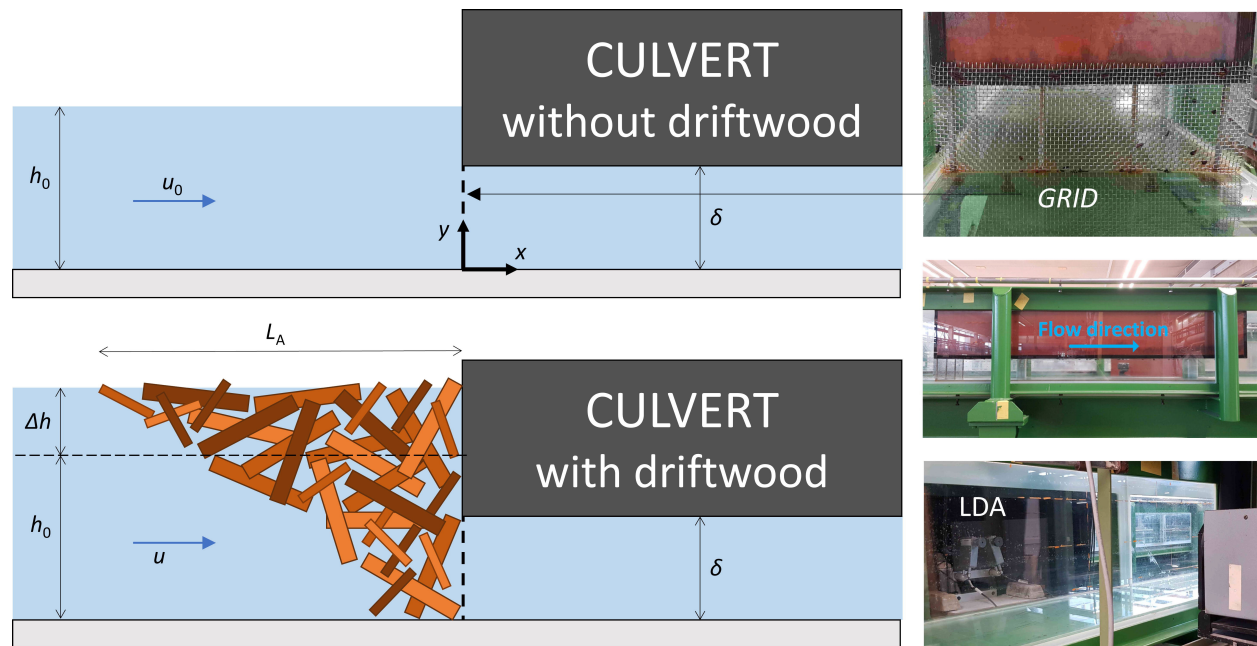
**Figure 2.** Definition sketch and picture of the experimental set-up, with and without driftwood.

This study is based on an experimental approach and all tests were conducted in the Hydraulic Laboratory of Delft University of Technology, the Netherlands. The objective of this study was to investigate the main features associated with the accumulation of driftwood at hydraulic structures and their influence on the backwater level rise  $\Delta h$ , i.e. the increase in water level relative to the initial water level without driftwood  $h_0$  (Figure 2). The physical model was built in a smooth (glass) inverted flume with a length of 14 m, a width  $B = 0.4$  m and a height of 0.45 m, where a fully submerged outlet-controlled culvert was reproduced. Based on the dimensions of typical prototype structures in the Limburg province (e.g. Geul and Geleenbeek), a geometric scale of 1:20 was chosen, leading to a culvert opening  $\delta = 0.12$  m (2.4 m in the prototype) and  $L = 1.6$  m (32 m in the prototype). The structure was made of plywood and to prevent logs from entering the culvert, a protective grid was installed on the upstream side with 4 vertical bars ( $\varnothing = 8$  mm) and a grate with openings of  $4 \times 4$  mm, which was the largest size to prevent the smallest log from passing through. A movable sill was located at the end of the flume, allowing to control the water levels at the downstream end of the culvert (i.e. outlet control structure). Pictures of the set-up and a definition sketch with the main parameters are presented in Figure 2.

A particularly relevant parameter for engineers and designers is the length of the accumulation  $L_A$ , defined as the horizontal distance between the most upstream log and the inlet of the culvert (Figure 2). This value was measured 3 minutes after each batch was introduced in the flume and its development is depicted in Figure 5, as a function of the initial velocity  $u_0$  and of which fraction of the total volume  $V_S$  is added. Results showed, as expected, that the length of the accumulation grew for increasing driftwood volumes. A correlation between the accumulation length and  $u_0$  is also clearly visible: higher values of  $u_0$  generate shorter accumulations. Images also confirm that higher initial velocities  $u_0$  can drag logs to the entrance of the culvert, therefore increasing the local head losses and inducing higher backwater level rises, as previously shown in Figure 4.

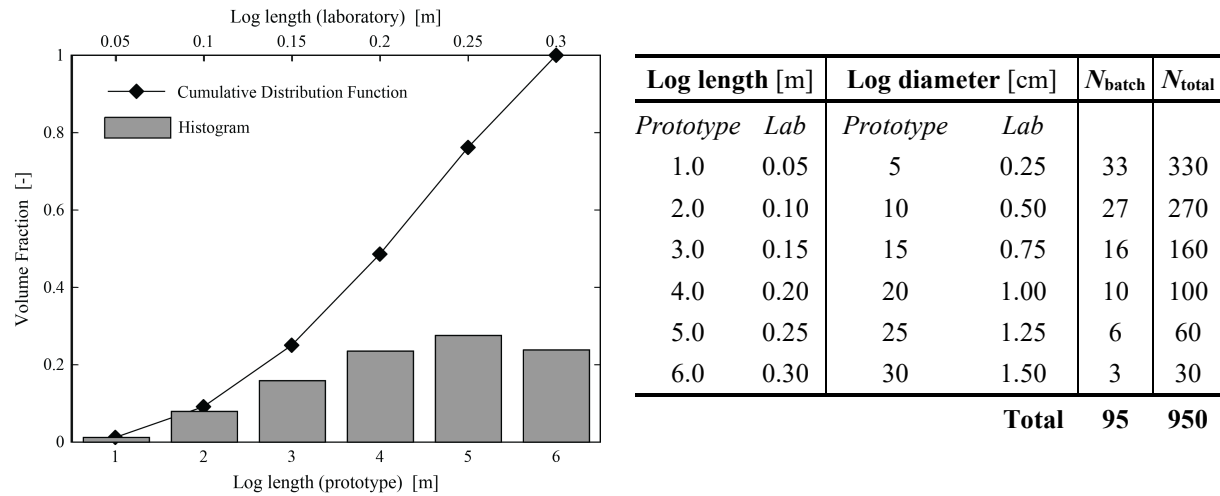
**Figure 3.** Driftwood characteristics. Note that an additional 10% was included in  $V_s = 7.4 \text{ L}$  (lab scale) to consider irregularities in the shape of the natural logs used in this study. Both prototype and laboratory scale are indicated, the lab scale was 1:20.

Previous observations during the 2021 floods showed that at this specific location accumulations only contained driftwood. It was therefore decided to use a fixed volume of driftwood across all experiments with a value  $V_s = 7.4 \text{ L} = 0.0074 \text{ m}^3$ . Depending on the flow conditions in Table 1, this volume ranged between 0.4 to 2.3 times the characteristic value suggested by Schalko (2018). The composition of the driftwood mixture is based on observations at the Geul inverted siphon after the 2021 flood events, as documented by Ronckers (2023b). Figure 3 shows the discretised distribution of log sizes at prototype scale (laboratory was scaled 1:20). The length to diameter ratio for natural logs was assumed to be 20. The logs used in this work were natural sticks from the Limburg province, whose properties corresponded well to "dense wood" by Ruiz-Villanueva et al. (2014), with a buoyancy of 21% and average density of  $\rho_d = 800 \text{ kg/m}^3$ .

At the beginning of each test, the desired discharge was set, then the downstream sill was adjusted to reach the desired water level and submergence ratio. Careful attention was given to prevent air entrapment below the culvert. The total driftwood volume  $V_s$  was divided into 10 equal batches (Figure 3), added one at the time and therefore allowing to

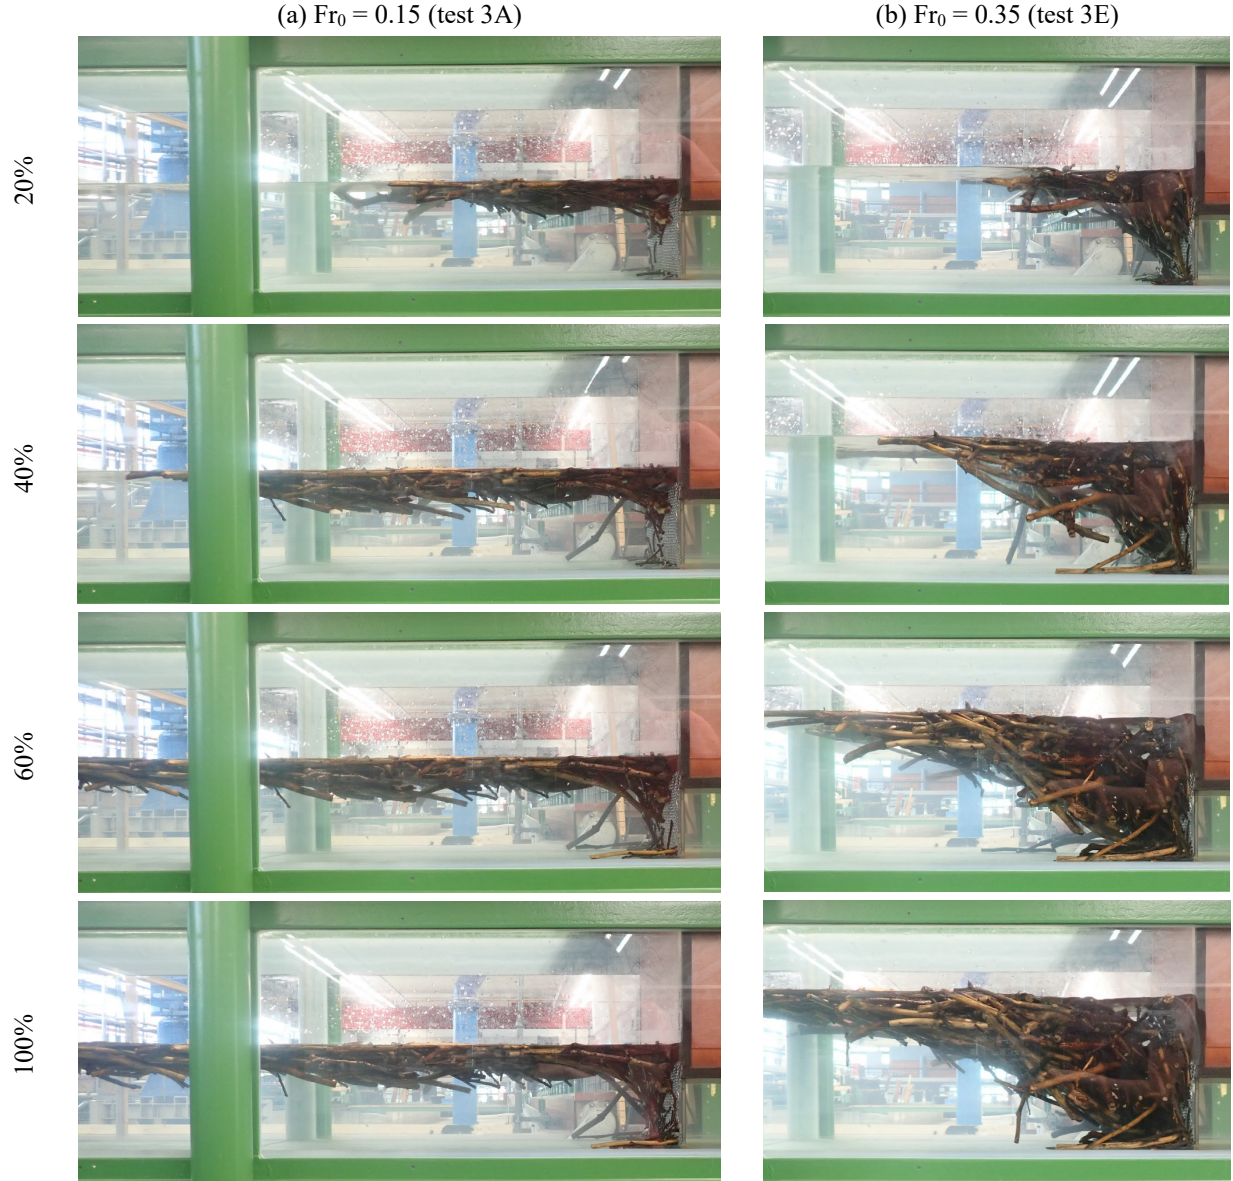
**Figure 4.** Evolution of driftwood accumulation for fraction of the total volumes for two selected flow conditions, both with an initial submergence  $h_0/\delta = 1.4$ : (a)  $Fr_0 = 0.15$  (test 3A); (b)  $Fr_0 = 0.35$  (test 3E).

The set-up did not allow for logs to go through the culvert, hence inducing the formation of a driftwood accumulation on the upstream side of the structure, that grew in size with the arrival of the new log batches. The pictures taken after each batch show some interesting features that are shown in Figure 4 for two selected flow conditions ( $Fr_0 = 0.15$  and  $0.35$ ), both with a submergence  $h_0/\delta = 1.4$ . One can immediately notice a difference in behavior between  $Fr_0 = 0.15$  and the higher Froude numbers, clearly showing that for weaker flows most driftwood remained floating at the surface, with a carpet that kept growing horizontally, but not vertically (*i.e.* the entrance of the culvert remains almost unblocked). This can be explained by the fact that the flow is too weak to pull many branches down towards the grate. As a result, adding more driftwood mainly increased the length of the accumulation, but the backwater rise remained limited. Contrarily, larger Froude numbers ( $Fr_0 = 0.35$ ) showed the development of a more typical accumulation, where the flow was sufficiently strong to pull branches down towards the grate, causing substantial backwater rise. Observations also showed the accumulation to take on an arched geometry with the addition of more log batches (Figure 4), fitting with the observations of Schalko (2019a) at debris racks. The large number of logs that accumulated on the upstream side of the grate induced a drag flow through a porous medium, that is responsible for the head-losses that contribute strongly to the upstream backwater rise (Follett et al. 2020, Poppema and Wüthrich, 2024). Similar results were observed for other flow conditions and submergence rates, as detailed by Ronckers (2023a).

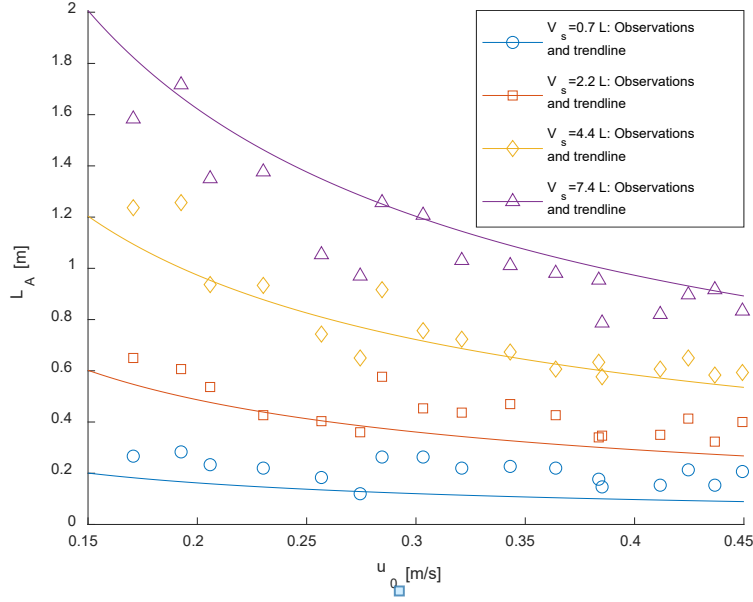
**Figure 5.** Observed carpet lengths, plotted for four driftwood volumes, decrease with increasing initial flow velocity. Fitted trendlines are of the shape  $L_A = \beta \cdot \frac{V_s}{u_0^\gamma}$  in Eq. (1) with  $\beta = 66.9$  and  $\gamma = 0.74$ .

A relationship between the accumulation and the initial flow conditions is attempted in Figure 5, in the form

$$L_A = \beta \cdot \frac{V_S}{u_0^\gamma} \quad (1)$$

where  $\beta$  and  $\gamma$  are empirical parameters derived with best-fit approach with laboratory data. While Eq. (1) remains indicative, good agreement was observed for all volumes and initial flow conditions, with  $\beta = 66.9$  and  $\gamma = 0.74$  for variable  $L_A$  in meters,  $V_S$  in  $m^3$  and  $u_0$  in  $m/s$ .

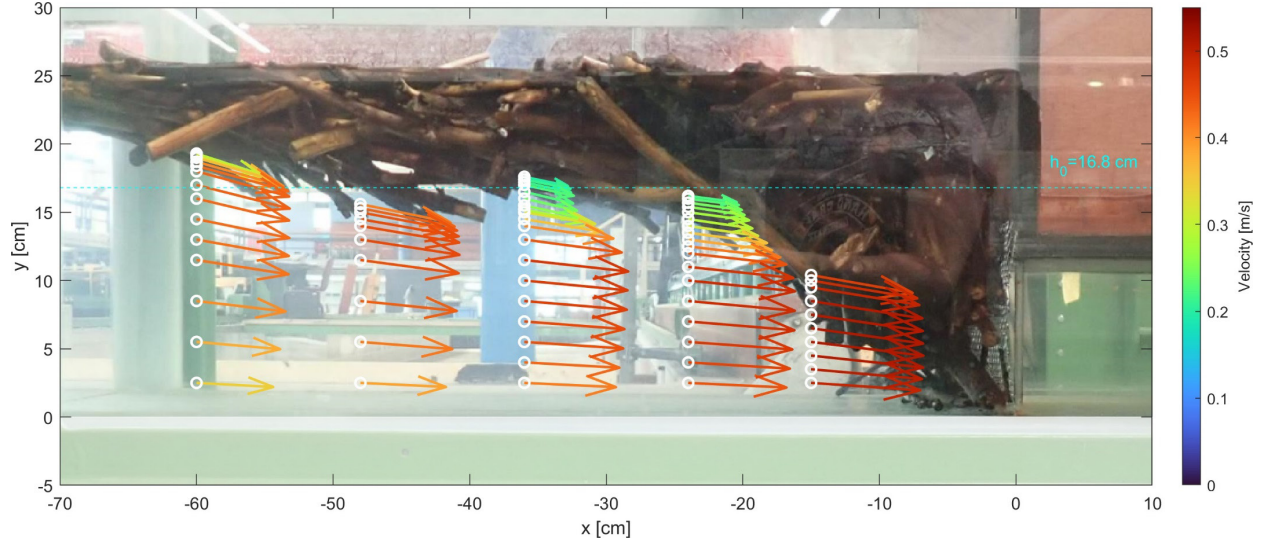
**Figure 6.** The velocity field under the accumulation, for  $Fr_0 = 0.35$  and an initial submergence rate of 1.4. Average velocities are in the centre line of the flume, measured by the LDA.

For three selected flow conditions, detailed velocity profiles were measured using the LDA, as detailed in Section 2.1. At every point data was sampled for three minutes at a frequency of 1000 Hz. These measurements provided detailed information on the 2D flow field under the accumulation. An example of the time-averaged velocities is shown in Figure 6 for  $Fr_0 = 0.35$  and a submergence rate of 1.4. Similar results were also obtained for  $Fr_0 = 0.15$  and  $Fr_0 = 0.25$ , as detailed by Ronckers (2023a). Results show that horizontal velocities and velocity magnitudes decrease directly under the accumulation compared to lower in the water column. This is especially the case for the measurements at  $x = -36$  cm (i.e.  $-3\delta$ ) and  $-24$  cm ( $-2\delta$ ), which are sheltered by an upstream part of the accumulation extending further down. Near the start of the accumulation, at  $x = -60$  cm ( $-5\delta$ ), a clear downward deflection of the flow is visible directly under the accumulation. Weaker downward flow is visible at the other measurement locations, which is a consequence of flow deflection by the accumulation and by the culvert opening being located near the bottom of the flume.

This means that the downward flow deflection by the driftwood is compensated by the cross-sectional increase from backwater rise. In fact, Figure 6 shows that the accumulation is located above the initial water level until approximately  $x = -25$  cm ( $x/\delta \sim -2$ ), resulting in little flow resistance within the original flow area and some ‘*additional*’ weak flow on top of it, overall resulting in reduced velocities underneath the accumulation. This is remarkable, since accumulations at bridges and debris racks are reported to cause higher velocities near the bed, responsible for scour (Diehl, 1997; Schalko et al., 2019b). Although the lowest 25 mm could not be measured in our case due to limitations of the setup, significant flow acceleration at the bed seems unlikely from extrapolating the profiles. Possibly, flow acceleration only occurs when accumulations extend further down, whether that is at completely different accumulations and conditions, or simply elsewhere at the present accumulation (e.g.  $x = -5$  cm in Fig. 6). Alternatively, it could be due to type of structure: the flow depth inside the pressurized culvert studied here cannot increase with backwater rise, like it would at more commonly studied bridges and debris racks. This fixed flow depth could result in higher backwater rise, increasing upstream flow depth and thus decreasing the probability of net flow acceleration.

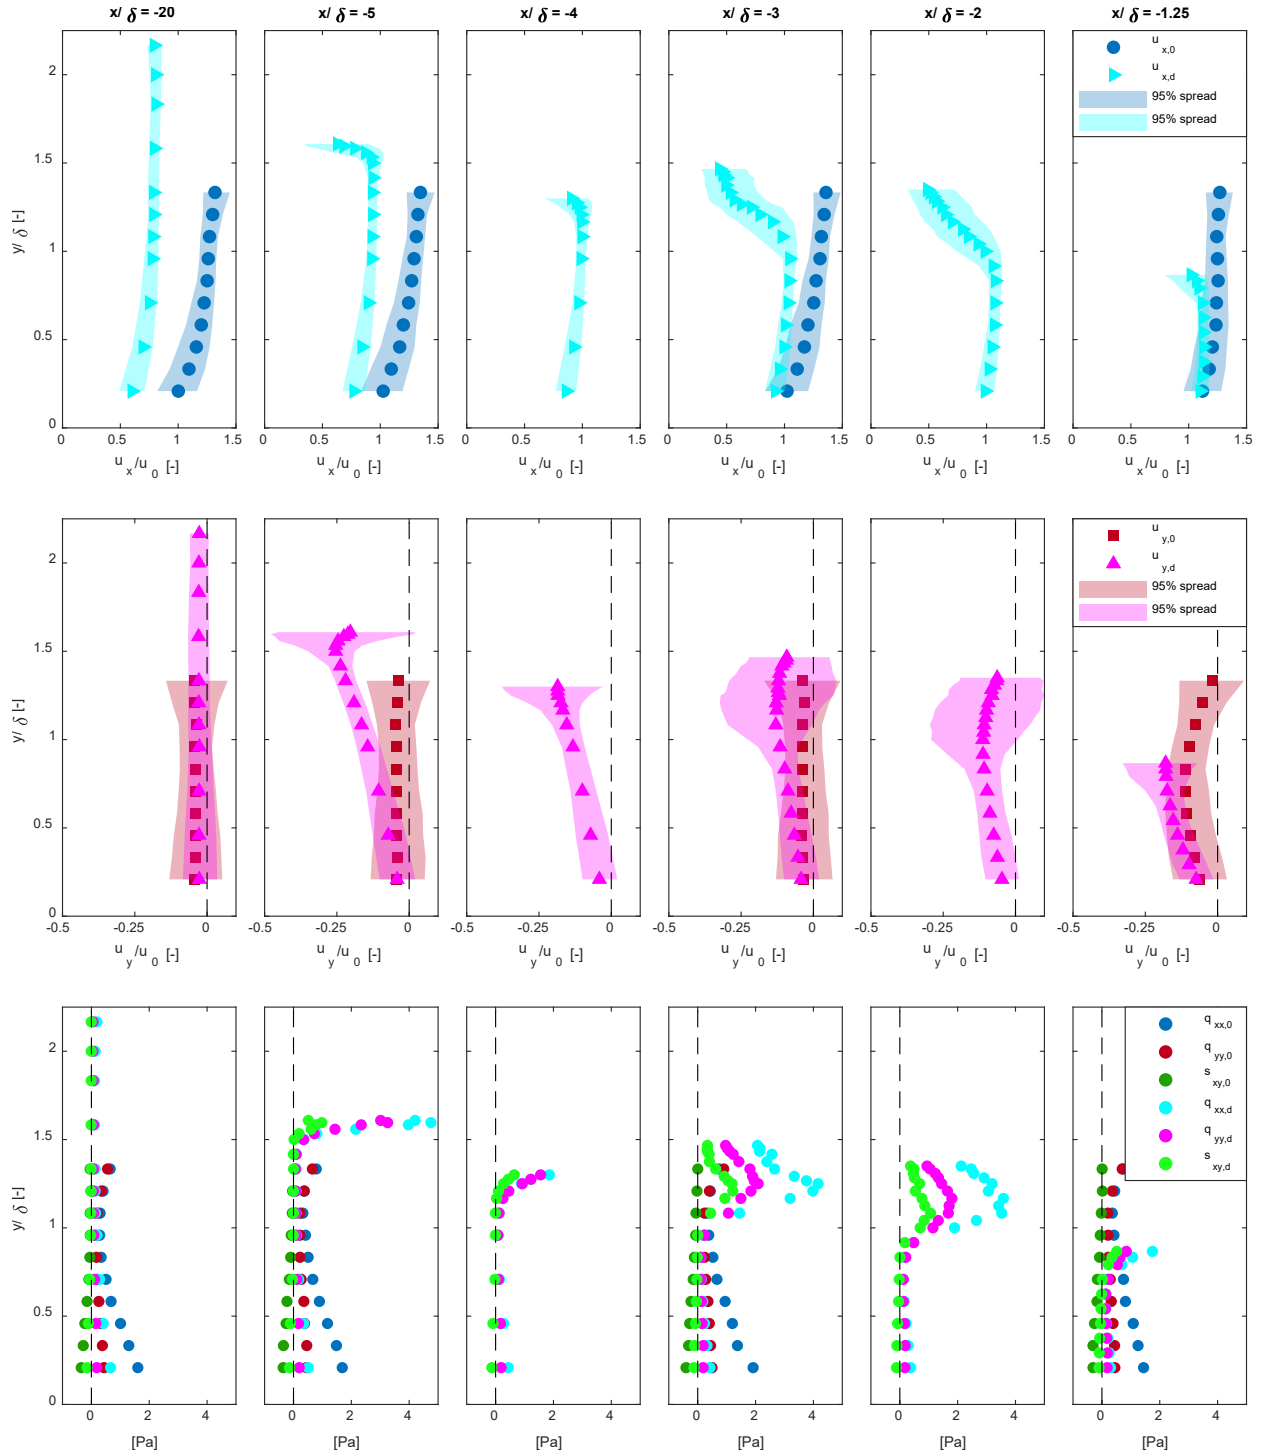
**Figure 7.** Measured horizontal velocities (top row), vertical velocities (middle row) and Reynolds stresses (bottom row) measured under the accumulation. Negative vertical velocity indicates downward flow. Markers indicate the value averaged over the 3 minute measurement intervals, shaded areas the 2.5<sup>th</sup> to 97.5<sup>th</sup> percentile, *i.e.* the 95% spread.  $Fr=0.35$ ,  $h_0/\delta=1.4$ , test 3E.

Velocity profiles are plotted in detail in Figure 7, for the situation with and without driftwood, as well as profiles of the Reynolds stresses. At all depths, the horizontal flow velocities under the driftwood accumulation are lower than at the same position without driftwood, while vertical velocities are usually higher, especially directly under the accumulation. The horizontal velocities under the accumulation increase slightly in the  $x$ -direction, since the flow is funneled in the diminishing area underneath the accumulation, but they remain lower than the driftwood without driftwood until  $x = -15$  cm (i.e.  $-1.25\delta$ ).

Looking at the behavior of these Reynolds stresses in Figure 7, the horizontal, vertical and shear stresses all show a sharp increase directly under the accumulation. This is especially apparent where there are large vertical gradients in the horizontal velocity profile, e.g. at  $x/\delta = -5$  near the accumulation, or at  $x/\delta = -3$ ,  $y/\delta = 1.25$ . These increased stresses can be explained by the rough bottom of the accumulation and the turbulent flow around logs. At  $x/\delta = -2$  and  $x/\delta = -3$ , the highest measured locations show a clear drop in the stresses. These are the locations identified above as being sheltered by upstream driftwood (Figure 6). Conversely, the Reynolds stresses decreased compared to the situation without driftwood at the lowest data points. This effect was also observed when  $Fr_0 = 0.25$ , but in case of  $Fr_0 = 0.15$  the difference in the lower half of the water column compared to the situation without driftwood was minimal.

The velocity profiles measured underneath the accumulation allow to estimate the discharge that went through the accumulation  $Q_a$ . This is done by integrating the streamwise velocity profiles in Figure 7a assuming a typical logarithmic profile with  $u^* \sim 0.015$  m/s, and a maximum roughness  $k_s \sim 1$  mm. For maximum reliability, data was also corrected based on measurements without driftwood to take into account that flow velocities in the center of the flume

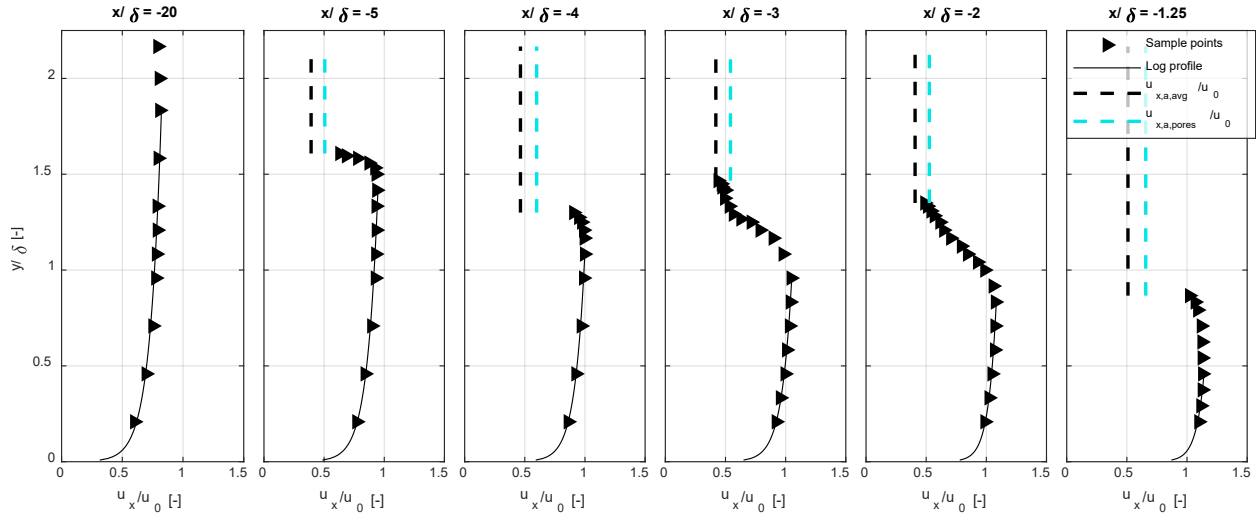
**Figure 8.** Flow velocities measured under the accumulation (same data presented in Figure 7a), together with the calculated flow velocities through the accumulation  $u_{x,a,avg}$  and  $u_{x,a,pores}$  defined in Eq. (4) and (5) respectively. ( $Fr_0 = 0.35$ ,  $h_0/\delta = 1.4$ , test 3E).

The values of these average velocities through the accumulation  $u_{x,a,avg}$  and  $u_{x,a,pores}$  are plotted in Figure 8 together with the velocity profiles measured with the LDA, showing a relatively good agreement. In line with expectations, due to the increased friction, the velocities through the pores are lower than the velocities below the driftwood accumulation. However, the accumulation was highly non-uniform across the width of the cross section, suggesting that the velocities measured at the centerline might not be representative of whole cross-section. Despite these limitations, these are promising results that will certainly contribute to a better understanding of the hydro-dynamic processes associated with the accumulation of driftwood at hydraulic structures.
