## Experimental investigation of the in-plane cyclic behaviour of calcium silicate brick masonry walls

Bulletin of Earthquake Engineering

# Experimental investigation of the in-plane cyclic behaviour of calcium silicate brick masonry walls

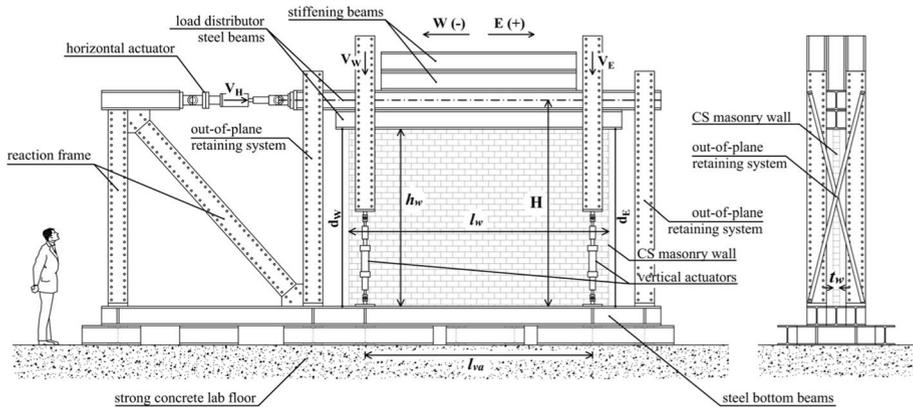
Figure 1 shows a scheme of the test set-up. The frame was designed in order to provide both a uniform vertical pressure (throughout four actuators, having each a capacity of 100 kN) and an imposed horizontal displacement (via an actuator with a capacity of 400 kN) at the top of the walls. The top and bottom brick course of each specimen was glued to a steel beam with a high performance glue to prevent sliding or tensile failure at the steel-masonry interface. It should be noted that this solution slightly modifies the location where the damage can start with respect to a URM wall on concrete foundations, since no damage can occur along the interfaces with the steel beams. The bottom steel beam was rigidly connected to other cross-beams anchored to the strong concrete laboratory floor, whereas a load-spreading beam was bolted over the top steel beam and connected to the horizontal actuator. The height of application of the load with respect to the wall base is identified by  $H$  in Fig. 1. The offset between the height of application of the load and the height of the wall caused small bending moment at the top of the cantilever walls, so that the moment profile of these specimens did not strictly correspond to that of a cantilever wall. For this reason the shear ratio of these walls differs from the aspect ratio. In the test set-up used for the tests carried out in 2015, the actuator was connected at the west end of the steel

**Fig. 1** Test set-up

beam. This detail was modified in 2016, when the actuator was connected directly to the centre of the steel beam by means of two steel tubes, one at each side of the beam (Esposito and Ravenshorst 2017) (the detail is not shown in Fig. 1). The weight of the actuator was always balanced by a counter weight in both the testing periods. The vertical actuators connected the cross-beams at the base of the wall to the load-spreading beam on the top. The four actuators were controlled pairwise (on the front and back of the wall) to ensure that the load in each actuator of the pair was the same. The distance  $l_{va}$  between each pair of actuators was equal to 1.9 m for the slender walls, and 3.7 m for the squat walls. Given the large distance between the two couples of vertical actuators in the configuration used for the tests on squat walls, two additional steel beams were added above the load-spreading beam to ensure a uniform spreading of the vertical load. The out-of-plane displacements and rotations of the top beam were prevented by a transversal steel frame (in Fig. 1 only the columns are shown).

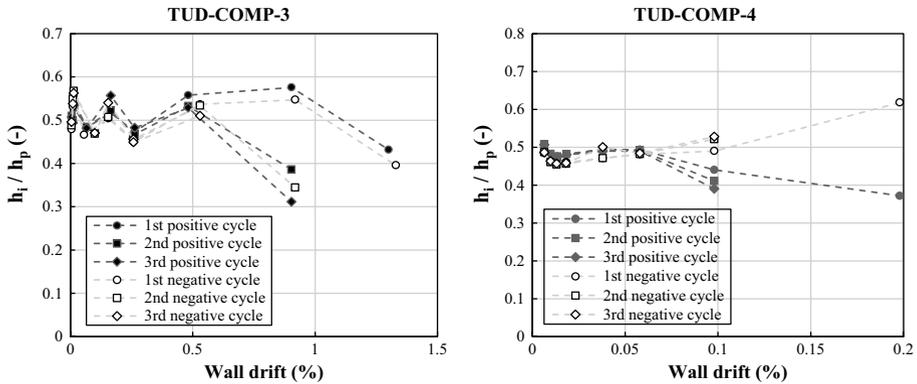
**Fig. 2** Height of the inflection point at the peak displacements normalized with respect to the wall height, for a slender wall (TUD-COMP-3) and a squat wall (TUD-COMP-4)

As mentioned above, the testing programme considered two different boundary conditions: cantilever and double clamped boundary conditions. For the cantilever case the load was maintained constant in each vertical actuator:  $V_E = V_W$ , where  $V_E$  and  $V_W$  were the measured forces in each pair of actuators (as shown in Fig. 1). For the double clamped walls the forces in the actuators were dynamically updated according to a mixed force–displacement control of the vertical actuators, by means of which the total vertical load was maintained constant ( $V_E + V_W = \text{const.}$ ) and the top beam horizontal ( $d_E = d_W$ , see Fig. 1). For the double-clamped tests the height of the inflection point (i.e. the point of zero moment) is conventionally taken as half of the height of the wall. Although this is not valid throughout the whole duration of the test, it can be observed that the values of the height of the inflection point measured at the peak displacements of each cycle are indeed distributed around the half of the height of the wall, as shown in Fig. 2 for a slender and a squat wall.

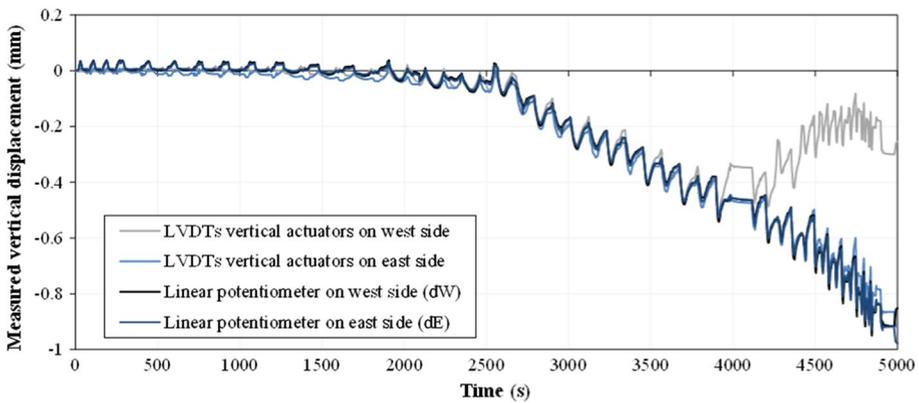
**Fig. 3** Vertical displacements measured by the LVDTs in the vertical actuators and by the linear potentiometers on the side of the wall

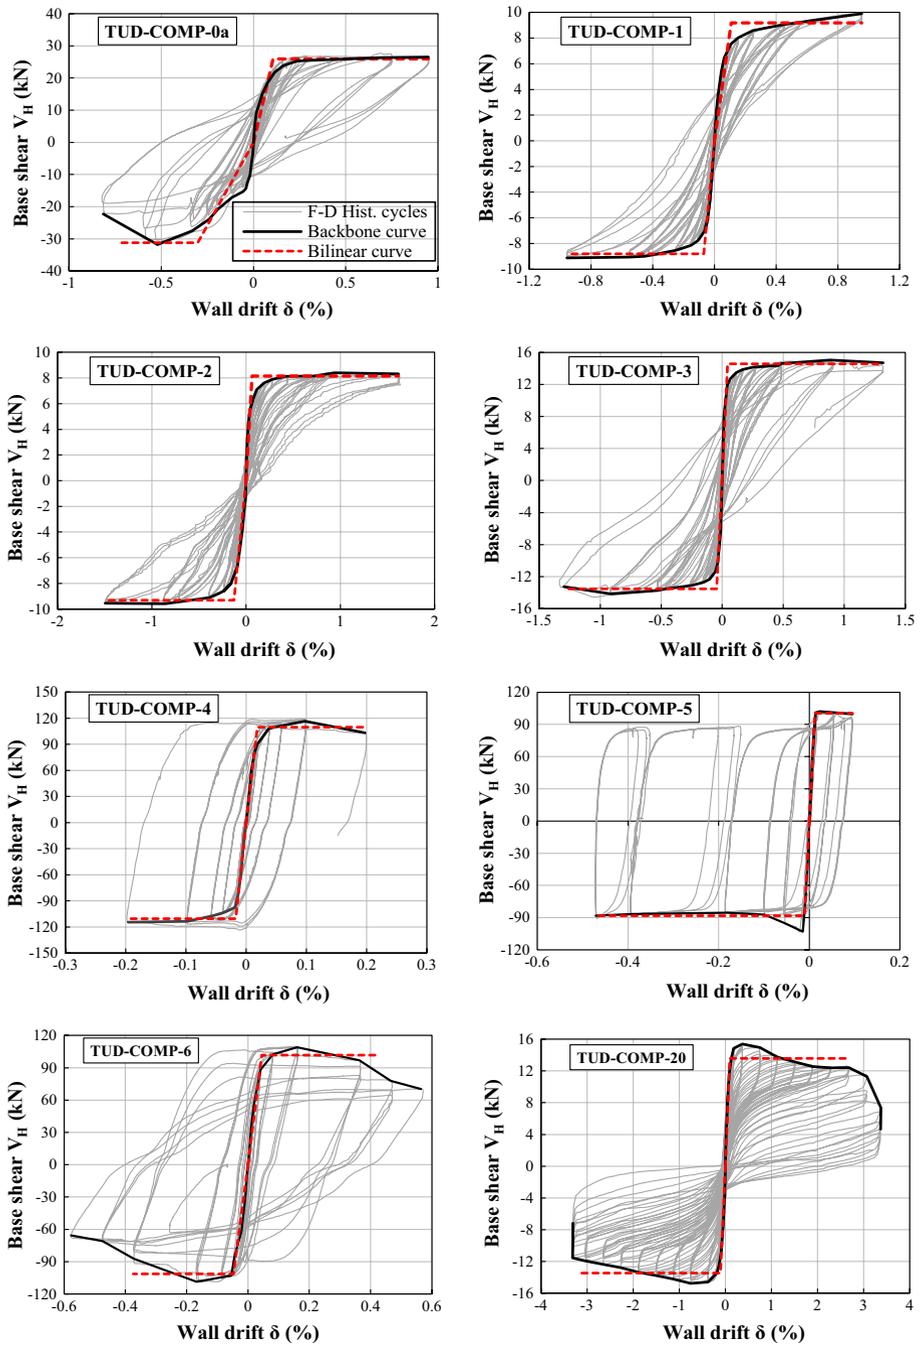
Fig. 4 Hysteretic curves, backbone curves (thicker black lines), and equivalent bilinear curves (red dashed lines) for the eight performed experiments

The hysteretic behaviour of the tested walls is discussed in this section for the slender and the squat walls. The complete hysteretic response, the backbone curve (computed as the envelope of the cyclic curve), and the equivalent bilinear curve of the walls are presented in Fig. 4, while Fig. 5 shows the first visible crack and the crack pattern as detected at the end of the tests.

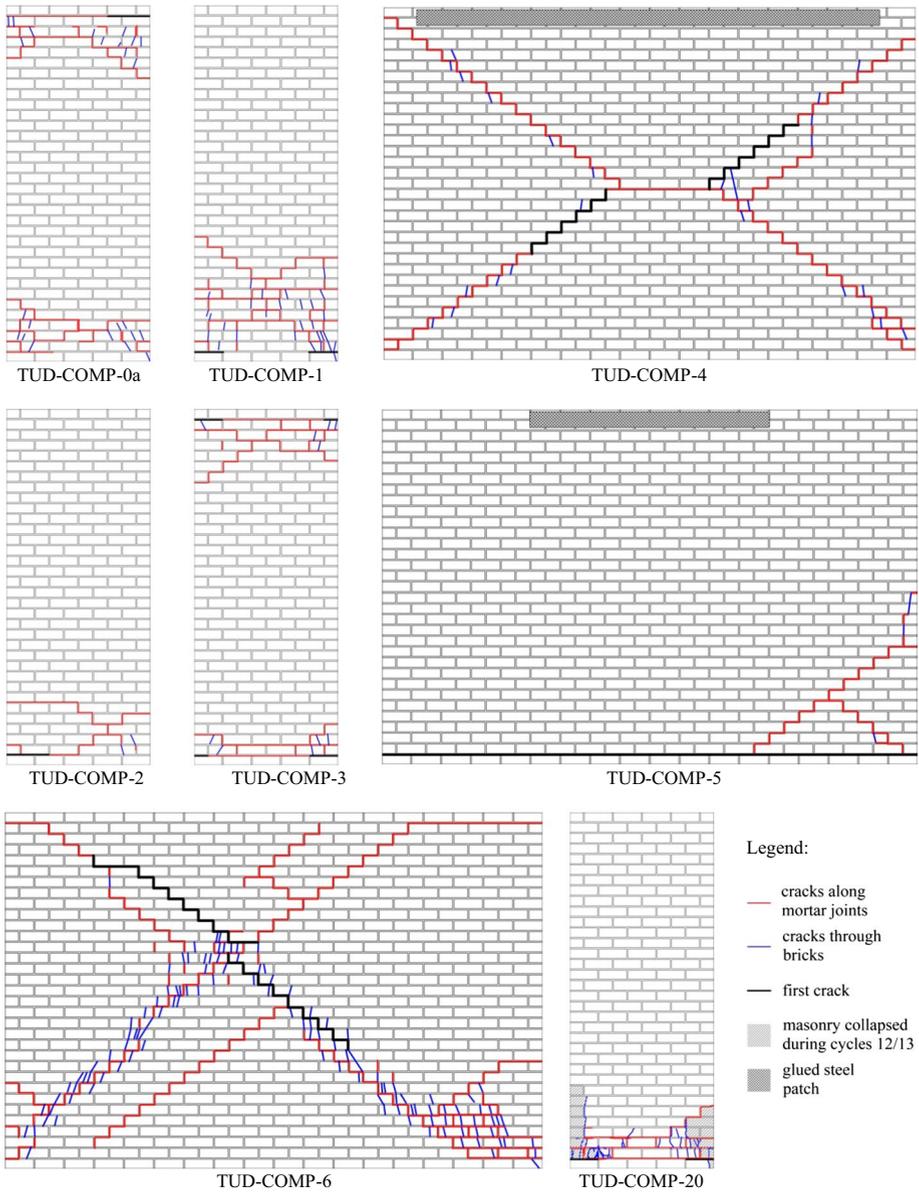
**Fig. 5** Crack pattern detected at the end of the tests

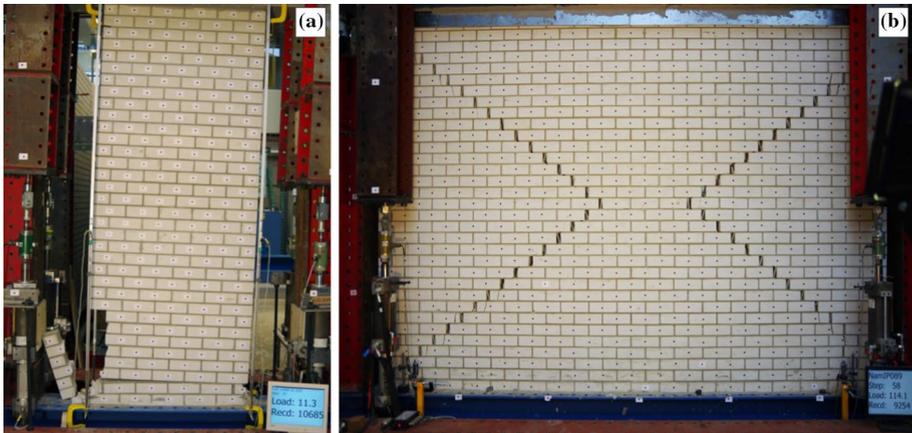
**Fig. 6** Crack pattern of the specimens at maximum positive drift for slender walls (TUD-COMP-20) (a) and squat walls (TUD-COMP-4) (b)

The behaviour of the slender walls was overall characterised by rocking behaviour (Fig. 6a), with first cracks opening along the bed-joints at corners (only at the bottom for cantilever walls, as shown in Fig. 7a). In the following cycles new flexural cracks originated at higher level and short diagonal cracks opened close to the corners (Fig. 7b). After

The three squat walls were all characterised by shear dominated failure (Fig. 6b). Shear sliding occurred along the mortar bed-joints, with progressive widening of residual cracks perpendicular to the head-joints (a maximum residual crack width of about 50 mm was observed at the end of the tests). The shear cracks outlined distinct portions of the walls (Figs. 5 and 6b), with those near the sides gradually pushed out the wall. The tests were stopped when these portions were about to be pushed out completely (Fig. 8a). In detail, each wall's behaviour was slightly different from the others. Diagonal shear cracks opened close to the centre of walls TUD-COMP-4 and TUD-COMP-6 and then quickly expanded to the corners, whereas the failure of specimen TUD-COMP-5 was mainly characterised by sliding along the mortar joint on top of the first layer of bricks. Also the appearance of the diagonal cracks in specimens TUD-COMP-4 and TUD-COMP-6 was different: while in the former a clear main crack could

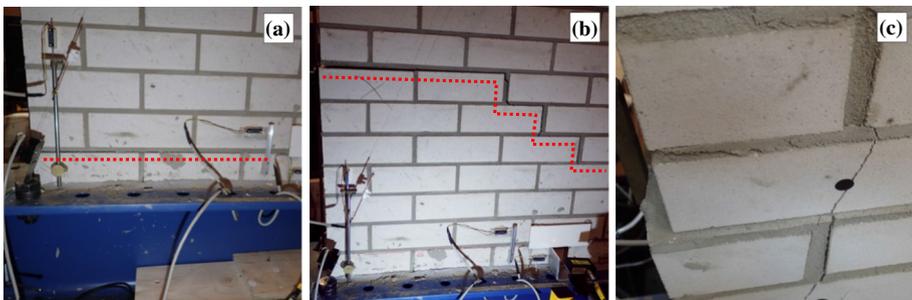
**Fig. 7** Details of the observed crack pattern for specimen TUD-COMP-1: initial crack at the base of the slender walls (a), and crack migrated in the following cycles (b); residual sliding at the end of the test (c)

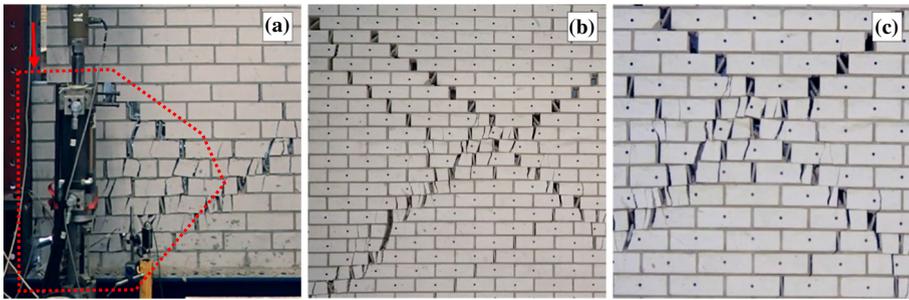
**Fig. 8** Details of the observed crack pattern for specimen TUD-COMP-6: left toe close to be pushed out of the wall at the end of the test (a); multiple diagonal cracks (b); cracks passing through the bricks in the middle of the panel (c)

be observed, several parallel cracks opened along the main diagonals of the latter in subsequent cycles (Fig. 8b). Moreover, for TUD-COMP-6 significant cracking of the bricks was observed, especially in the middle of the panel, where the two compressed struts crossed each other (Fig. 8c), and at toes. It should be also noted that a horizontal crack formed along the first top mortar layer of walls TUD-COMP-4 and TUD-COMP-5 while connecting the steel beam glued on top of the wall to the load distributor beam and the stiffening beams, because these were slightly deflected. This problem was solved with wall TUD-COMP-6 by changing the order in which the bolts were tightened. The crack was repaired by gluing steel plates on both sides of the wall (as shown in Figs. 5 and 6b), so that a stiff connection between the first and second top bricklayers was created. That prevented the crack to develop along that joint, but did not change the overall behaviour of the wall. Nevertheless, this procedure is not recommended, and replacement of the top masonry course could have been a suitable alternative.

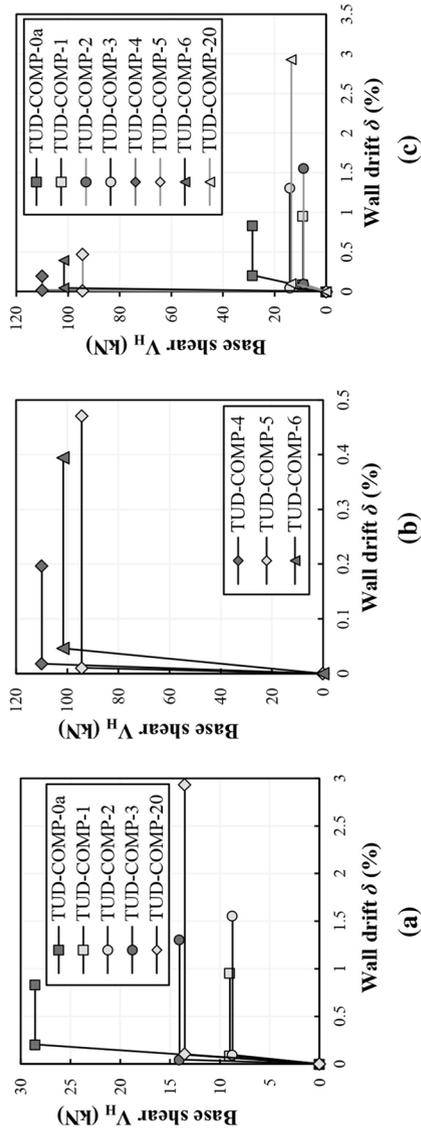
Fig. 9 Equivalent bilinear curves: **a** slender walls; **b** squat walls; **c** every wall

The cyclic response of in-plane experimental tests is commonly idealised by bilinear curves. Each curve requires the definition of three parameters: the effective stiffness  $k_{eff}$ , the ultimate shear force  $V_u$ , and the ultimate drift capacity  $\delta_u$ . The value of these parameters was computed in this study following the approach proposed in past works (e.g. Salmanpour et al. 2015; Morandi et al. 2018). The effective stiffness, i.e. the elastic stiffness of the bilinear curve, is calculated as the secant to the backbone curve at  $0.7V_p$ . The ultimate drift capacity of the curve is defined as the drift corresponding to a force degradation equal to 20% of  $V_p$ . When such a degradation was not observed before the end of the test, the ultimate drift was computed as an average of the largest drifts reached by the wall in the positive and negative loading direction (in case of TUD COMP 5, only negative loading was considered). The ultimate shear force, corresponding to the horizontal branch of the curve, is determined by imposing that the area below the backbone curve and the equivalent bilinear curve up to the ultimate drift are equal. The bilinear curves were initially computed for both loading directions (Fig. 4), and average values were then derived. Figure 9 shows the average equivalent bilinear curves. Table 5 reports the parameters of the bilinear curves, along with the ratio between the peak and the ultimate shear force  $V_u/V_p$  and the ultimate ductility of the system  $\mu_u$ , defined as the ratio between the ultimate drift capacity

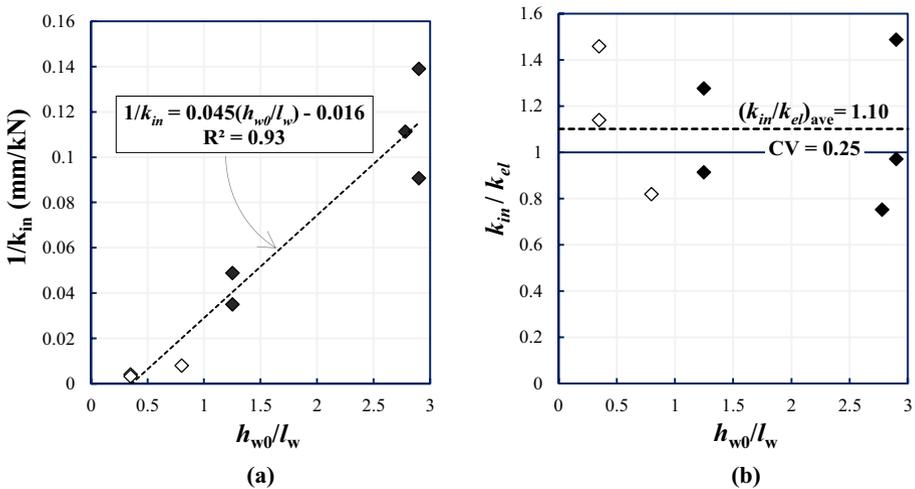
**Fig. 10** Relationship between the initial stiffness and the shear ratio (a), and ratio between the initial stiffness  $k_{in}$  and the estimated elastic stiffness  $k_{el}$  (b). Black diamonds stand for slender walls, and white diamonds for squat walls

For each test, the initial stiffness of the wall  $k_{in}$  was computed as the slope of the secant line connecting the maximum and minimum extreme points of the loop during the first run of the first cycle (that corresponded approximately to 20% of the peak base shear). Even though different values of the initial stiffness were measured even for specimens with the same geometry and boundary conditions, negative dependence of the initial stiffness on the shear ratio was observed (the linear regression line computed between the reciprocal of  $k_{in}$  and the shear ratio  $h_w G/I_w$  is highlighted in Fig. 10a).

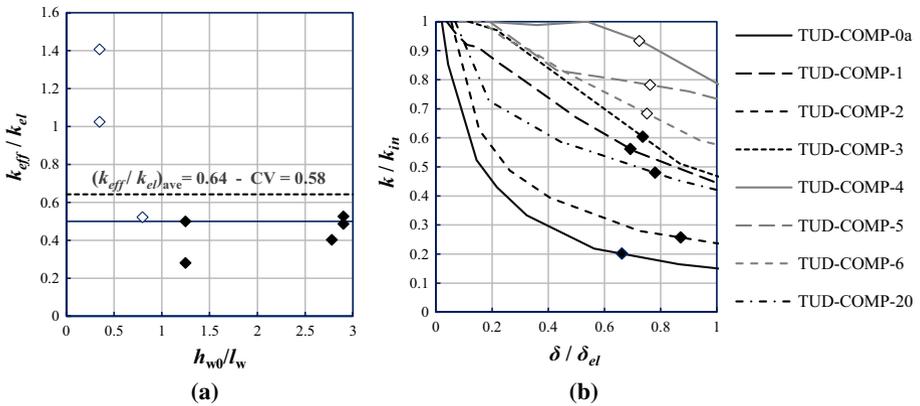
**Fig. 11** Ratio between the effective stiffness and the estimated elastic stiffness (a), and values of the wall stiffness  $k$  normalised with respect to  $k_{in}$  at increasing values of the wall drift  $\delta$  normalised with respect to  $\delta_{el}$  (b).  $k$  is computed as the secant stiffness at increasing values of  $\delta/\delta_{el}$ . The black (slender walls) and white (squat walls) diamonds correspond to the point at which the effective stiffness is computed

As discussed in the previous section, the effective stiffness  $k_{eff}$  of an equivalent bilinear curve is evaluated as the secant stiffness computed at 70% of the peak lateral force. At the same time, standards and guidelines commonly suggest to estimate the stiffness of an equivalent bilinear curve as a reduced value of the elastic stiffness  $k_{el}$  (usually 50% of  $k_{el}$ ). Figure 11a shows a comparison between the effective stiffness  $k_{eff}$  derived from the experimental tests and the elastic stiffness  $k_{el}$ . On average, the use of 50% of  $k_{el}$  leads to an underestimation of  $k_{eff}$ . However, the results are very dispersed ( $CV=0.58$ ), mainly influenced by the high effective stiffness of the two double clamped squat walls (TUD-COMP-4 and TUD-COMP-5). In fact, the degradation of the wall stiffness  $k$  at increasing values of the wall drift was slower for squat walls than for slender walls, as shown in Fig. 11b. For this reason, the effective stiffness may be assumed to be a larger fraction of  $k_{el}$  for squat walls (approximately when  $h_{w0}/l_w < 1$ ), whereas the use of 50% of  $k_{el}$  seems more appropriate for slender walls ( $h_{w0}/l_w > 1$ ). The small number of tests and the dispersion of the results do not allow to draw more precise conclusions. In fact, the performed tests showed that the reduction of the elastic stiffness by a factor often

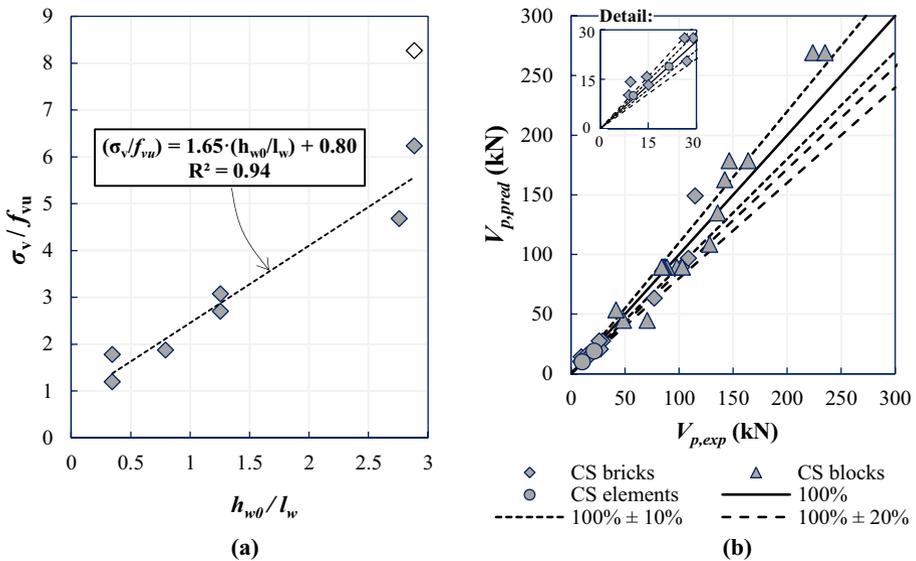
**Fig. 12** Influence of the shear ratio on the peak shear strength of the tested walls and calibration of Eq. (2) (a). Comparison between the force capacity predicted according to Eq. (2) and the experimental values for an extended dataset of tests (detail for low peak loads in the inset) (b)

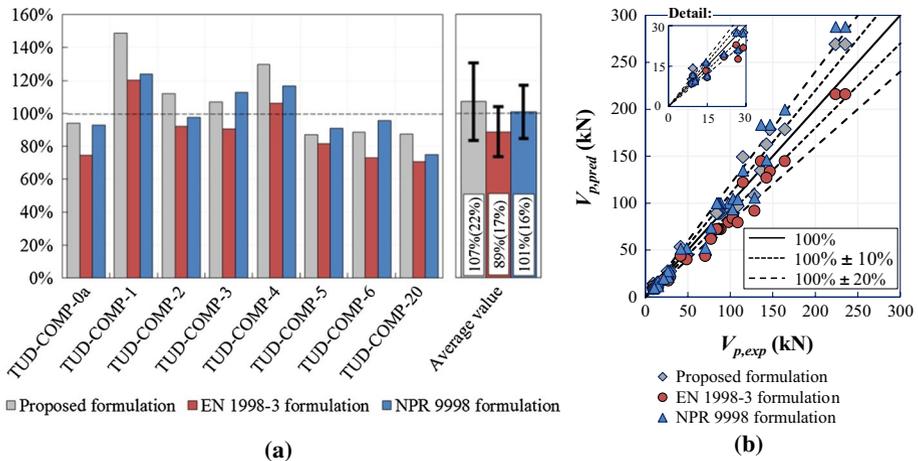
**Fig. 13** Comparison between the force capacity predicted for the tested specimens **(a)** and for an extended dataset of tests (detail for low peak loads in the inset) **(b)** according to Eq. (2) and to EN 1998-3 or NPR 9998 formulations

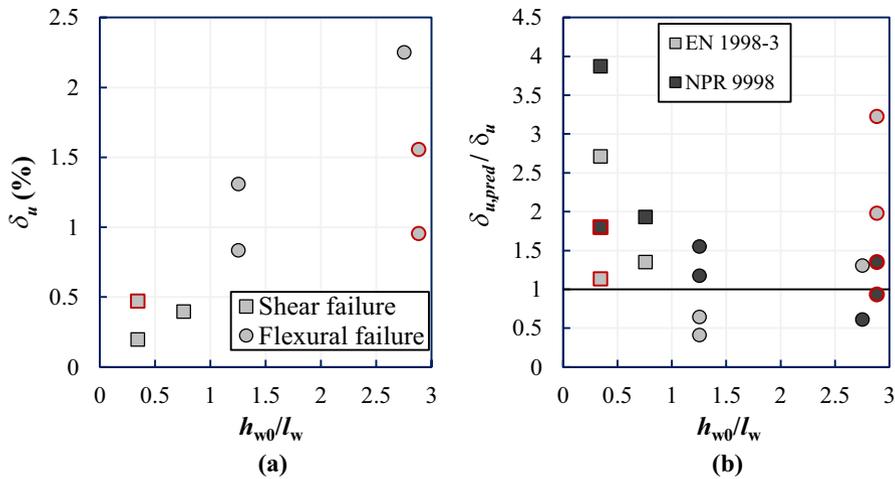
**Fig. 14** Experimental NC drift of the tested walls, and comparison with the predictions by EN 1998-3 and NPR 9998 (walls failing in shear are represented by square markers, walls failing in flexure by round markers). The walls whose ultimate drift could not be reached due to limitations of the test setup are identified by red markers

Similar to the approach adopted for the force capacity, the observed NC drifts were compared to the predictions obtained according to Eurocode 8—part 3 (CEN 2005b) and NPR 9998 (NEN 2018). The equations recommended by the two standards are summarised in Table 7. A summary of the results is listed in Table 8, and a comparison between the experimental and predicted results is shown in Fig. 14b. For walls failing in shear, non-conservative estimates of the drift capacity are obtained according to both the standards. The error is larger adopting the value recommended in NPR 9998, since that value is higher than the value prescribed in EC8-3 (0.75% vs. 0.53%), while the walls showed limited ductility during the experimental tests. However, past experimental tests (Beyer and Mergos 2015) and numerical simulations (Wilding et al. 2017) showed that the deformation capacity of walls failing in shear decreases with the number of applied cycles, and this fact may partially explain the large NC drift recommended in the Dutch guideline, which

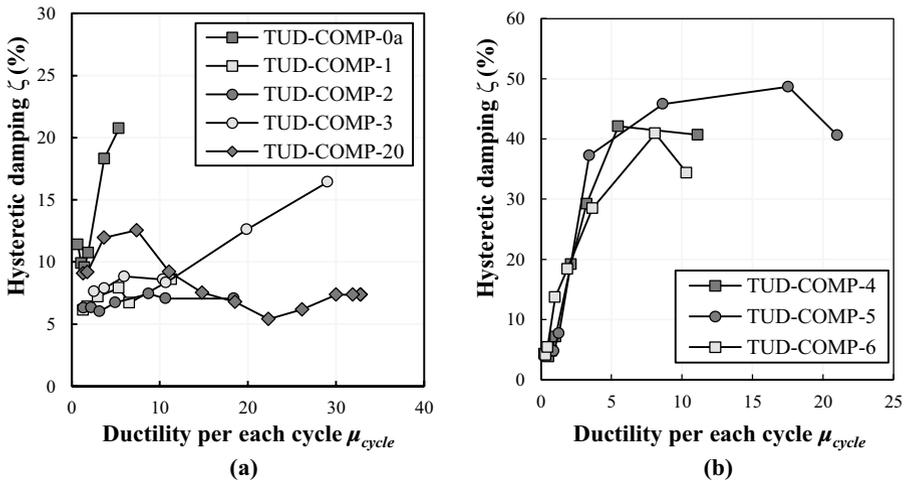
**Fig. 15** Hysteretic damping at increasing values of ductility per cycle for **a** slender and **b** squat walls

Figure 15 shows the equivalent hysteretic damping coefficient  $\xi_{hyst}$  computed at increasing values of the ductility of the wall per each cycle  $\mu_{cycle}$ , computed as the ratio between the wall drift  $\delta$  and the elastic drift  $\delta_{el}$ . As already observed by Magenes and Calvi (1997), the dissipated energy increases along with the damage and is related to the failure mechanism. The squat walls, characterised by shear failure, reached high values of equivalent damping. The obtained maximum dissipated energy and damping were similar for the three squat walls ( $40\% < \xi_{max} < 50\%$ ), even though slightly larger values were computed when the sliding occurred along a single bed-joint at the base of the wall, such as in specimen TUD-COMP-5. On the other hand, for the slender walls, characterised by rocking behaviour, smaller damping values were obtained. For the two slender double clamped walls (TUD-COMP-0a and TUD-COMP-3) the damping values in the last cycles were larger than for the cantilever walls, since both top and bottom ends of the walls were subjected to damage. The measured values of the damping coefficient were in line with those observed on recent tests on CS brick masonry walls (Graziotti et al. 2016a), but significantly higher than the ones reported from tests on CS blocks masonry walls (Magenes et al. 2008). In fact, in the present study, dissipative mechanisms such as the opening of short diagonal cracks, the compressive splitting of the bricks, and the sliding along the mortar joints were observed even for walls whose failure was mainly governed by rocking.
