Ventilation and COVID-19 transmission risks on board of Dutch governmental ships

Atze Boerstra ^{a,b}, & Mark Verlinde ^a

Abstract. The Dutch government (specifically the 'Rijksrederij', the governmental shipping company) owns a fleet of just under 100 ships that are equipped to service the internal waterways and parts of the North Sea. Think in this context of e.g. Coast Guard ships, ships that help to fight oil accidents or ships that maintain buoys. Just after the COVID-19 pandemic had started the 'Rijksrederij' decided that it was necessary to investigate to what extent the fleet might pose a risk for cross-contamination of this new disease on board. This was approached with a specific focus on ventilation and the airborne route. The objective was to find out whether the most important spaces on board of the ships were adequately ventilated and to evaluate how ships can be made or kept 'COVID-resistant' as far as the airborne route is concerned. A sample of 16 ships of different types, most of them mechanically ventilated, were surveyed. This included a general inspection, an inspection of relevant HVAC system characteristics and measurements of e.g. air supply flows. Also, s

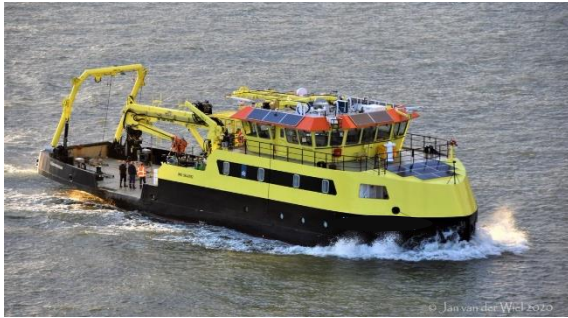
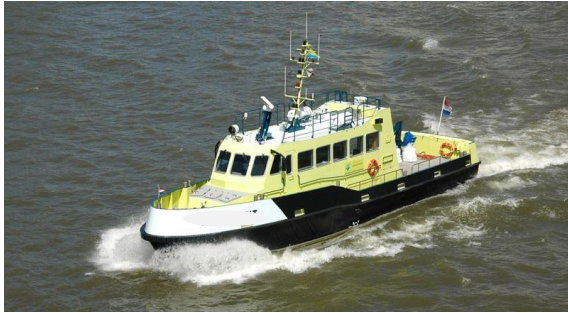
Fig. 1 - Two example ships used by the Rijksrederij; the upper one is for week patrols, the lower one is for day patrols
