Dielectric Coatings for High Voltage Gas Insulated Switchgear

van der Born, D. (2017). *Dielectric Coatings for High Voltage Gas Insulated Switchgear*. [Dissertation (TU Delft), Delft University of Technology]. <https://doi.org/10.4233/uuid:4f1b06bc-3d01-4107-8c85-21c0e278c4bd>

PROEFSCHRIFT

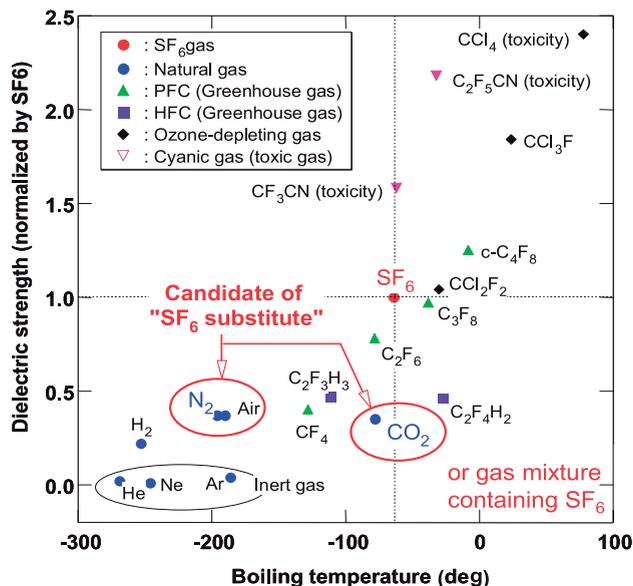
Figure 2.1: SF_6 replacement candidates with dielectric strength and boiling point [34].

mize the size increase of GIS designs containing the candidate gas. Possible replacement gases are shown in Figure 2.1.

Figure 2.1 shows a range of gases which are readily available. Newly designed gas mixtures, such as Alstom G^3 and ABB C5 FK gas are not included. From the figure it can be seen that the gases which have a higher dielectric strength than SF_6 are either toxic, ozone depleting or are greenhouse gases. These gases are therefore unsuitable to replace SF_6 .

As can already be seen from Figure 2.1 the replacement candidates show a low dielectric strength compared to SF_6 at equal gas pressure. In several papers the dielectric performance of air, N_2 , CO_2 and mixtures of those gases including small concentrations of SF_6 is investigated.

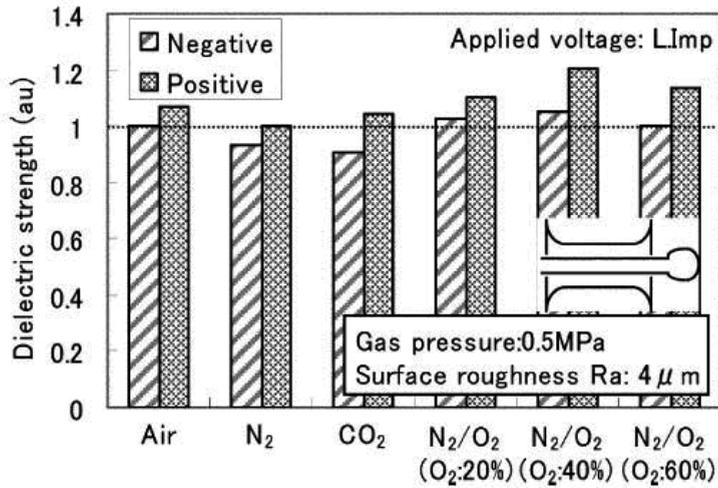
Figure 2.2: Comparison of the lightning impulse breakdown strength of various gases and gas mixtures [19]

In [25, 26] the lightning impulse (LI) breakdown strength of air, N_2 , CO_2 and N_2/O_2 mixtures with varying oxygen concentrations is compared. The results are shown in Figure 2.2.

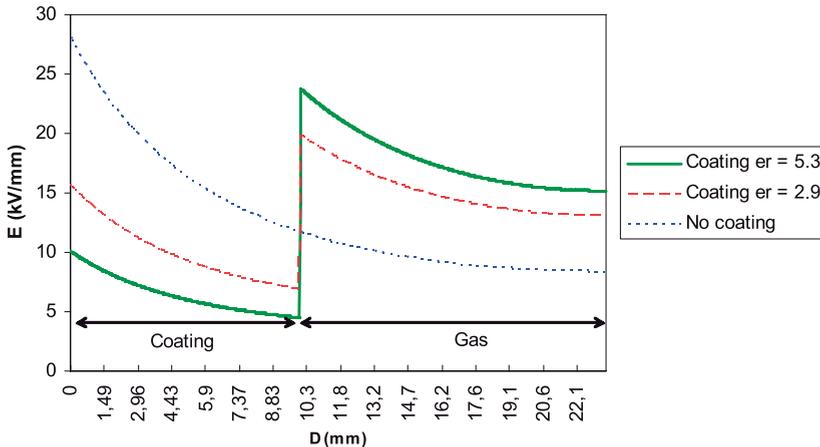
Figure 2.6: Electric field distribution in a rod-plane configuration with and without coating [5]

The electric field distribution along a straight line between the rod tip and the plane is represented by the dotted blue line in Figure 2.6. The parameter D on the horizontal axis represents the position in the gas gap. The rod tip is located at $D = 0$ mm and the surface of the plane electrode is positioned at the right end of the horizontal axis ($D = 23.31$ mm). The local electric field strength E in kV/mm is displayed on the vertical axis.

The highest electric field strength of roughly 28 kV/mm is located at the tip of the rod electrode where the electric field is most divergent. The electric field near the surface of the plane electrode is more homogeneous. There, the lowest field strength of roughly 9 kV/mm is found.

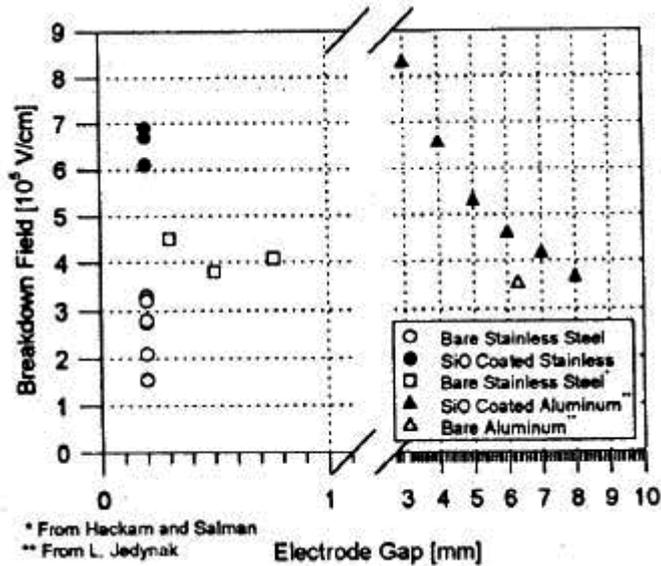
Figure 2.9: Breakdown strength of a vacuum gap with a coated and uncoated cathode [28]

The figure also shows results from [29], which are represented by the triangles on the right side. In this case an aluminium cathode with a Rogowski profile was used and the coating consisted of a 3 μm thick silicon oxide layer. The gap distance was varied between 3 and 8 mm for the coated cathode and was fixed at 6.3 mm for the uncoated cathode. With a gap distance of 3 mm the coated cathode shows an improvement of roughly 130%.

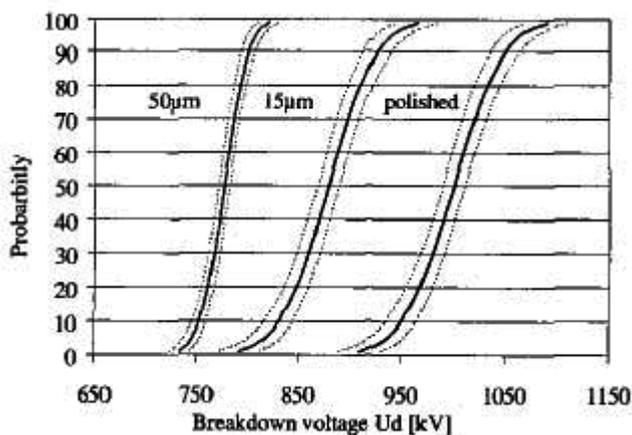
Figure 2.11: Normal distribution of breakdown voltage including 95% confidence intervals, positive LI voltage, $s = 40$ mm, variation of R_z , uncoated [10]

In Figure 2.11 the breakdown voltage as a function of surface roughness is shown in the case of positive lighting impulse voltage. The polarity refers to the polarity of the rod electrode. It can be seen from the figure that the breakdown voltage decreases with an increase in surface roughness, which is consistent with the theory of Pedersen [38]. Also in the case of positive DC voltage a comparable negative dependence of the breakdown voltage on the surface roughness of the rod electrode was shown [9].

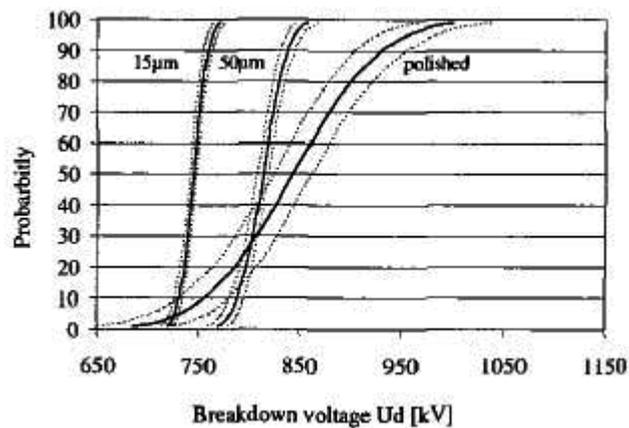
Figure 2.12: Normal distribution of breakdown voltage U_d including 95% confidence intervals, negative LI voltage, $s = 40$ mm, variation of R_z , uncoated [10]

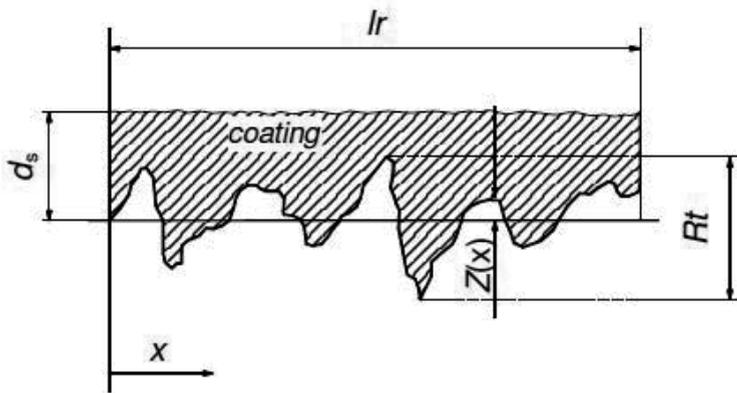
Figure 2.14: Schematic drawing of the cross-section of a coated electrode surface [11]

The application of a coating can theoretically reduce the influence of electrode surface roughness on the breakdown strength of gas gaps. During application the coating material fills up the unevenness of the electrode surface as shown in Figure 2.14, provided that the layer thickness of the coating is sufficient. The surface of the coating at the coating-gas interface should be significantly smoother, effectively removing the microscopic electric field enhancements from the gas. These field enhancements are now present in the coating material, which usually has a higher dielectric strength than the gas. Furthermore, due to the permittivity of the coating, the electric field at the metal surface is reduced, as explained in section 2.4.1.

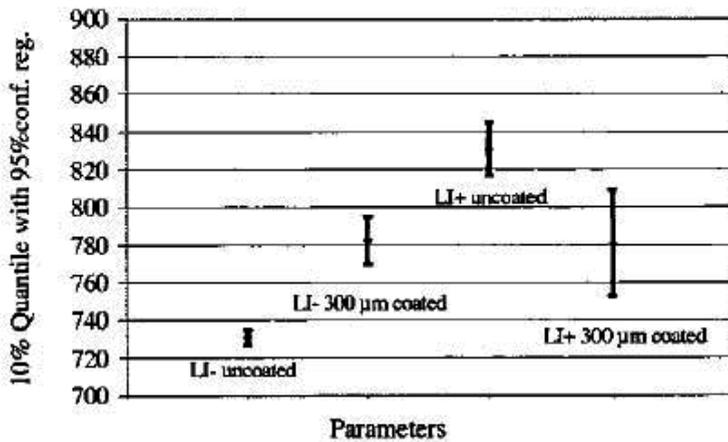
Figure 2.15: 10% quantile with 95% confidence intervals, epoxy coated and uncoated electrodes, $R_z = 15 \mu\text{m}$, $s = 40 \text{ mm}$, coating thickness is $300 \mu\text{m}$, positive and negative LI [10]

In [10, 11] the breakdown voltage of epoxy coated rod electrodes was also investigated and compared to uncoated electrodes. For the design of GIS components the 10% quantile of the breakdown voltage is the most important parameter. Figure 2.15 displays the 10% breakdown voltage of coated and uncoated electrodes under positive and negative lightning impulse voltage. As can be seen from the figure, at positive lightning impulse voltage the application of a coating results in a reduction of the 10% breakdown voltage. For negative lightning impulse voltage an increase of roughly 8% was found for a coated electrode. Note that the surface roughness of the coating is always between 6 and 10 μm .

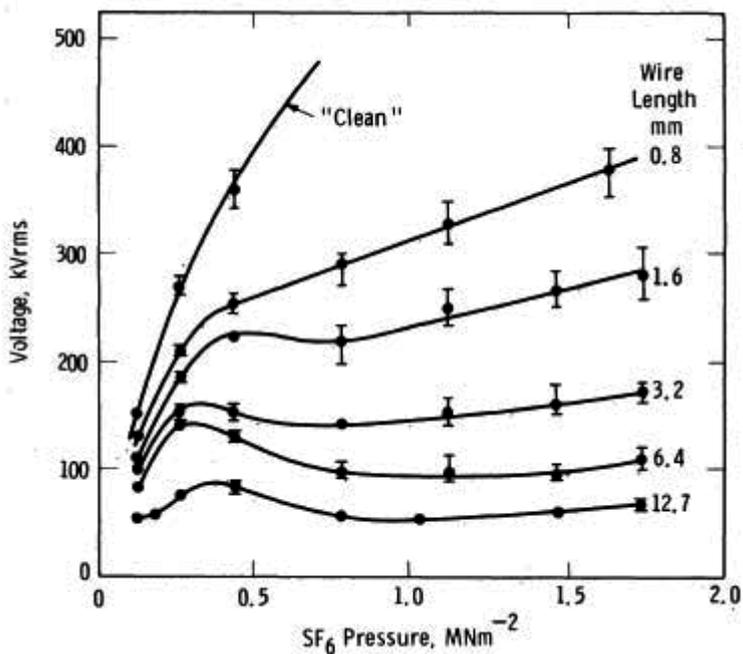
Figure 2.18: Breakdown voltage as a function of gas pressure and wire length, (0.4 mm diameter copper wire particles, AC voltage, 150/250 mm coaxial arrangement)[42]

Results obtained in [35–37] show that in the case of wire particles the breakdown voltage has a clear negative dependency with respect to the wire length, as shown in Figure 2.18. The presence of a “sharper” particle results in a lower breakdown voltage. For comparison, the figure also shows the breakdown voltage of a clean system.

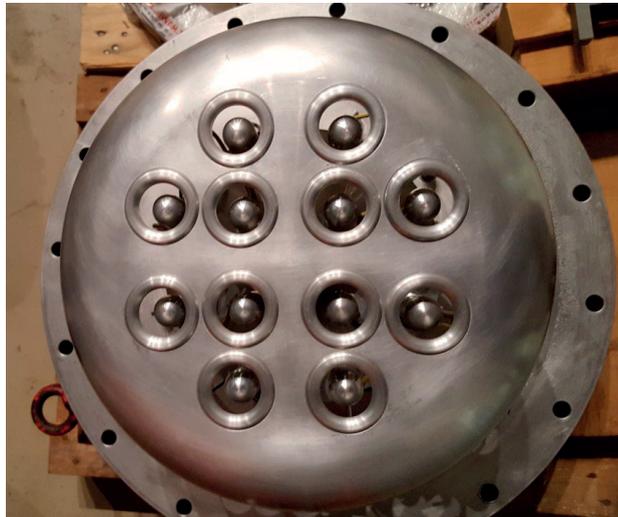
Figure 3.3: Revolver assembly for small rod electrodes.

For the breakdown tests two different revolver assemblies are used. For small electrodes with a diameter up to 48 mm an assembly is used in which 12 electrodes can be mounted. This assembly is shown in Figure 3.3. For electrodes with a diameter up to 90 mm another assembly is applied which can hold up to 4 electrodes and is shown in Figure 3.4. When changing from small electrodes to large electrodes with a diameter larger than 48 mm the revolver assembly in the tank is removed and replaced by the other assembly. The applied rod electrodes are described in section 3.2.

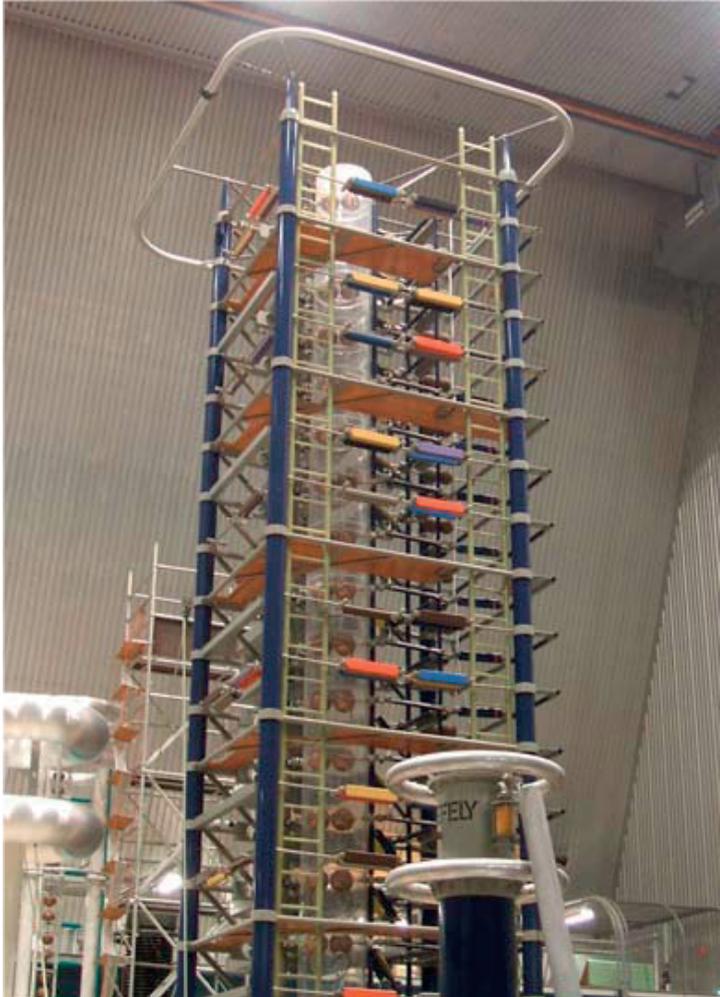
Figure 3.29: 20-stage Haefely impulse voltage generator.

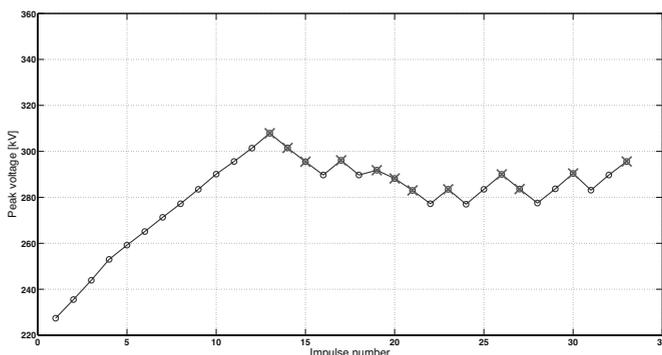
Figure 3.31: Combined test with step-up to breakdown and 50% up-down (the circles represent impulse applications and the crosses represent disruptive discharges).

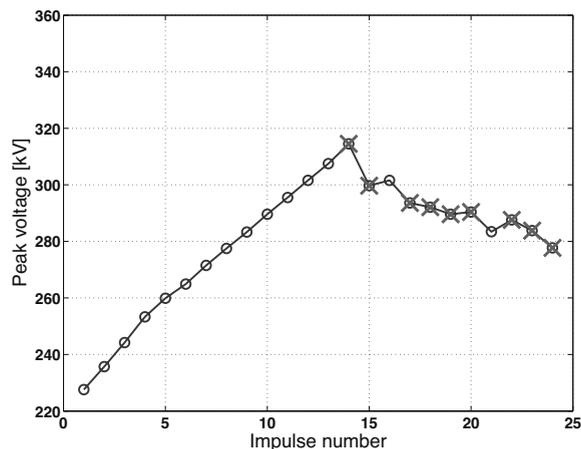
Figure 4.7: Breakdown test results of an EP-I coated electrode.

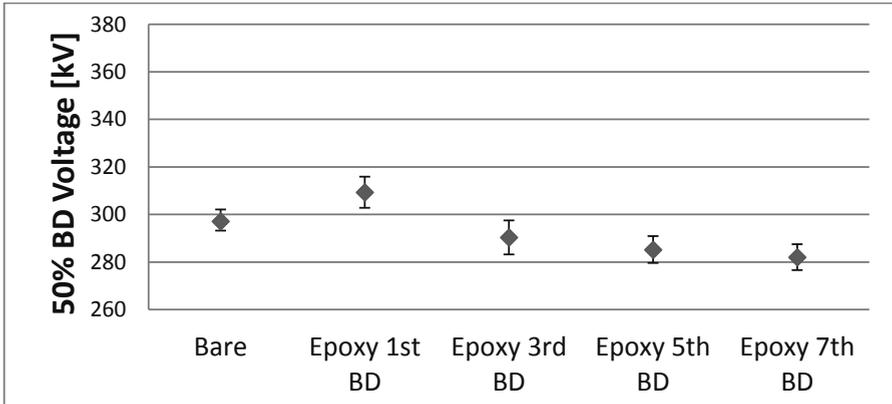
Figure 4.8: 50% Breakdown voltage of EP-I coated electrodes. The 95% confidence intervals are represented by the error bars.

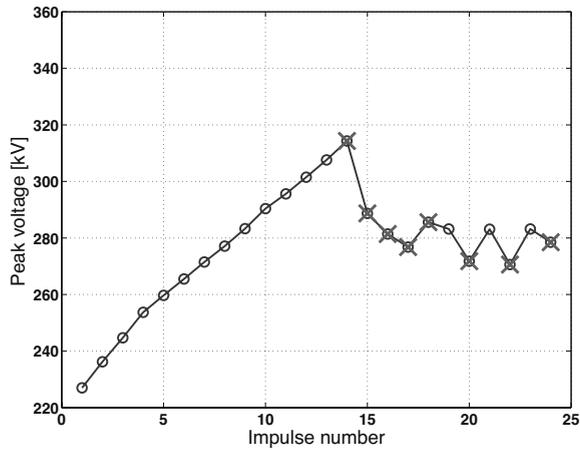
Figure 4.10: Breakdown test results of a FP-I coated electrode.

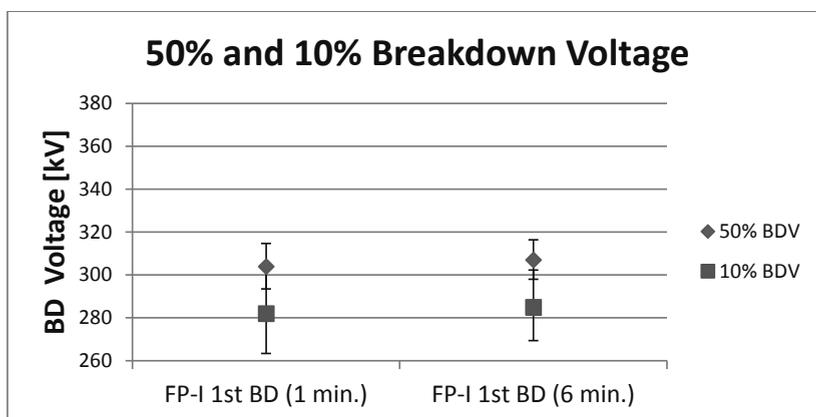
Figure 4.13: Comparison of 50% and 10% 1st Breakdown voltage of FP-I coated electrodes including 95% confidence intervals regarding addition of test results with 6 minutes waiting time between impulses.

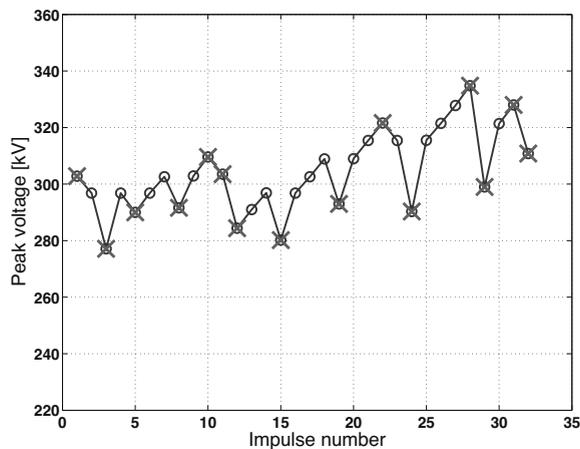
**Figure 4.19:** Breakdown results of a standard 50% up-down test on a FP-II coated electrode.

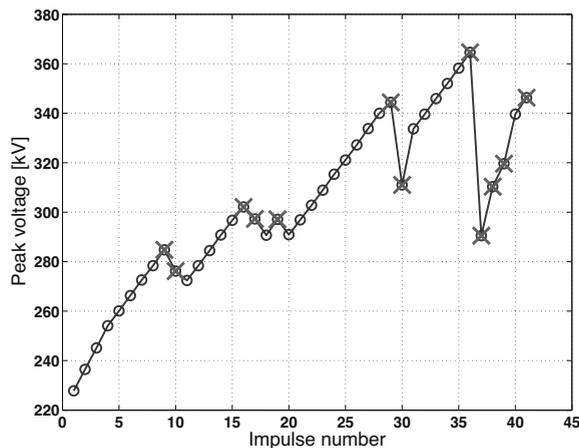
Figure 4.24: Breakdown test results of a FP-IV coated electrode.

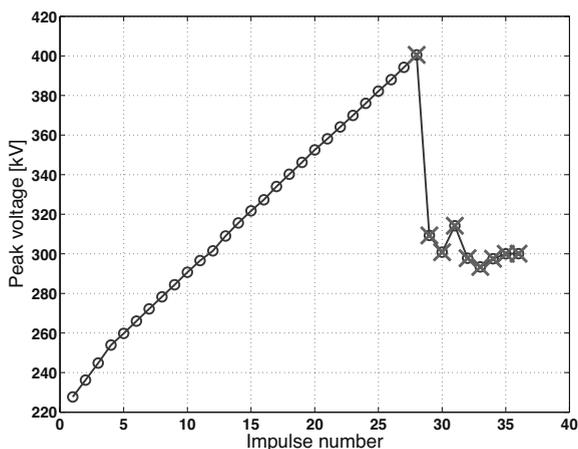
Figure 4.27: Breakdown test results of a PA11 coated electrode.

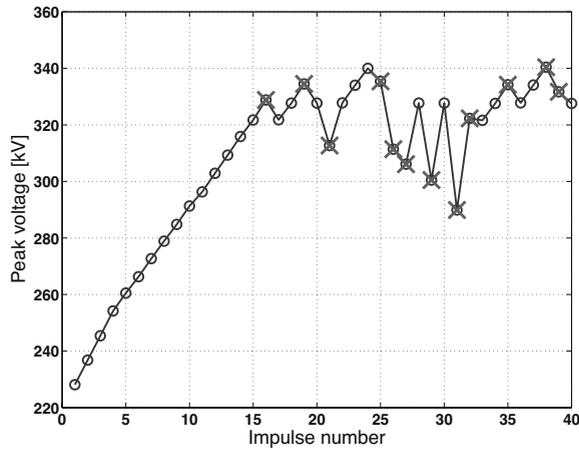
Figure 4.30: Breakdown test results of a semiconductor A coated electrode sample.

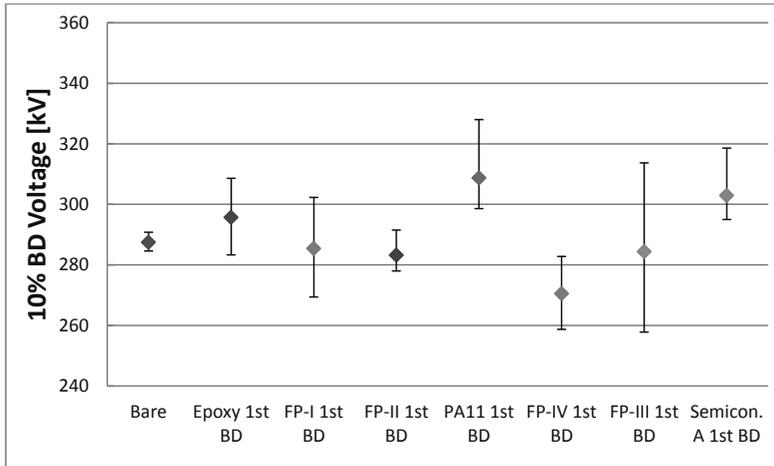
Figure 4.35: 10% 1st Breakdown voltage of the electrode samples coated with a thin coating including 95% confidence intervals.

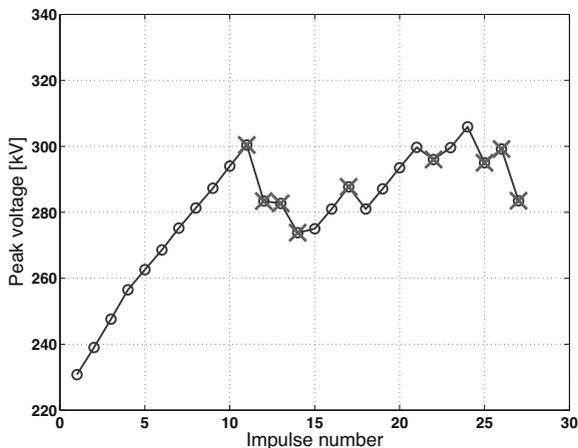
**Figure 4.37:** Breakdown test results of a FP-II – FP-I coated electrode.

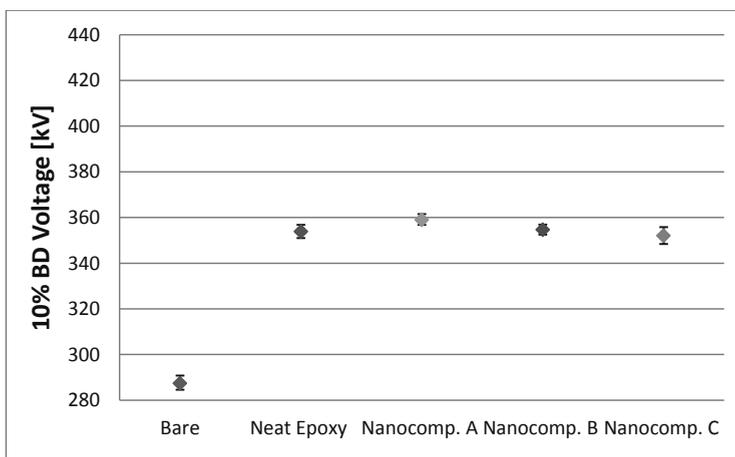
Figure 4.50: 10% Breakdown voltage of retested neat epoxy and epoxy nanocomposite coated electrode samples including 95% confidence intervals.

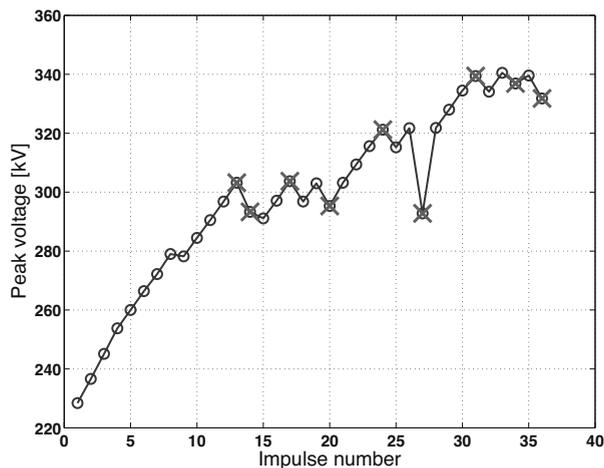
Figure 4.54: Breakdown test results of a FP-II coated electrode using a waiting time of six minutes.

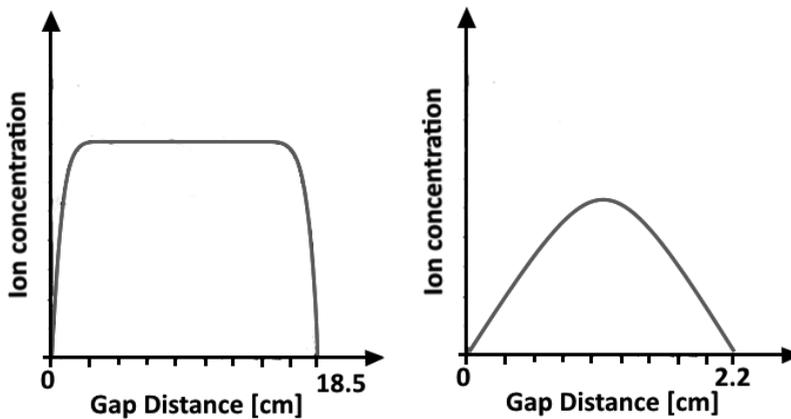
Figure 4.59: Sketch of charge carrier concentration profile of coaxial gap [51] (left) and rod-plane gap (right)

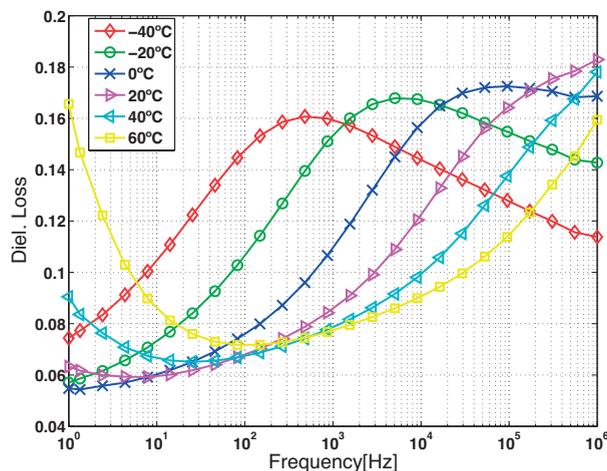
Figure 5.3: Dielectric losses of EP-I material samples as a function of frequency at temperatures between $-40\text{ }^{\circ}\text{C}$ and $60\text{ }^{\circ}\text{C}$. The frequency range is 1 Hz to 1 MHz.

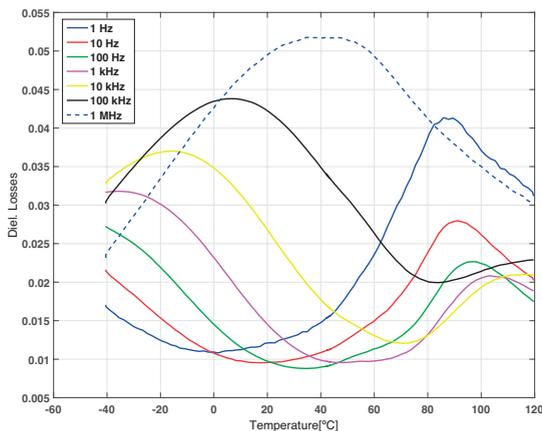
Figure 5.9: Dielectric losses of FP-I material samples as a function of temperature for frequencies between 1 Hz and 1 MHz. The temperature range is -40 °C to 120 °C.

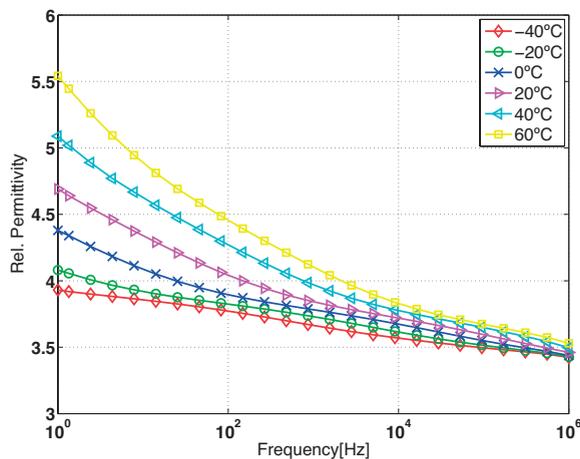
Figure 5.10: Relative permittivity of FP-IV material samples as a function of frequency at temperatures between -40°C and 60°C. The frequency range is 1 Hz to 1 MHz.

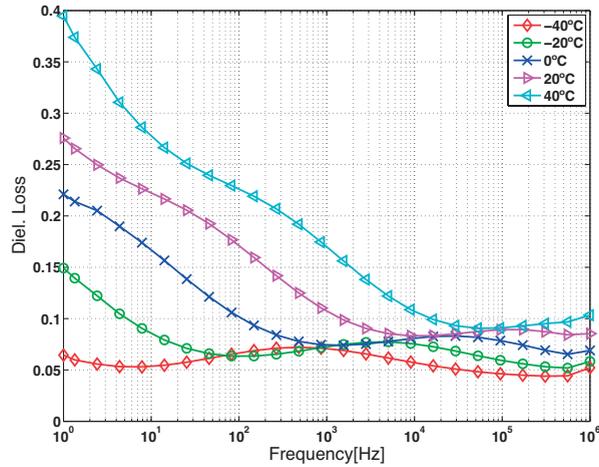
Figure 5.12: Dielectric losses of FP-IV material samples as a function of frequency at temperatures between -40°C and 40°C . The frequency range is 1 Hz to 1 MHz.

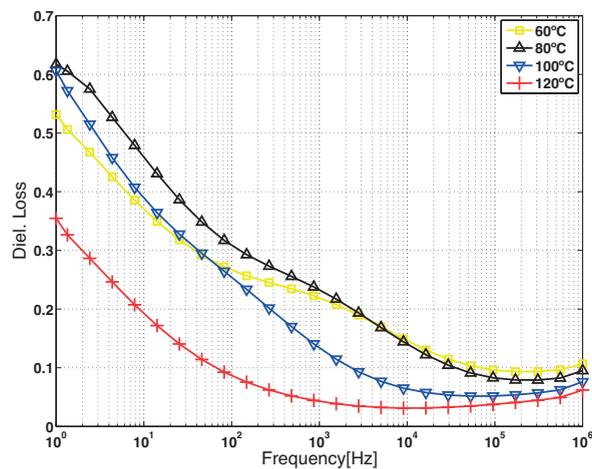
Figure 5.13: Dielectric losses of FP-IV material samples as a function of frequency at temperatures between 60°C and 120°C .

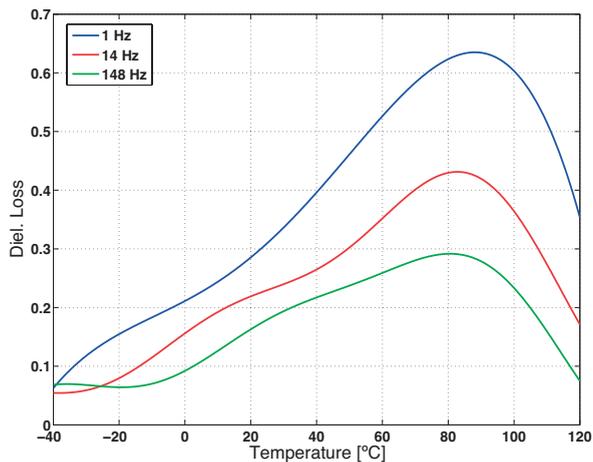
Figure 5.14: Dielectric losses of FP-IV material samples as a function of temperature for frequencies between 1 Hz and 148 Hz. The temperature range is -40 °C to 120 °C.

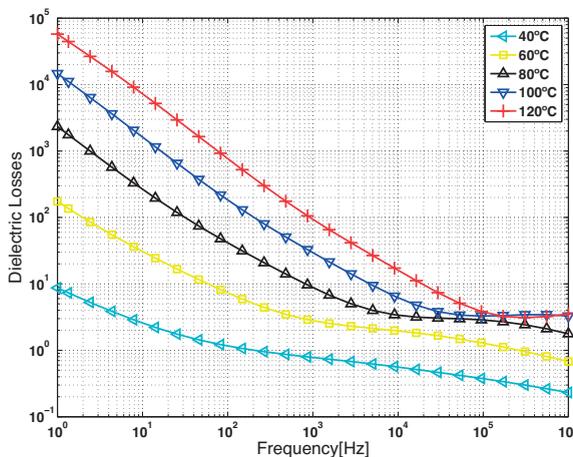
Figure 5.19: Dielectric losses of PA11 material samples as a function of frequency at temperatures between $40\text{ }^{\circ}\text{C}$ and $120\text{ }^{\circ}\text{C}$

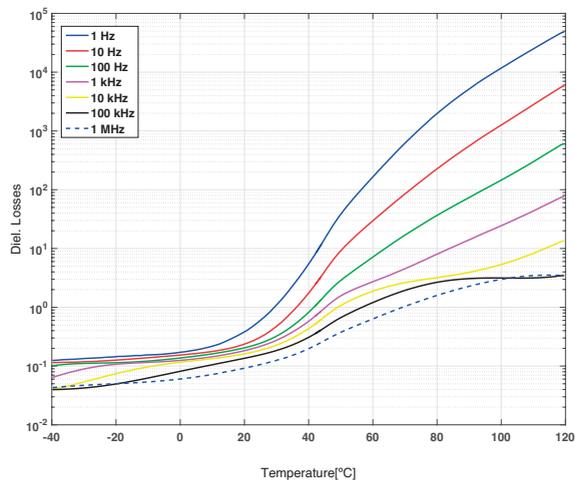
Figure 5.20: Dielectric losses of PA11 material samples as a function of temperature for frequencies between 1 Hz and 1 MHz. The temperature range is -40 °C to 120 °C.

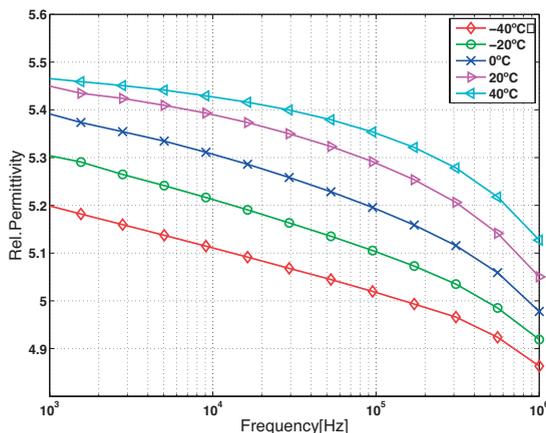
Figure 5.24: Relative permittivity of FP-II material samples as a function of frequency at temperatures between $-40\text{ }^{\circ}\text{C}$ and $40\text{ }^{\circ}\text{C}$. The frequency range is 1 kHz to 1 MHz.

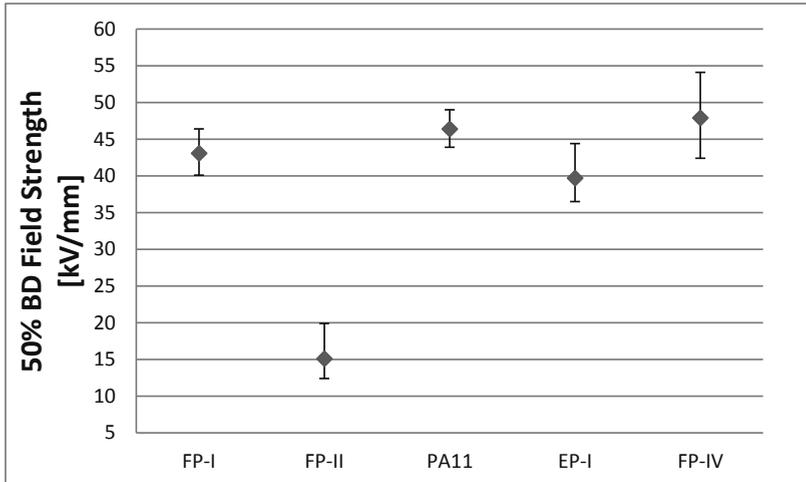
Figure 5.31: 50% Breakdown strength of thin coating materials. Including 95% confidence intervals.

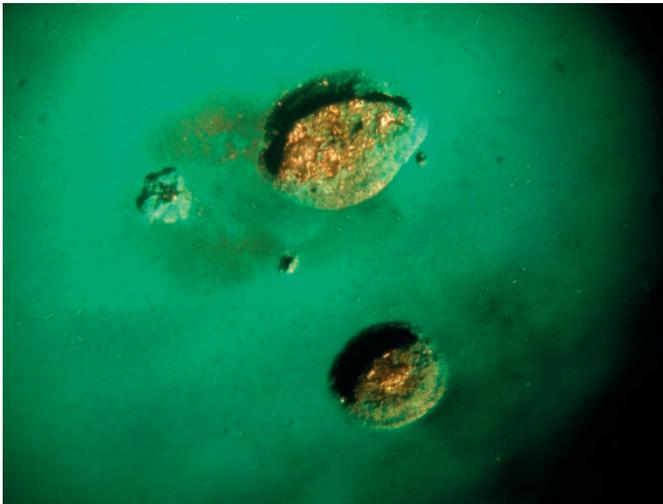
Figure 5.35: Microscopic view of the surface of an EP-I coated electrode after a breakdown test.

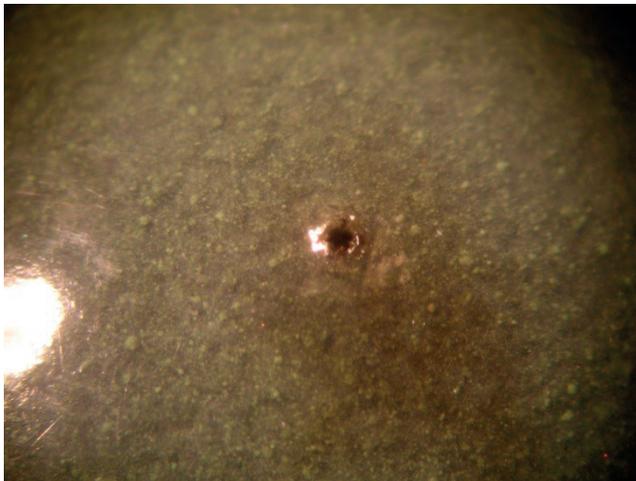
Figure 5.36: Microscopic view of the surface of a FP-I coated electrode after a breakdown test.

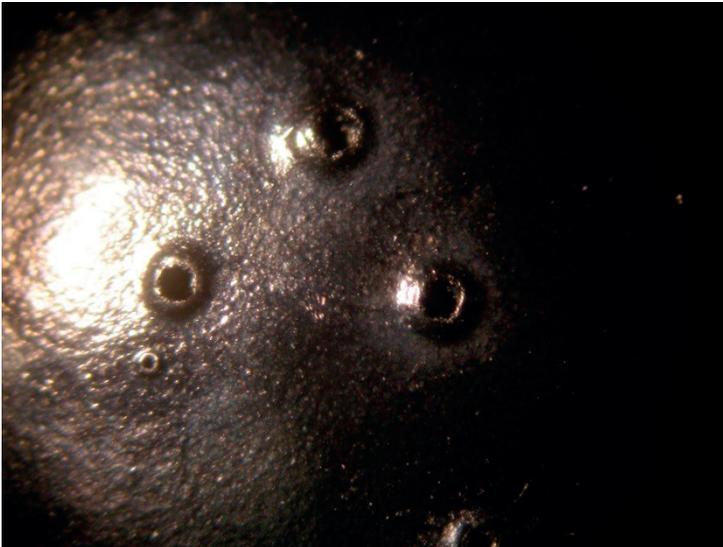
Figure 5.37: Microscopic view of the surface of a FP-II coated electrode after a breakdown test.

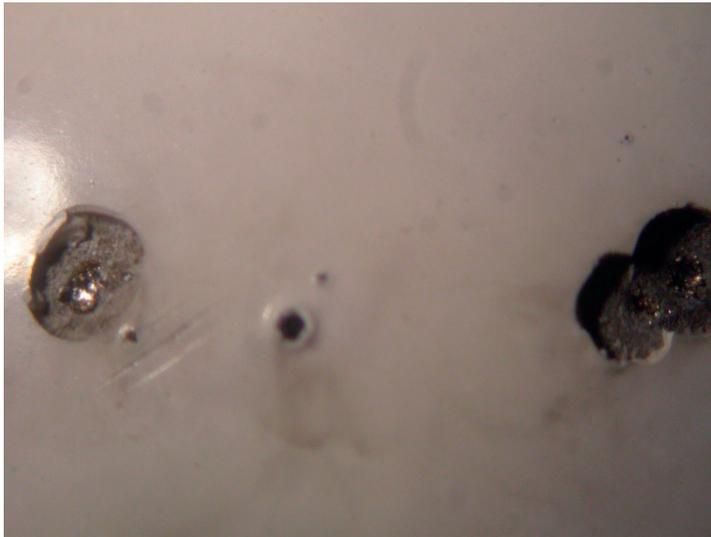
Figure 5.39: Microscopic view of the surface of a PA11 coated electrode after a breakdown test. Including more extensive breakdown damage.

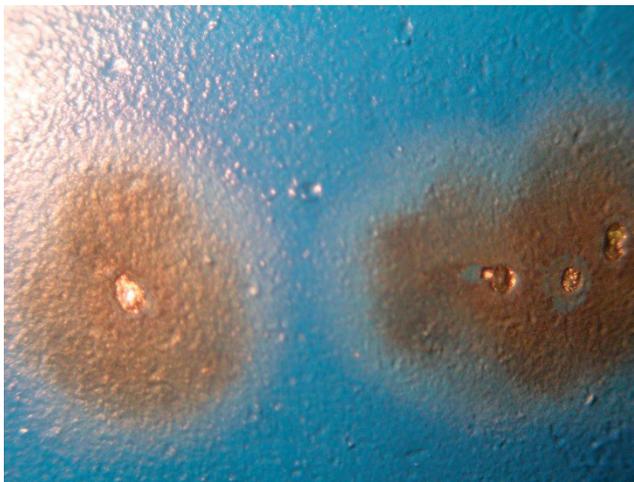
Figure 5.41: Microscopic view of the surface of a FP-III coated electrode after a breakdown test.

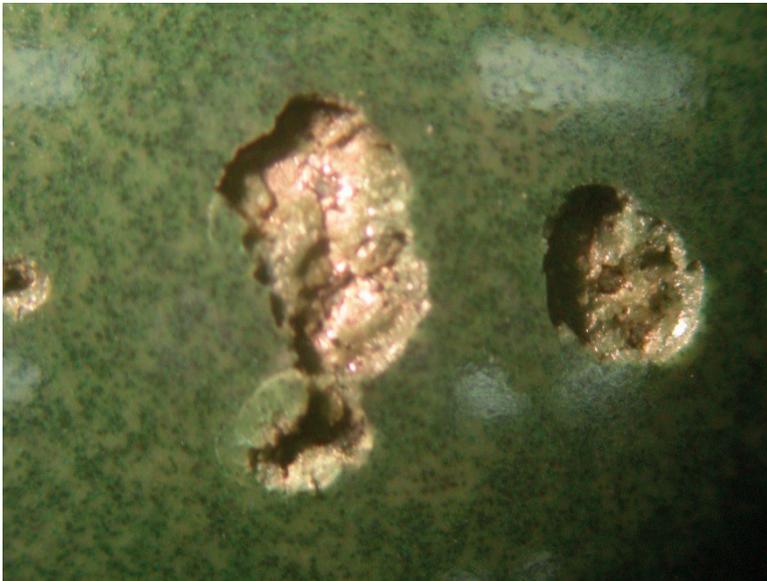
Figure 5.42: Microscopic view of the surface of a semiconductor A coated electrode after a breakdown test.

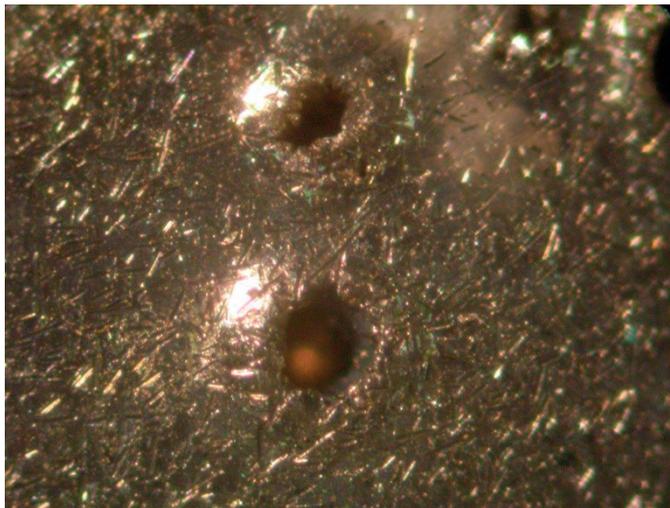
Figure 5.43: Microscopic view of the surface of a double layer FP-II – FP-I coated electrode after a breakdown test.

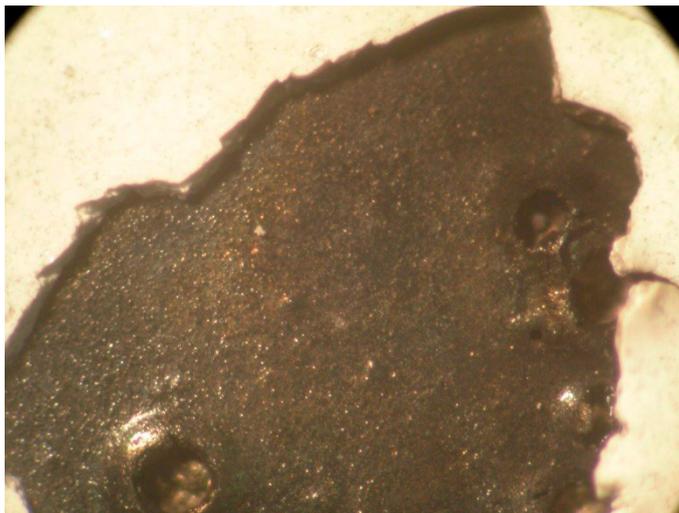
Figure 5.44: Microscopic view of the surface of a double layer FP-II – PA11 coated electrode after a breakdown test.

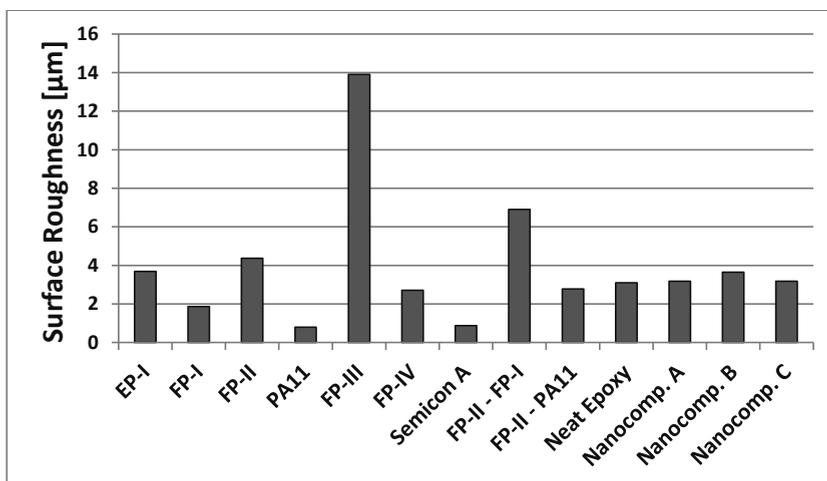
Figure 5.46: Surface roughness parameter R_y of all coating materials applied on small size electrodes.

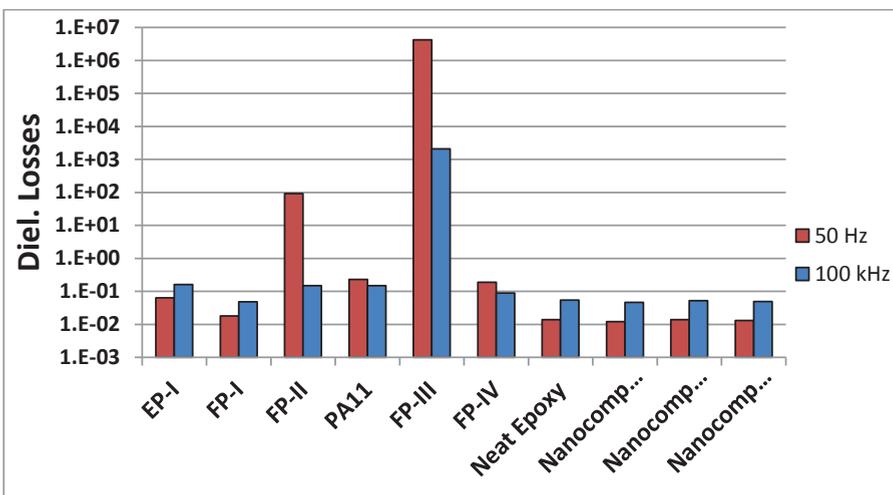
Figure 5.48: Dielectric losses of the coating materials at 50 Hz and 100 kHz.

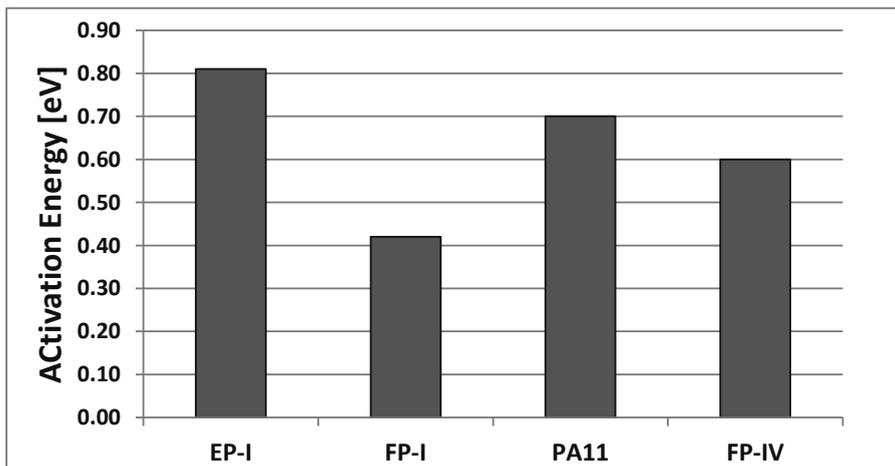
Figure 5.49: Activation energy of beta relaxation processes observed in four thin coating materials.

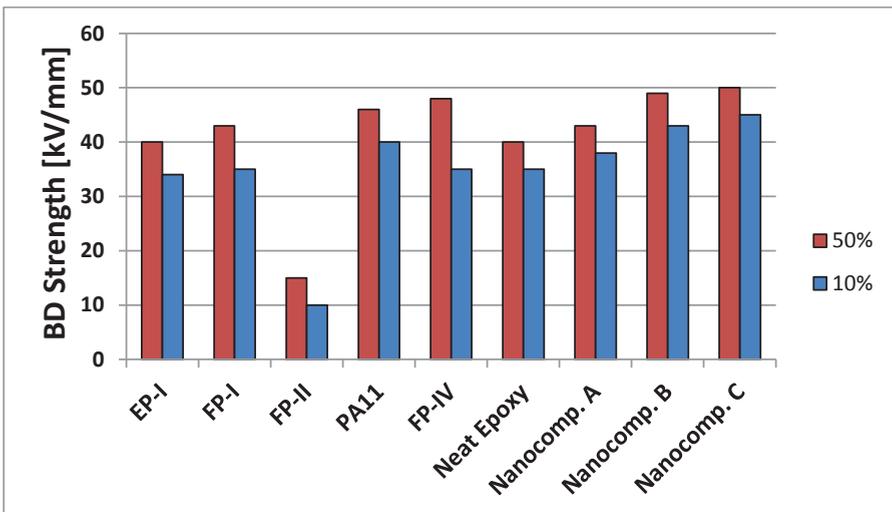
Figure 5.51: 50% and 10% Breakdown strength of the coating samples.

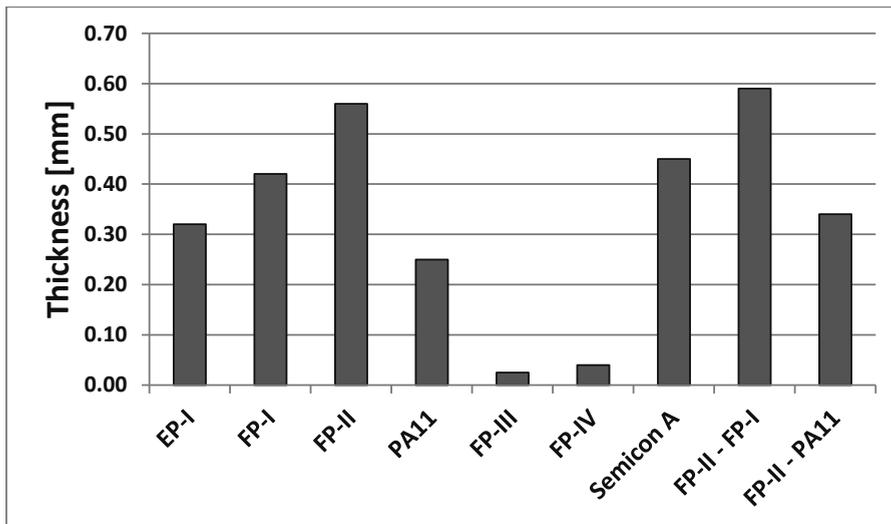
Figure 5.52: Layer thickness of thin coating materials.

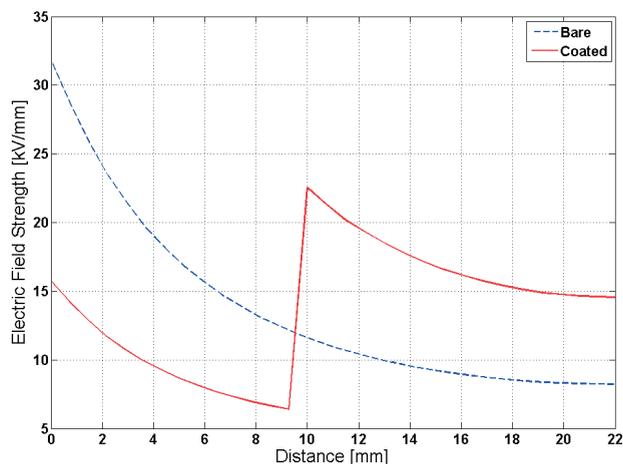
Figure 5.53: Electric field distribution in the rod plane gap with a bare (blue, dashed) and a neat epoxy coated (red) small size electrode.

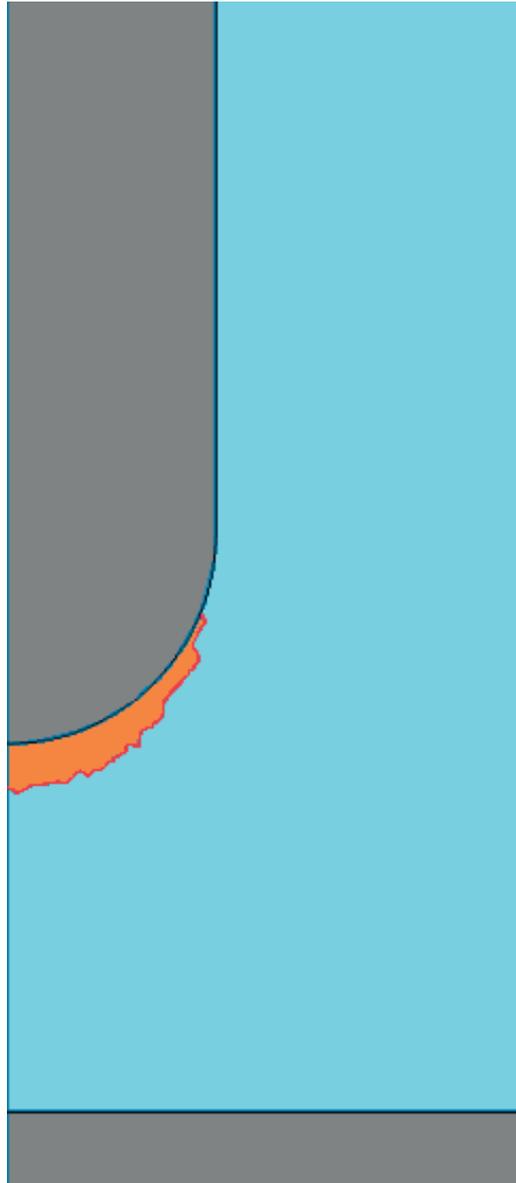
Figure 6.1: Sketch of rod-plane gap with critical region (orange) at the tip of the rod electrode bound by the red contour.

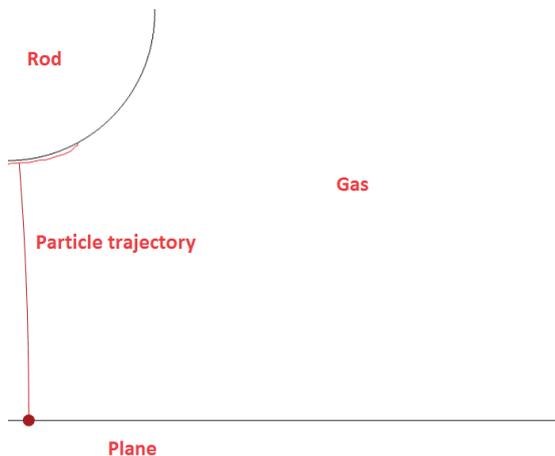
Figure 6.3: Sketch of the gas gap of the rod-plane test setup including critical region (bound by red contour) and particle trajectory along which the streamer integral is larger than K . ($V = 294$ kV)

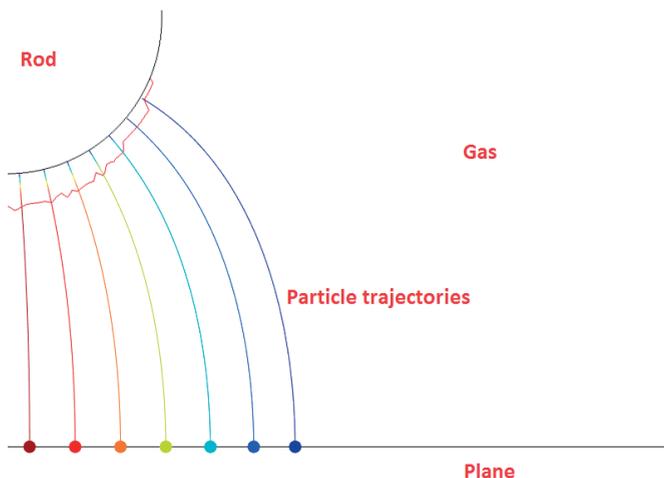
Figure 6.4: Sketch of the gas gap of the rod-plane test setup including critical region (bound by red contour) and particle trajectories along which the streamer integral is larger than K . ($V = 400$ kV)

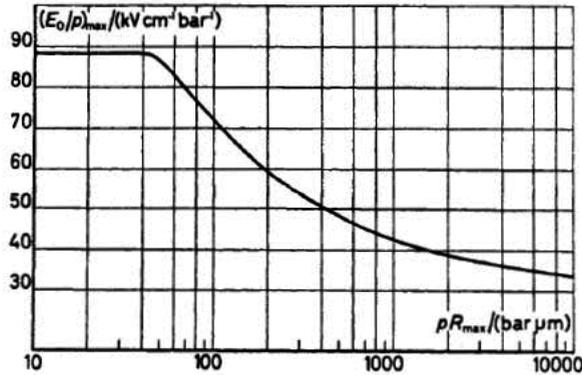
Figure 6.5: Critical electric field strength as a function of the product of the gas pressure and electrode surface roughness [38].

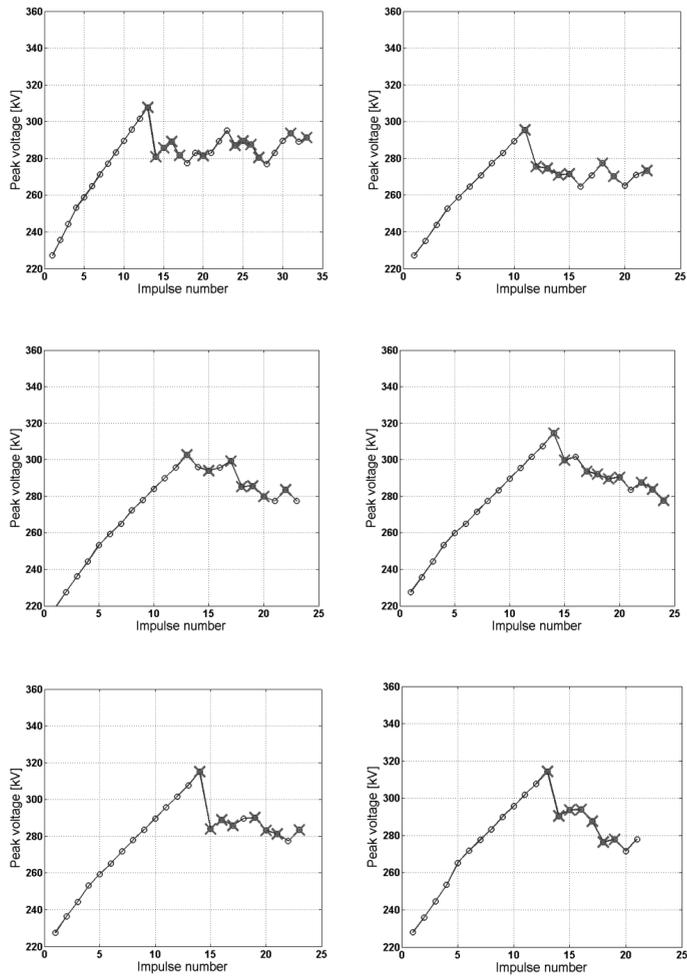
Figure A.3: EP-I coated – Top left: series 1, batch 1, electrode 7, Top right: series 1, batch 1, electrode 8, Middle left: series 1, batch 1, electrode 9, Middle right: series 1, batch 1, electrode 10, Bottom left: series 1, batch 1, electrode 11, Bottom right: series 1, batch 1, electrode 12

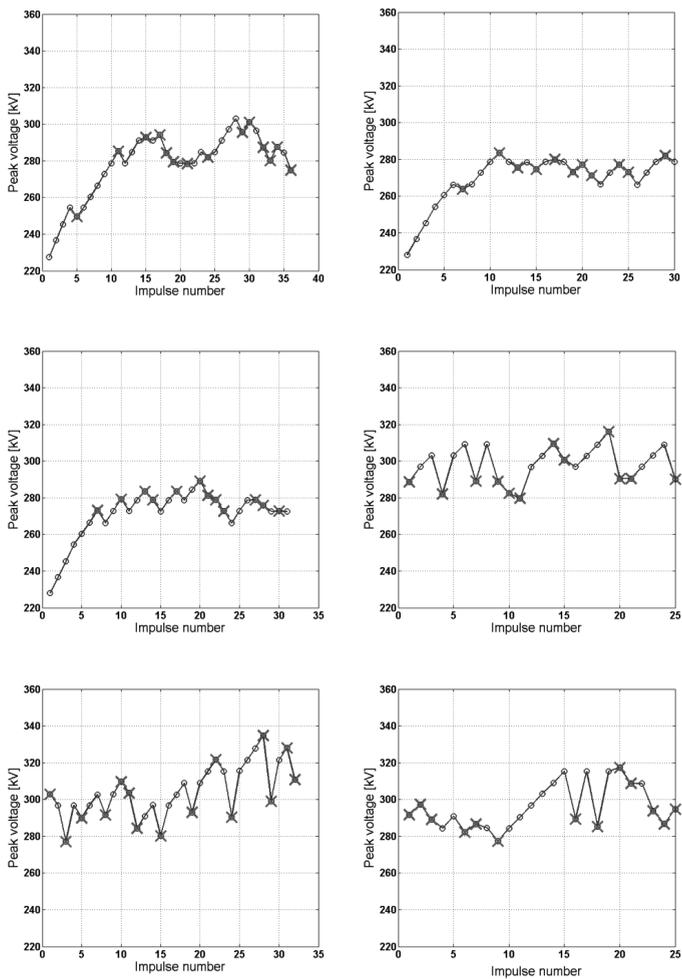
Figure A.9: FP-II extra tests - Top left: series 1, batch 5, electrode 1 (used electrode), Top right: series 1, batch 5, electrode 2 (used electrode), Middle left: series 1, batch 5, electrode 3 (used electrode), Middle right: series 1, batch 5, electrode 4 (new, 50% up-down), Bottom left: series 1, batch 5, electrode 5 (new, 50% up-down), Bottom right: series 1, batch 5, electrode 6 (new, 50% up-down)
