Dielectric Coatings for High Voltage Gas Insulated Switchgear

van der Born, D. (2017). *Dielectric Coatings for High Voltage Gas Insulated Switchgear*. [Dissertation (TU Delft), Delft University of Technology]. <https://doi.org/10.4233/uuid:4f1b06bc-3d01-4107-8c85-21c0e278c4bd>

PROEFSCHRIFT

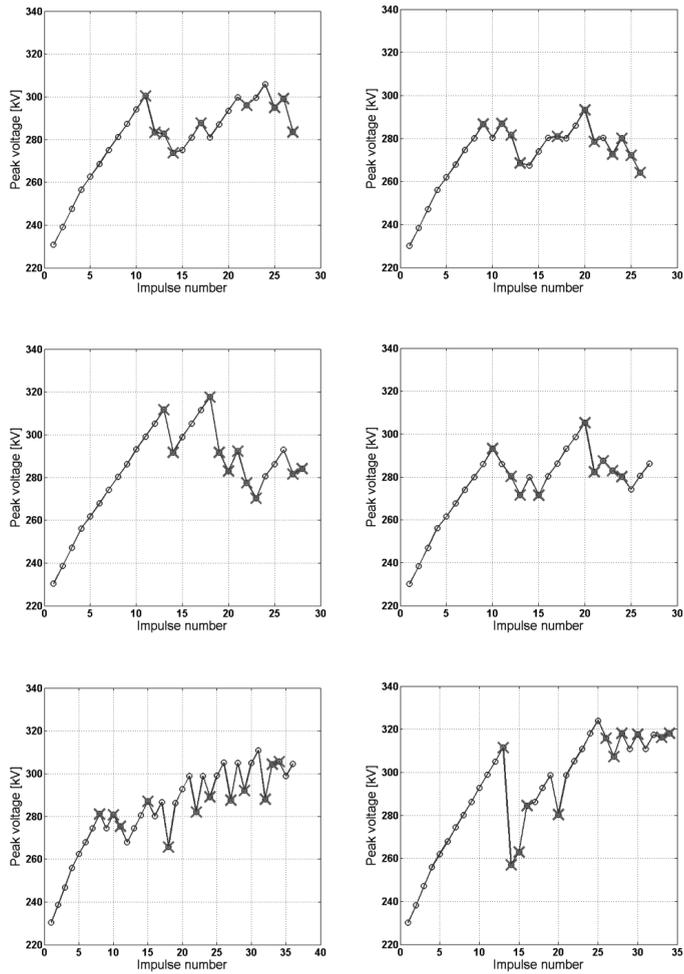
Figure A.13: FP-II – FP-I - Top left: series 3, batch 1, electrode 1, Top right: series 3, batch 1, electrode 2, Middle left: series 3, batch 1, electrode 3, Middle right: series 3, batch 1, electrode 4, Bottom left: series 3, batch 1, electrode 5, Bottom right: series 3, batch 1, electrode 6

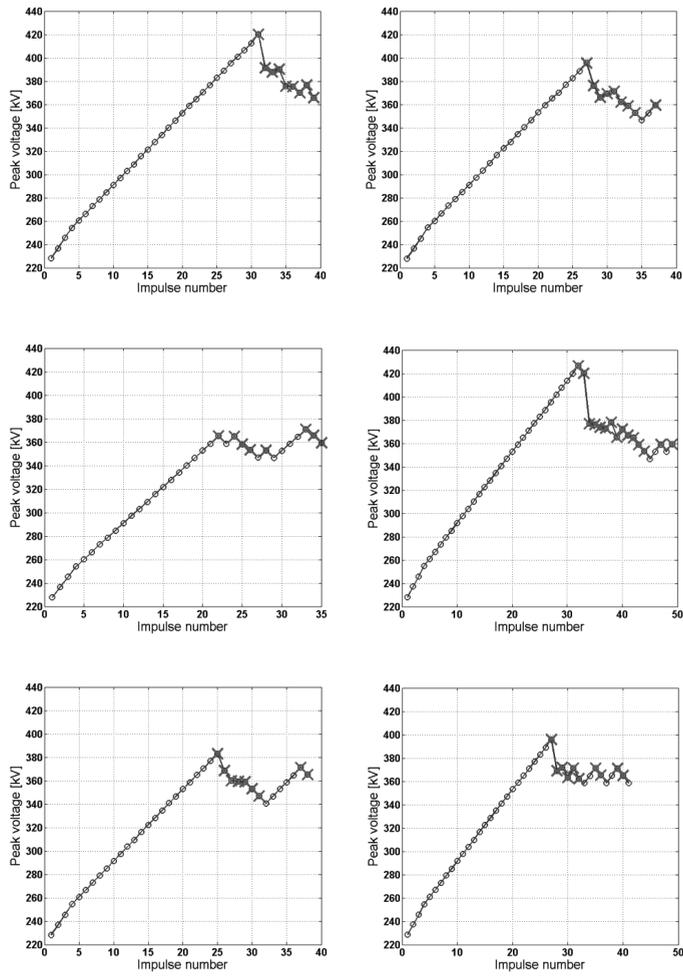
Figure A.18: Nanocomposite A - Top left: series 2, batch 3, electrode 1, Top right: series 2, batch 3, electrode 2, Middle left: series 2, batch 3, electrode 3, Middle right: series 2, batch 7, electrode 1, Bottom left: series 2, batch 7, electrode 2, Bottom right: series 2, batch 7, electrode 3

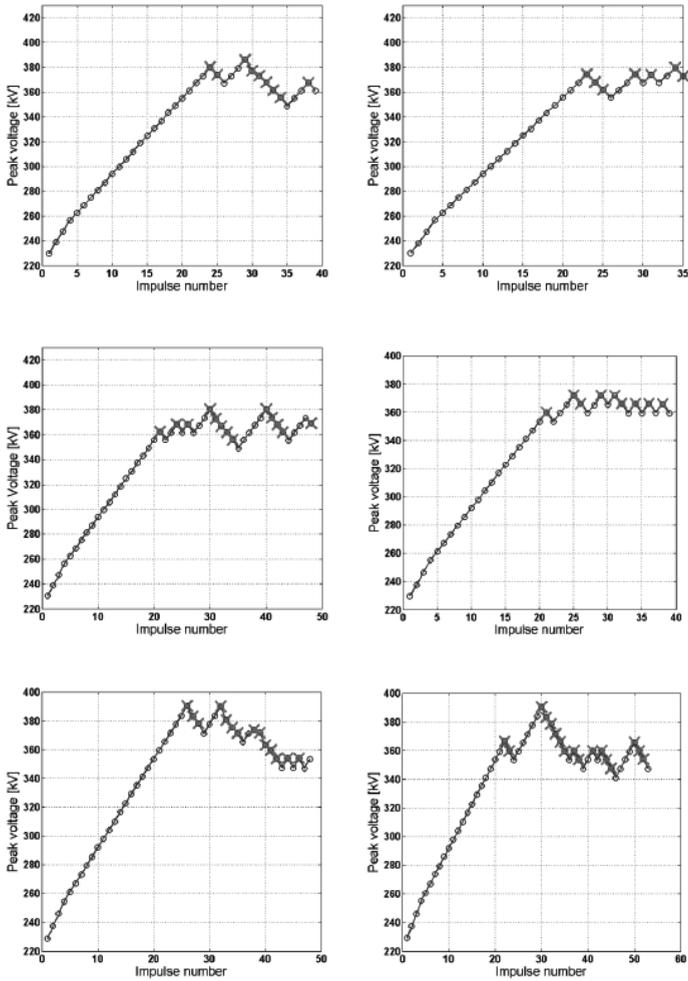
Figure A.19: Nanocomposite A retests - Top left: series 2, batch 4, electrode 1, Top right: series 2, batch 4, electrode 2, Middle left: series 2, batch 4, electrode 3, Middle right: series 2, batch 8, electrode 1, Bottom left: series 2, batch 8, electrode 2, Bottom right: series 2, batch 8, electrode 3

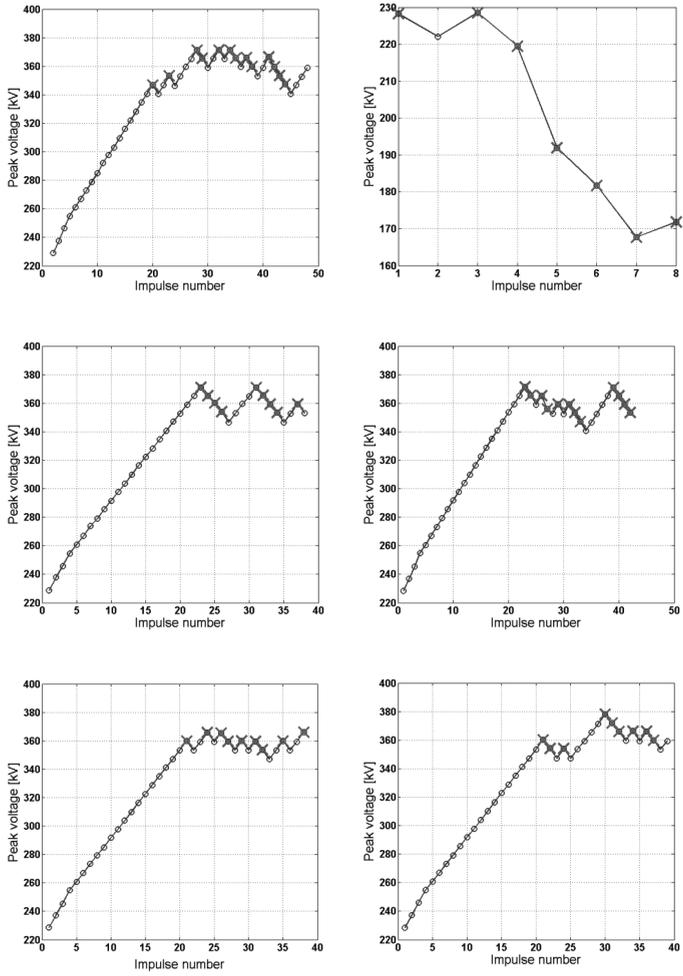
Figure A.21: Nanocomposite B retests - Top left: series 4, batch 2, electrode 1, Top right: series 4, batch 2, electrode 2, Middle left: series 4, batch 2, electrode 3, Middle right: series 4, batch 2, electrode 4, Bottom left: series 4, batch 2, electrode 5, Bottom right: series 4, batch 2, electrode 6

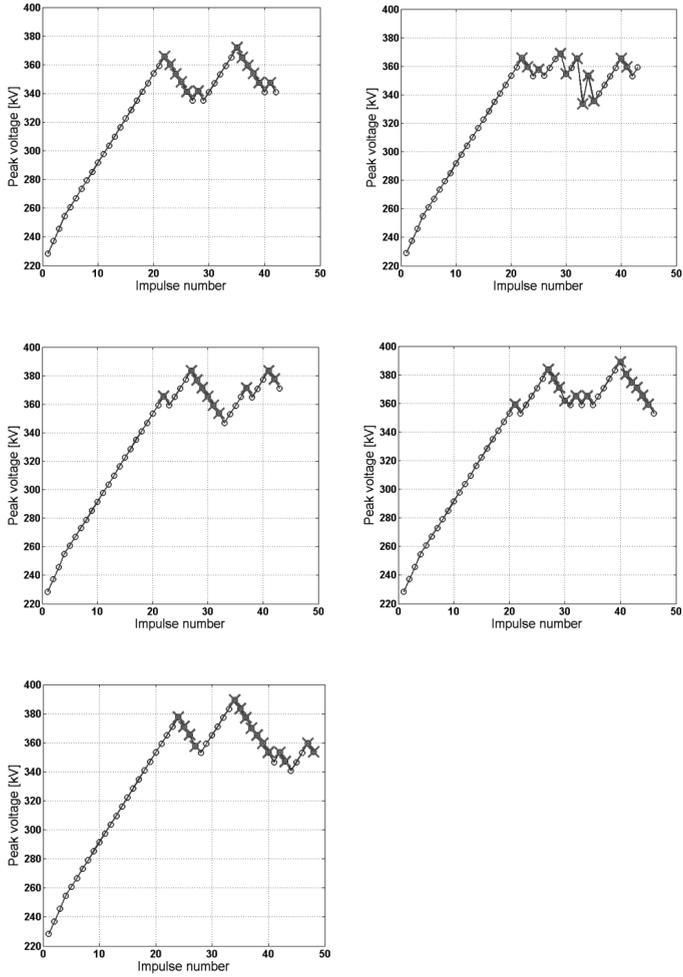
Figure A.23: Nanocomposite C retests - Top left: series 4, batch 2, electrode 7, Top right: series 4, batch 2, electrode 8, Middle left: series 4, batch 2, electrode 10, Middle right: series 4, batch 2, electrode 11, Bottom left: series 4, batch 2, electrode 12
