# A Comparative Study of the Effects of the 1872 Storm and Coastal Flood Risk Management in Denmark, Germany, and Sweden

**Abstract:** From November 12th to 13th in 1872, an extreme coastal flood event occurred in the south Baltic Sea. An unusual combination of winds created a storm surge reaching up to 3.5 m above mean sea level, which is more than a meter higher than all other observations over the past 200 years. On the Danish, German, and Swedish coasts, about 300 people lost their lives. The consequences of the storm in Denmark and Germany were more severe than in Sweden, with significantly larger destruction and higher numbers of casualties. In Denmark and Germany, the 1872 storm has been more extensively documented and remembered and still influences local and regional risk awareness. A comparative study indicates that the collective memory of the 1872 storm is related to the background knowledge about floods, the damage extent, and the response to the storm. Flood marks and dikes help to remember the events. In general, coastal flood defence is to the largest degree implemented in the affected areas in Germany, followed by Denmark, and is almost absent in Sweden, correspon

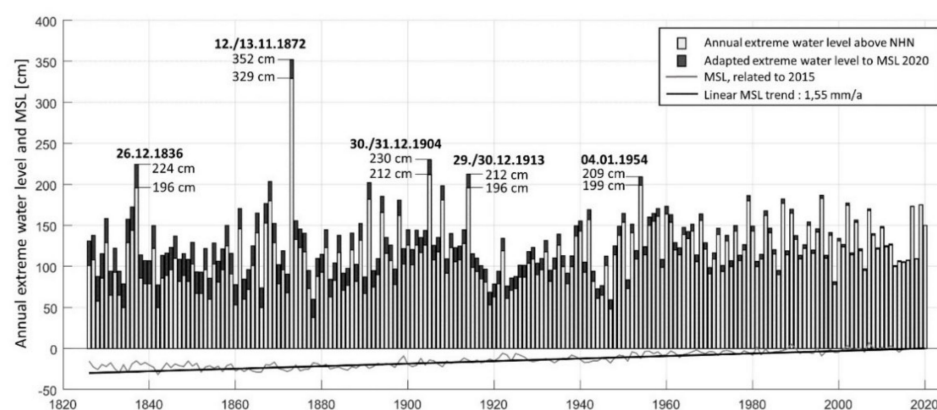
**Figure 1.** Annual extreme water level above NHN (German reference datum), annual extreme water levels adopted to MSL in 2020, MSL, and MSL trend at Lübeck-Travemünde gauge station for the period 1826 to 2020. The figure is based on data from Jensen and Töppe, and Kelln [14–16].

In 1872, a disastrous storm event affected the countries bordering the western parts of the south Baltic Sea. At the Danish, German, and Swedish coasts, around 300 people died, and more than 15,000 people lost their homes in the German state Schleswig-Holstein alone [11,12]. The water level variations in the south Baltic Sea are usually affected by modest surges due to wind setup. However, during the 1872 storm, the water levels in, e.g., Travemünde, Germany, locally rose to 3.3 m above normal sea level at that time [13,14]. This record-breaking event was more than a meter higher than all other events that have been observed at this station since it has started operating in 1826 (Figure 1).

On November 13th in 1872, an extreme storm event—often referred to as the 1872 storm—caused severe flooding along the coasts surrounding the western parts of the south Baltic Sea (Figure 2). The peak water levels during the 1872 storm were by far the highest on record, exceeding the observed water levels of the area in the last 100 years by more than a meter [30] (Figure 1).

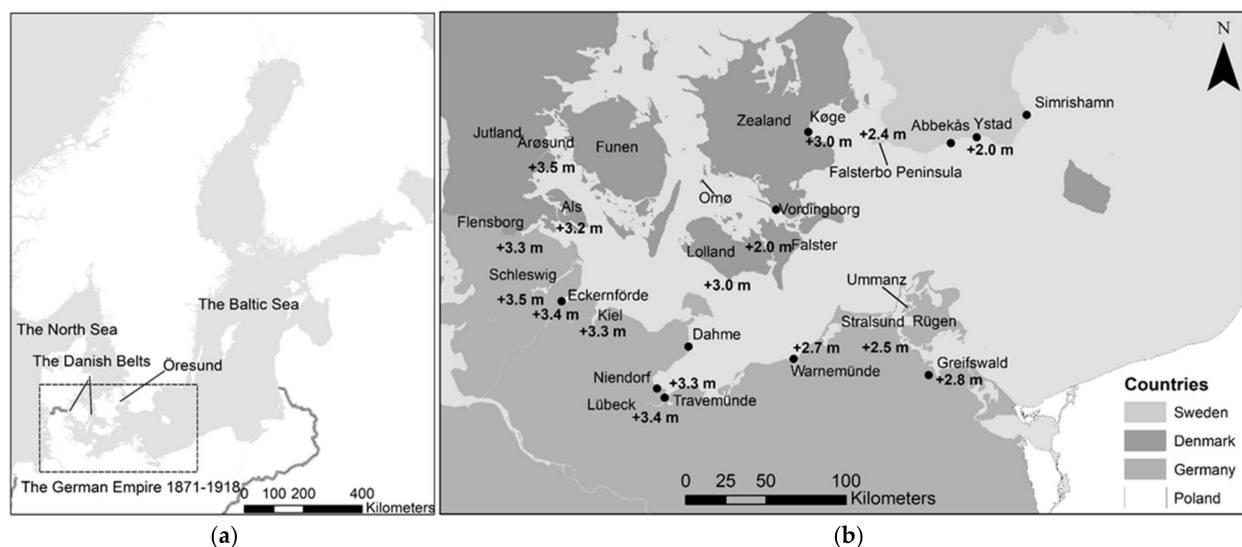
**Figure 2.** (a) Overview of the Baltic Sea basin. The land boundaries of the German Empire as in 1872 are indicated. (b) Overview of the affected area during the 1872 storm and the measured or reconstructed peak water levels along the coasts.

More specifically, during the 1872 storm, the still water level in Germany reached up to 3.3 m above normal sea level at that time in Travemünde, Kiel, and Flensburg, 3.4 m in Lübeck and Eckernförde, 3.5 m in Schleswig, 2.8 m in Greifswald, 2.7 m in Warnemünde, and 2.5 m in Stralsund [15,31]. In Denmark, the highest observations were made in Årøsund at the southeast coast of Jutland, at 3.5 m above normal sea level at that time, and in Als, at 3.2 m [31,32]. In Køge, on the east coast of Zealand, and Kramnitze Grab, Lolland, the peak water level reached 3.0 m above normal sea level at that time, and in Nykøbing, Falster, 2.0 m [32]. The peak water level at Falsterbo Peninsula in Sweden has been estimated to 2.4 m above normal sea level at that time, based on a flood mark and eyewitness stories [33]. From Ystad harbour on the Swedish south coast, there is an observation of 2.0 m above normal sea level at that time [34].

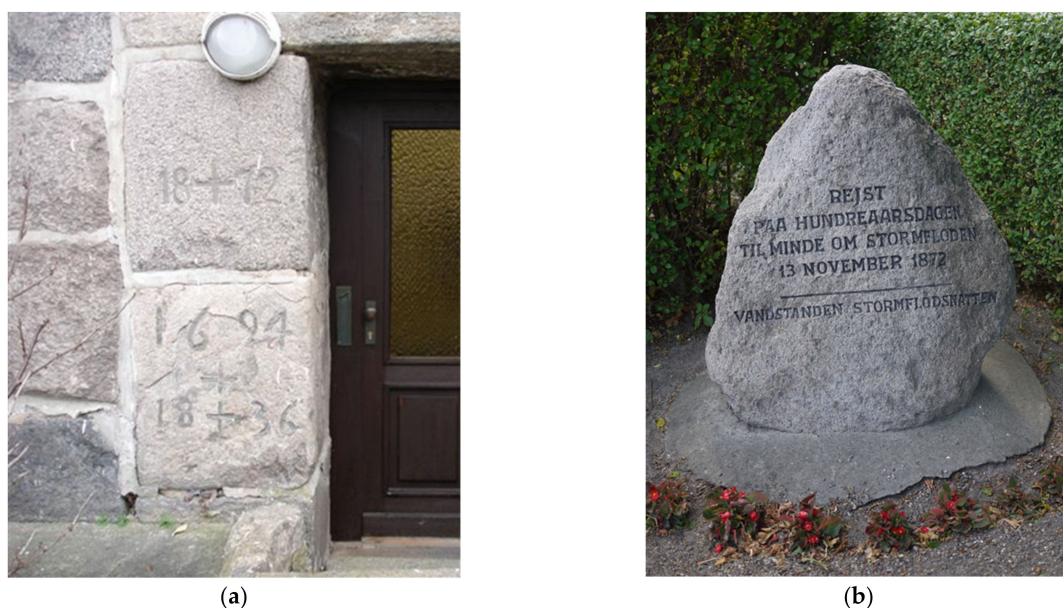
**Figure 3.** (a) Flood marks from 1694, 1836, and 1872 on a building in Schleswig, Germany. Photo: R. Sedlatschek; (b) Flood mark at Gedesby church (Gedser, Denmark) to memorize the 100th anniversary of the 1872 storm surge. Photo: Wikipedia.org.

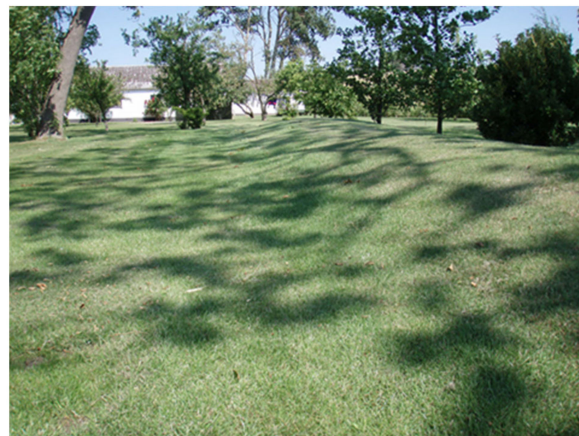
**Figure 5.** Remnants of a dike on the Danish island of Omø constructed after the 1872 storm, but later partly removed. Photo: Per Sørensen.

Along the Danish coast, other minor dikes were built to protect against a similar storm. However, as time passed without any storm surges reaching close to the 1872 storm surge level, flood risk awareness diminished. For example, the dike on the island of Omø that was constructed after the 1872 storm surge was later partly removed (Figure 5).
