## Elephant skin formation on UHPC surface Effects of climatic condition and blast furnace slag content

Yalçinkaya, Çağlar; Copuroglu, Oguzhan

Construction and Building Materials

Yalçinkaya, Ç., & Copuroglu, O. (2021). Elephant skin formation on UHPC surface: Effects of climatic condition and blast furnace slag content. *Construction and Building Materials*, 268, 1-12. Article 121126. <https://doi.org/10.1016/j.conbuildmat.2020.121126>

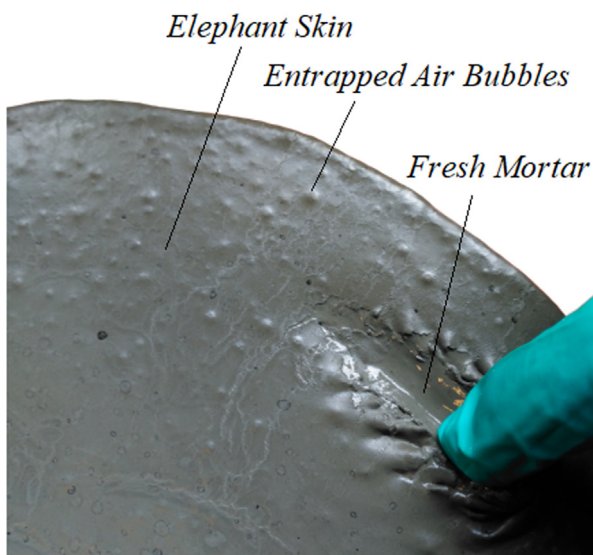
Fig. 3. Elephant skin formation just after slump-flow.

UHPC mixtures achieved the target slump-flow value without segregation. Note that the slump-flow test was performed on the laboratory condition of  $20\ ^\circ\text{C}$ -40% RH. In three to five minutes after the slump-flow test, the fresh mortar was covered by a dense layer called “elephant skin” (Fig. 3). This premature densification hindered the escapes routes of air bubbles from the surface and kept them entrapped. When the surface was scraped by finger, the fresh mortar could be seen under the skin. Moreover, as a result of pulling out the skin, wrinkles that are indicators of viscoelastic behavior can be observed. This behavior makes it almost impossible to properly finish and trowel the surface.

A semi-transparent and shiny layer at the top surface can be distinguished by the naked eye in Figs. 3–6 at both the fresh and hardened state of UHPCs. This is an organic film that mostly
