## Measurement at wind turbine near Waddinxveen

# Measurement at wind turbine near Waddinxveen

Paul Hölscher

February 10, 2017

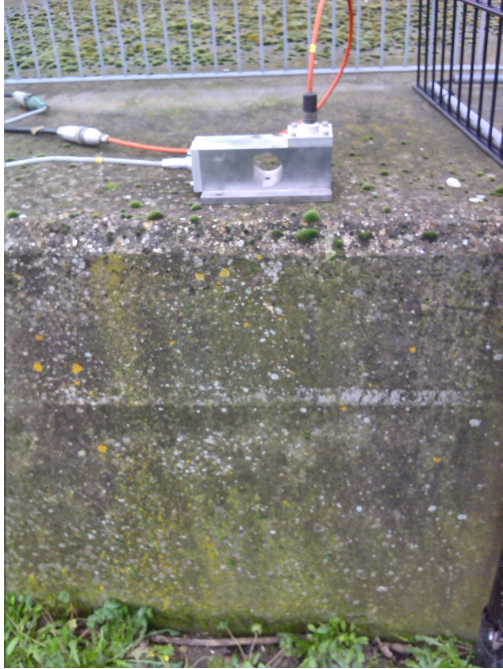
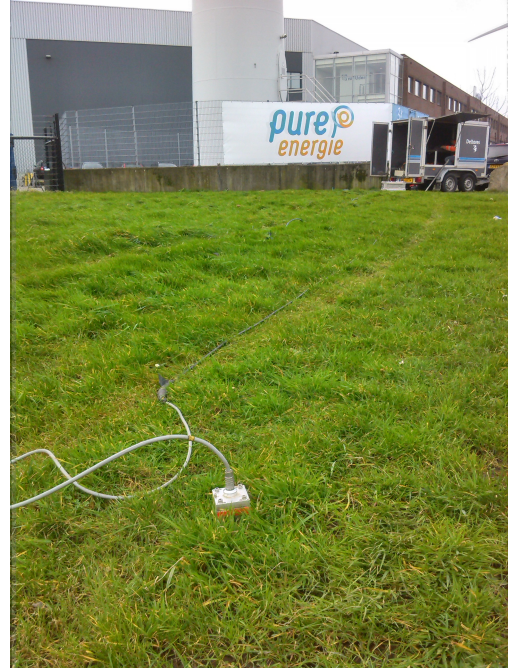
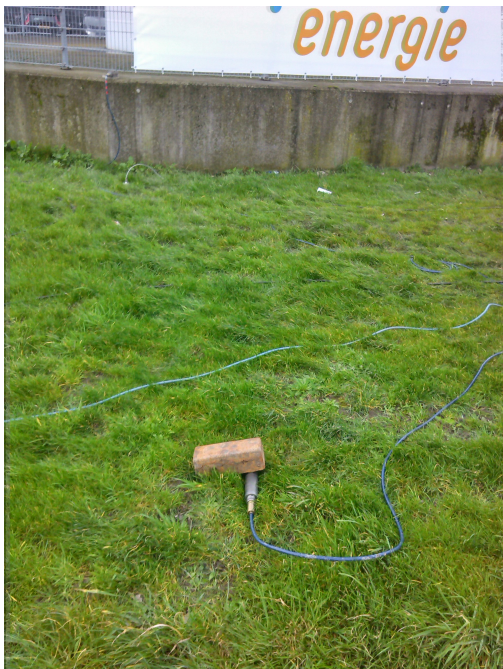
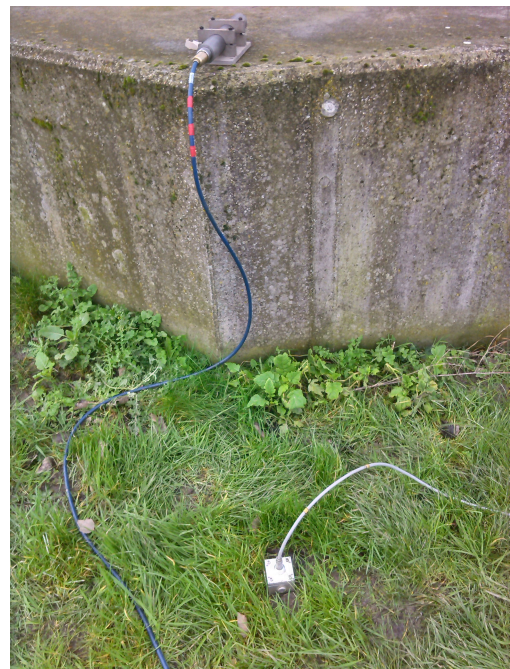
*(a) H10 and V11 on slab*

*(b) Overview from V6*

*(c) TC1 in the field*

*(d) TC3 and V5*

*Figure 1 Impression of measurement site and set-up*

Additionally 6 separated transducers are available. These are placed in special holders. These holders have a pin of about 20 cm, which facilitates a proper fixation into the soil. On the slab, the two holders are placed without any additional fixation. Figure 1 gives an idea of the field test.

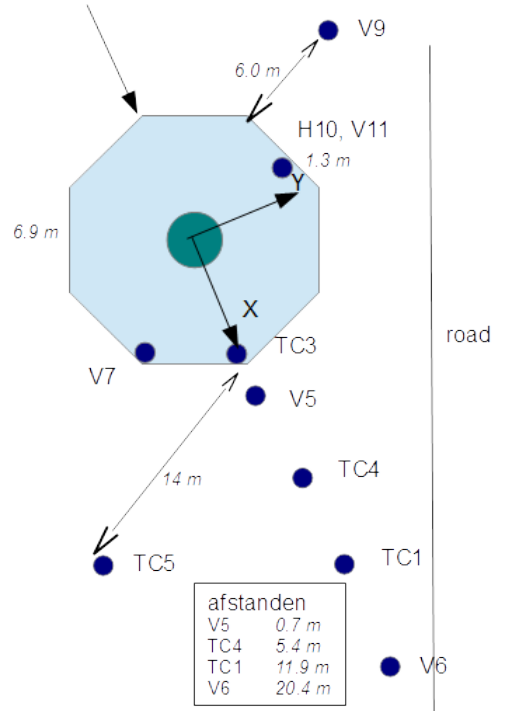
Figure 2 Lay out of measurement

Figure 2 shows a sketch of the measurements. Based on the limited targets of the measurement there has not been a lot of effort to create a very accurate determination of the position of the devices. The slab was accessible from one side only, therefore, all transducers are located at this side of the slab.

The farthest transducer (V6) is just at the edge of the road (Nijverheidsweg).

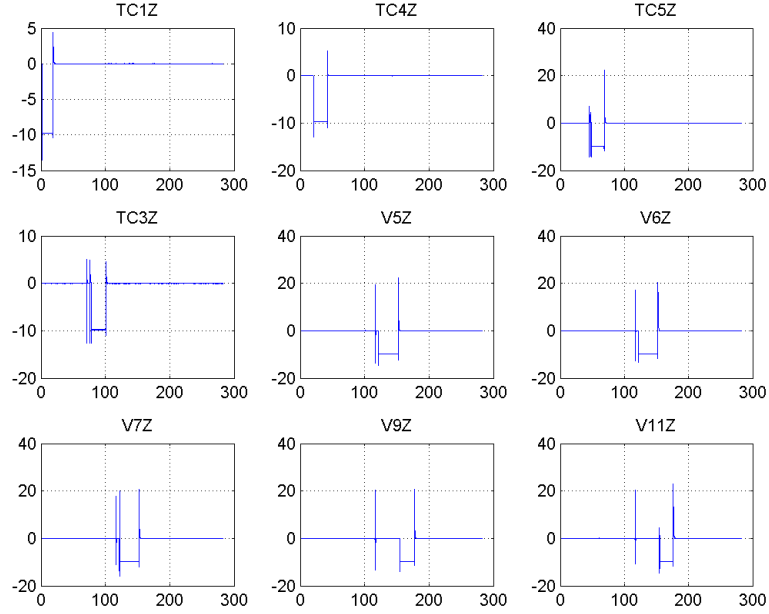
*Figure 3 Test of vertical transducers*

A simple test of the transducers is switching of the 1-g compensation. The equipment has a special button for this purpose. Figure 3 shows the results. It is clear that all transducers show a  $-10 \text{ m/s}^2$  signal when the compensation was switched off.

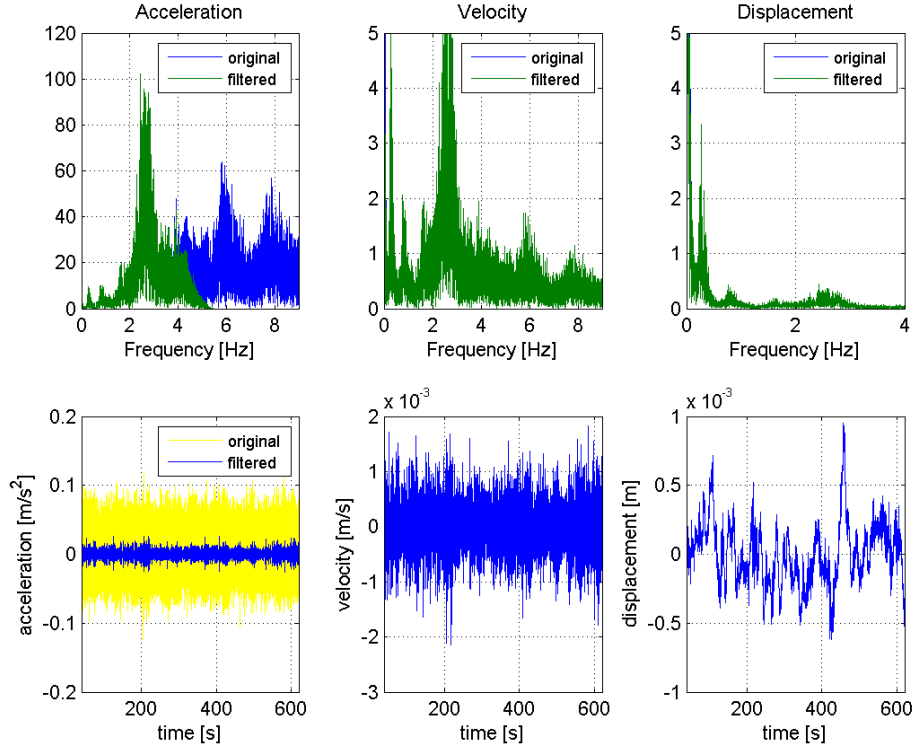
Figure 4 Acceleration, velocity and displacement of the slab (measurement 01)

The measured motion of the slab is analyzed. Figure 4 shows the processed results. At top the frequency domain is shown, at the bottom the time domain data.

The lower left figure shows that the equipment has a high noise level, which is easily removed by filtering high frequencies (above 80 Hz). The yellow line is the original signal, the blue line is the one after filtering at 4.5 Hz. At top the

frequency domain data are shown. The low frequency peak at 0.32 Hz is in the acceleration already visible and in the displacement the most important motion. Other frequency peaks are found at 0.82 Hz, 1.6 Hz, 2.6 Hz, 5.9 Hz and 7.8 Hz. The frequency 0.82 Hz seems to be induced by the blades passing, that was counted to be 0.79 Hz (see Section 3.1).

This shows that the equipment is reasonably able to measure the low frequencies. It is possible to integrate these with respect to time to velocity of the transducer. Further integration with respect to time is more complicated, but with some additional effort reasonable results are obtained.

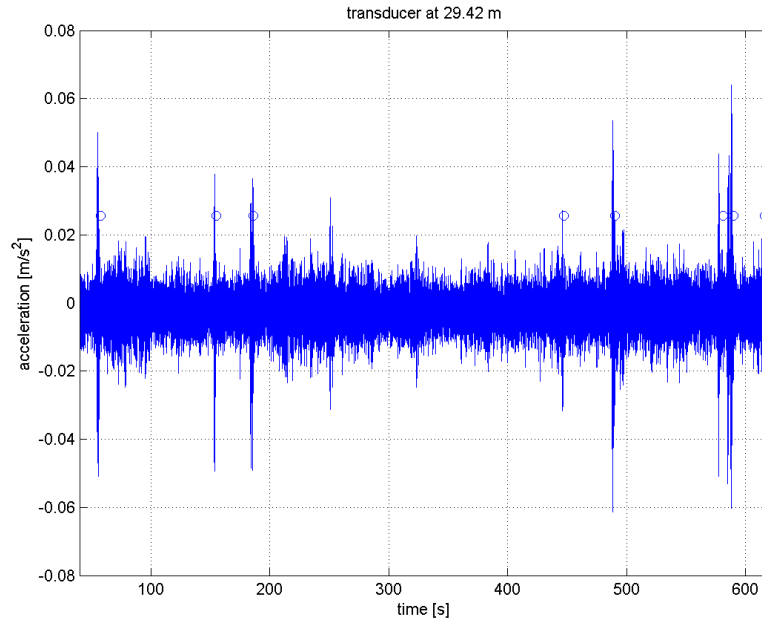
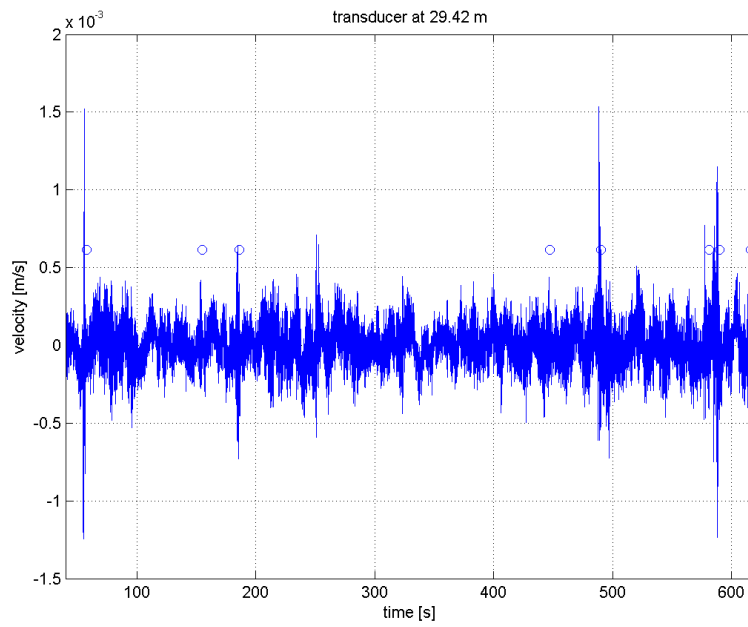
Figure 5 Results device close to the road with lorries passing.  
Top: acceleration, bottom: velocity

Figure 5 shows for measurement 8 the acceleration and velocity measured along the road with the written down passages of lorries, vans and cars. It is clear that the vibrations of the passing traffic is determining the extremes in these transducers.

This means that at least in the soil, the extremes are determined by the traffic and not by the wind turbine. To overcome this quandary, the measurements close to the road are inspected visually, and intervals without mayor vibrations are selected. The influence of cars is small and maybe not always clear.

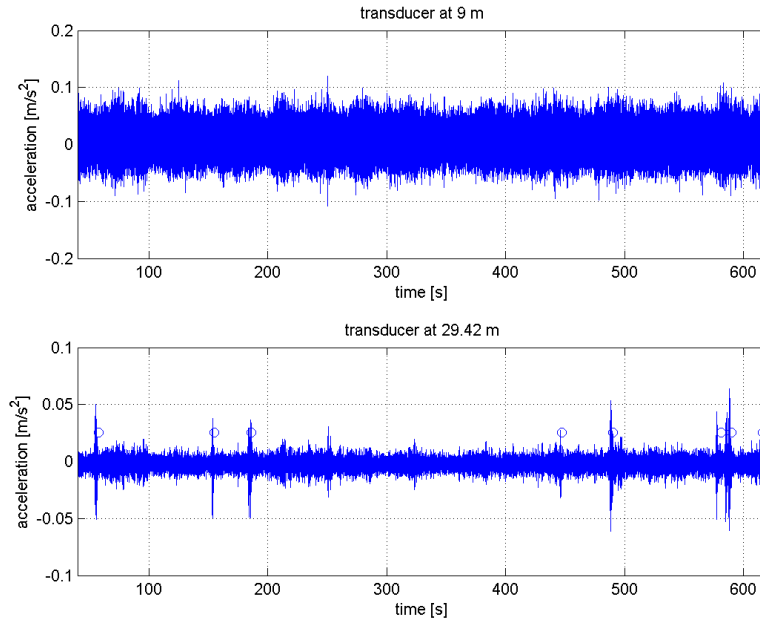
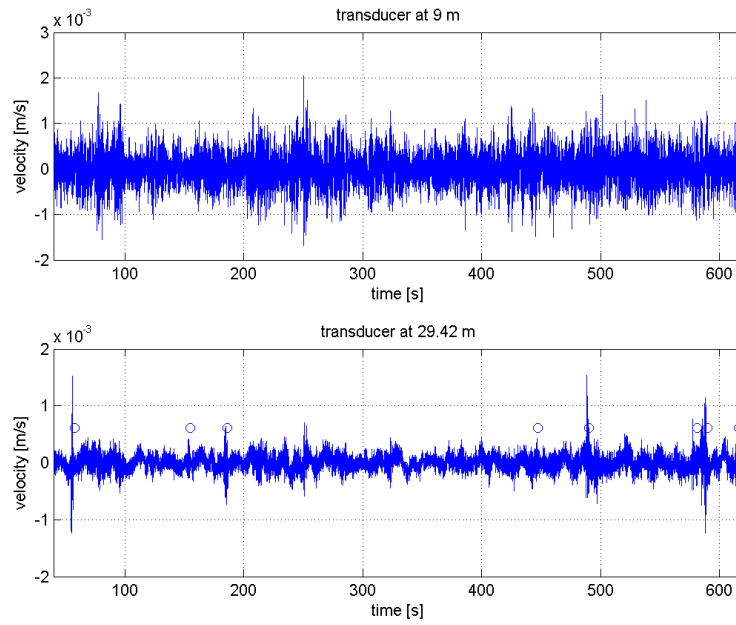
Figure 6 Results device TC5Z and V6Z with lorries passing (measurement 08).  
Top: acceleration, bottom: velocity

Figure 6 and Figure 7 show the vibrations further away from the road. At the distance of the wind turbine these vibrations are just still visible. However, it

seems better to limit the interval of the measurement to a interval without visible passages of lorries in transducer V6Z.

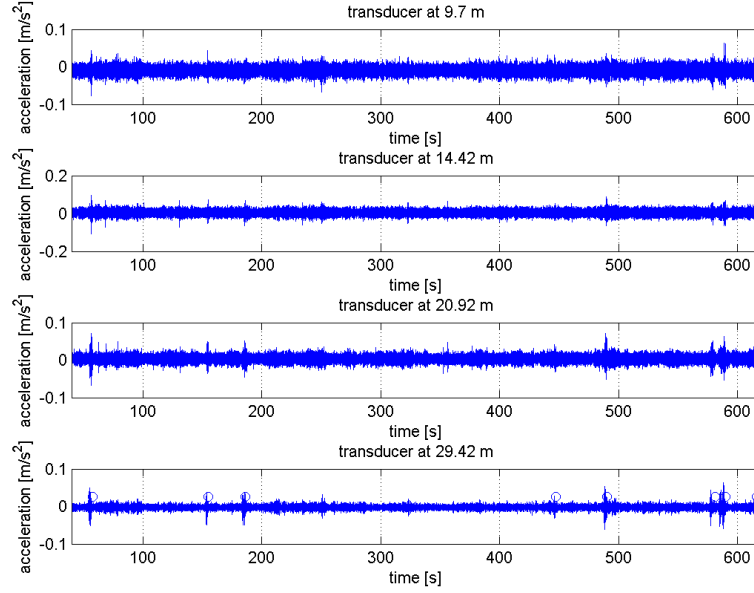
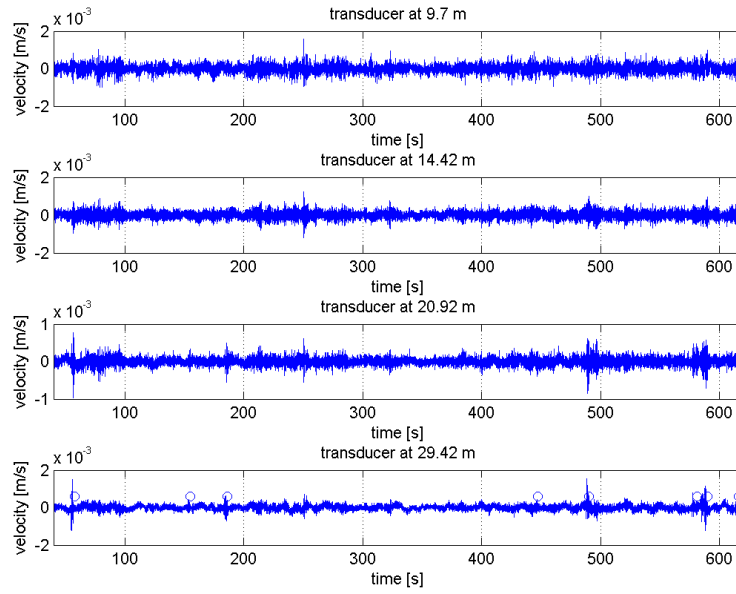
Figure 7 Results device on ray  $x$ -axis with lorries passing (measurement 08).  
Top: acceleration, bottom: velocity

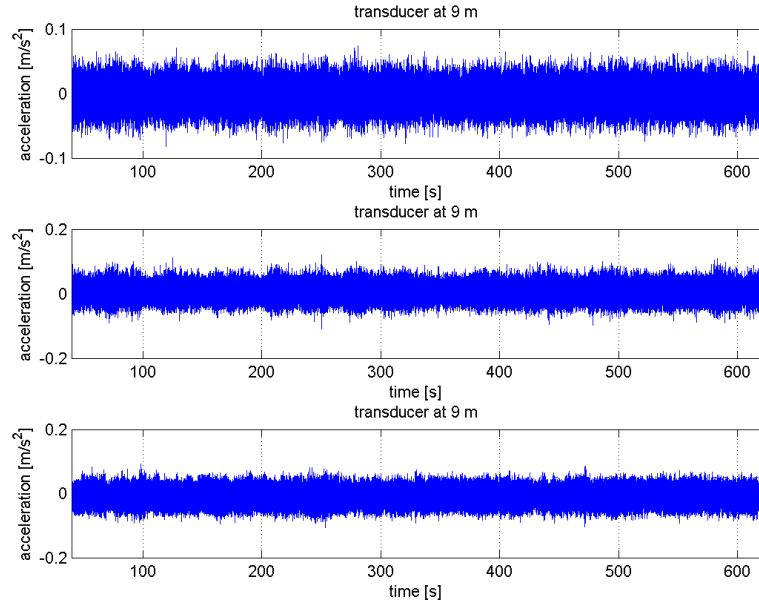
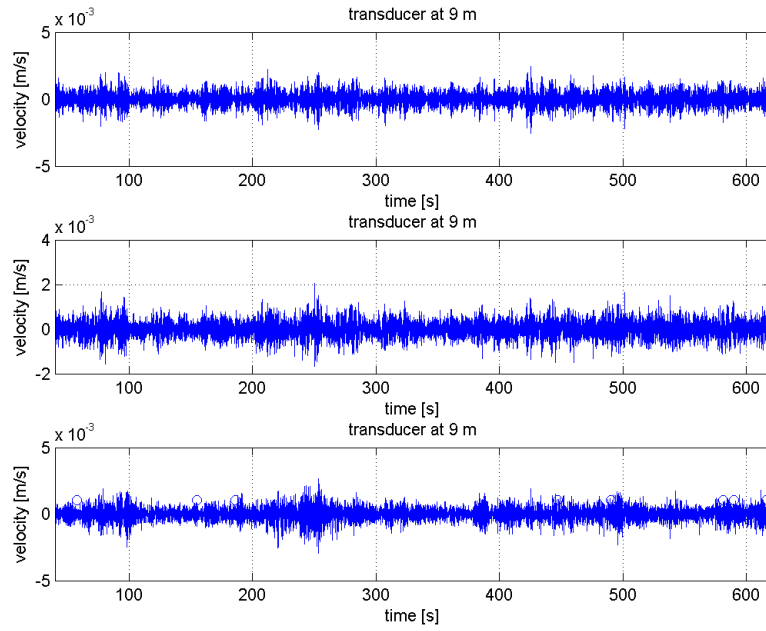
Figure 8 Motions in TC3 on slab in three directions for measurement 08

Figure 8 shows the results on the slab for measurement 08 on the slab. In the bottom figure the passages of the lorries are shown. These figures shows that on the slab the passages of the lorries are hardly visible. The variations in the measurement at the slab are thus essentially the variations in the wind and the response of the wind turbine itself.

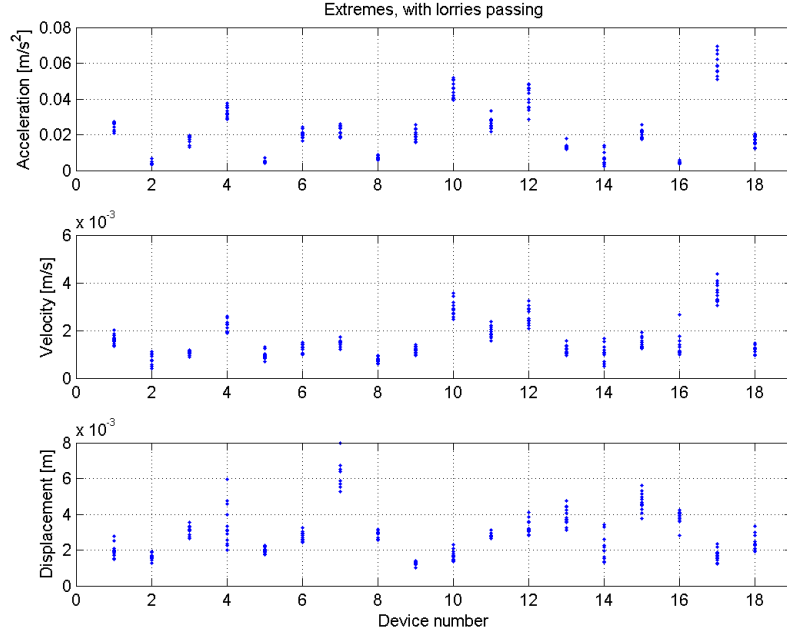
*Figure 9 Maximum values in 10 min interval with lorry passages included  
Top acceleration, middle velocity and bottom displacement*

In total 13 measurements of 11 minutes each are done. This coincides with the standard usage of 10 minutes intervals in practice. For each interval the maximum value is selected. Figure 9 shows the results. The horizontal axis shows the device number, that is one higher than the channel number in Table 2. These figures give also some idea on the variation in these peak values. For the displacement,

the data must be handled with care, since the integration method used might give some strange results.

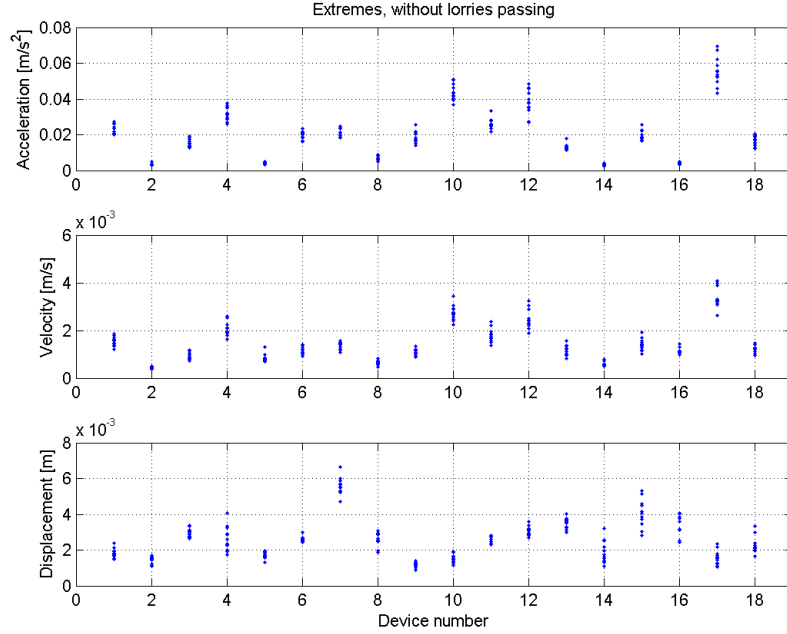
Figure 10 Maximum values in longest interval without lorry passages.  
Top acceleration, middle velocity and bottom displacement

Figure 10 shows the similar results as in Figure 9, but now limited to time intervals without clearly visible passages of lorries. Excluding the lorry passages leads to some minor changes in these plots, mainly in the locations close to the road and far from the wind turbine.

The channels 10, 11, 12, 15, 17 and 18 are located at the slab.

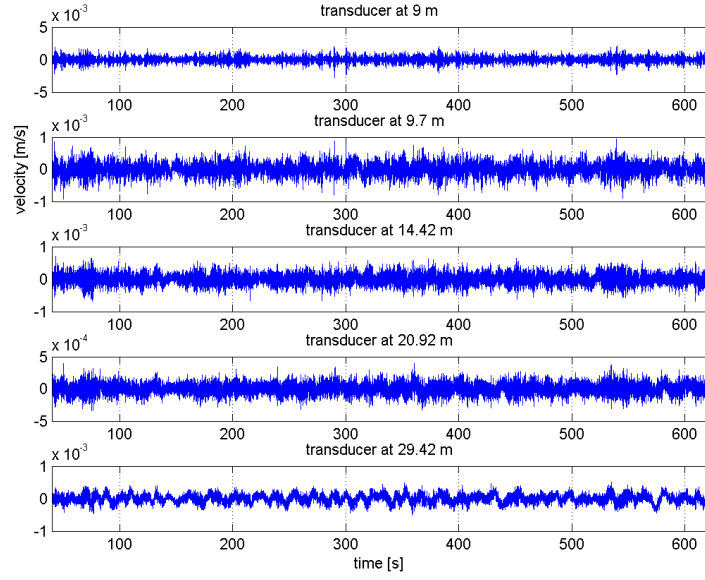
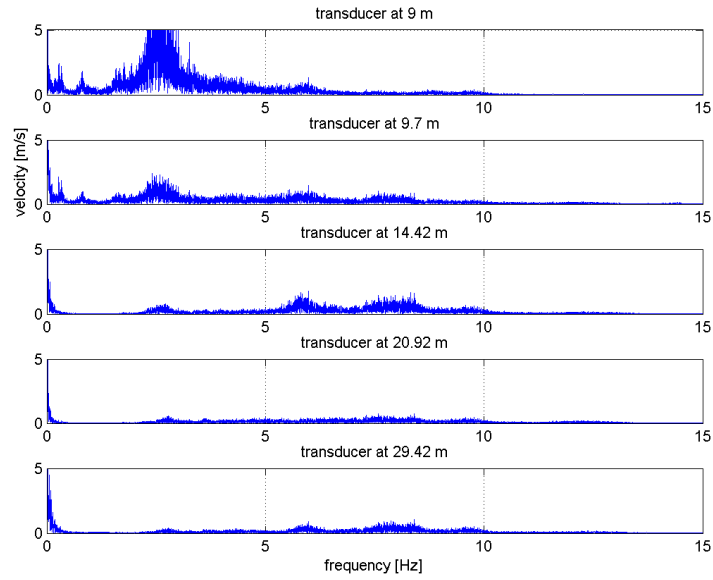
Figure 11 Measurement 09, vertical vibrations measured on x-axis

Figure 11 shows the signals in the soil.

The top figure shows the time signals. The top row is the transducer on the slab. This shows that even without lorries passing the vibrations are irregular with periods of higher and lower peaks. The bottom row shows the vertical vibration along the road. No special vibrations that suggest lorry passage are observed. This signal suggests that one or two frequencies are dominating the response.

The bottom figure shows the results in the frequency domain. The response in the frequency domain show a very particular behavior.

- For low frequencies, say below 1 Hz, the soil has a clear response. The nearest transducer (at 9.7 m) is about 0.7 m from the transducer at the slab. Here the peaks at 0.3 Hz and 1 Hz are still visible. In the other transducers only

the static component is seen. In the farthest transducer the response seems to increase a bit. Maybe this is due to the fact that these low frequencies are transferred into the deep soil by the pile foundation and it takes some distance to propagate up to the surface.

- Between 1 and 2 Hz, no signal is observed at all.
- The peak at 2.5 Hz is strongly damped.
- The peaks at higher frequencies, 6 Hz and 8 Hz, are typical dynamic phenomena, these are propagating damped waves. Above 10 Hz minor vibrations are observed.

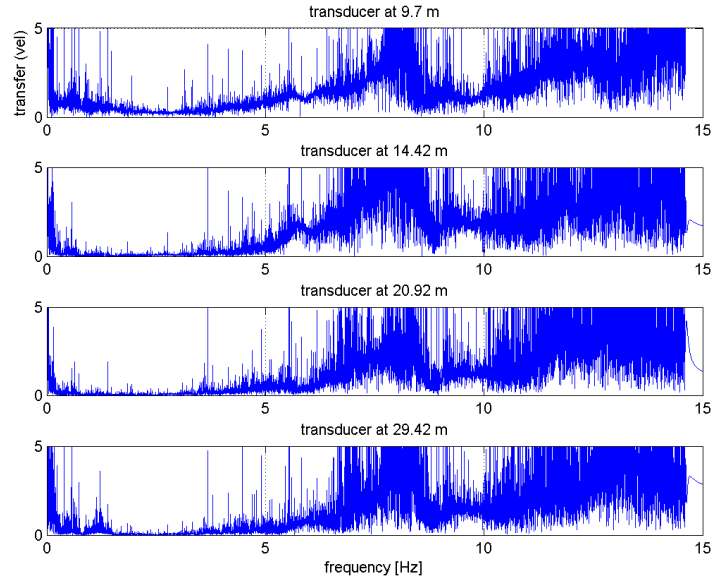
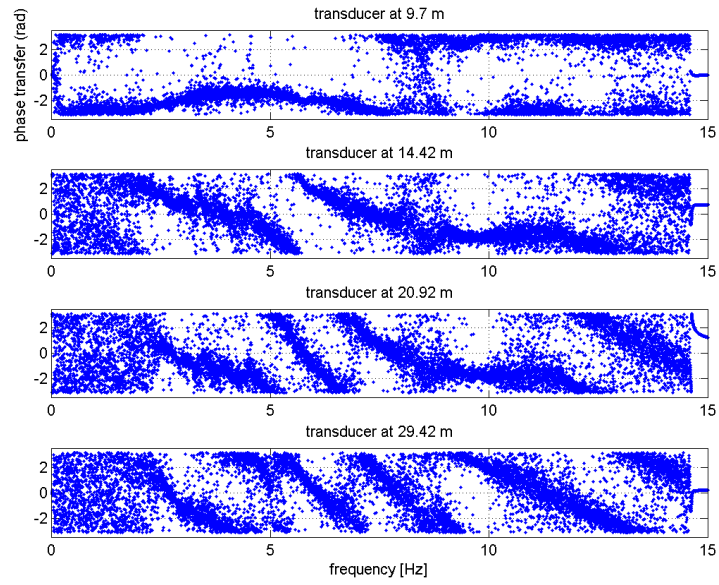
Figure 12 Measurement 09, frequency domain transferfunction from slab to the vertical vibrations in the soil along  $x$ -axis

Figure 12 shows the same results, but now normalized on the vertical vibration measured at the slab. The first channel is therefore omitted. The strong peaks in the figure are due to the normalization. If the amplitude of the normalizing signal in one frequency is small, the value will be high. This is possible because there is no full causality in the signals: e.g. the vertical vibration in the slab is the summation of the rotation ( $\phi_y$ ) and vertical translation ( $u_z$ ) of the slab. These two signals may cancel in the slab. However, they may propagate along different paths or different speed to the transducer. There the signals are not canceling. The quotient will be high.

The bottom figure shows the phase angle of the quotient. This is related with the propagation of waves. The top figure at 9.7 m is close to the transducer on the slab that is used for the normalizing. The phase angle is almost  $\pi$  or  $-\pi = \pi - 2\pi$ . This means that the signals are in anti-phase, while in-phase is expected and also visible in the time signals after strong magnification for 8 Hz signal, the frequency that dominates the velocity signal. At this frequency there are many points in the phase plot for phase angle 0 rad.

The transducers further away show more or less a band structure, which is typical for a propagating wave. From these bands the wave speed can be estimated, resulting is 40-50 m/s. This is a reasonable value for the soft top layer in Gouda.

For the low frequencies the phase angle is not clear, all values from  $-\pi$  to  $+\pi$  are observed. This is maybe due to the short distance between the transducers.

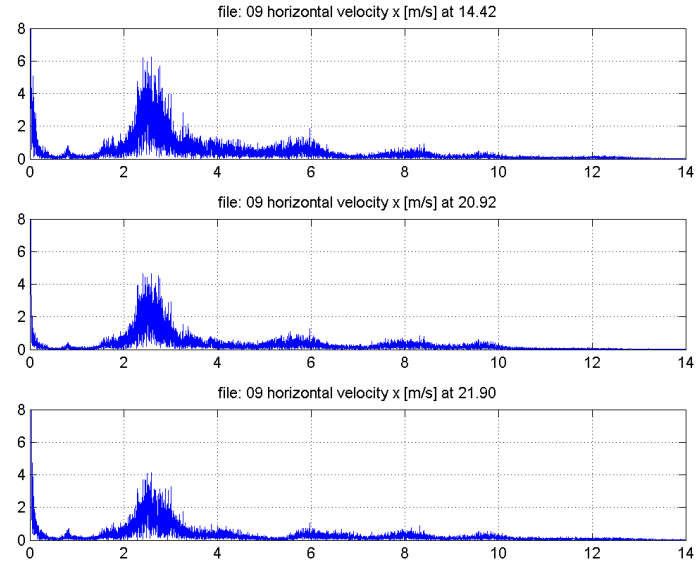
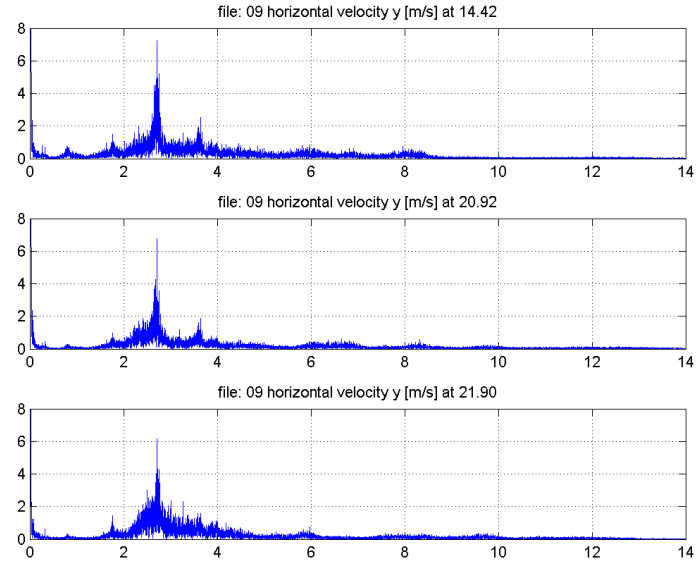
*Figure 13 Measurement 09, horizontal velocity in soil (frequency domain)*

Three transducers in the soil measure horizontal accelerations. These are integrated to velocity and presented in this section. Again measurement 09 is considered. Figure 13 shows the results in the frequency domain.

The figures show a similar pattern as the vertical vibrations (shown in Figure 11b at page 19). However, the horizontal vibrations show less damping with distance for the frequencies under say 5 Hz.

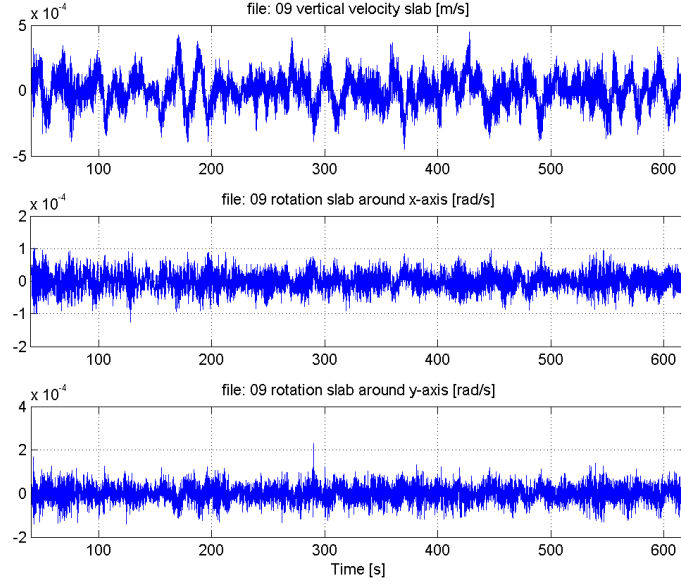
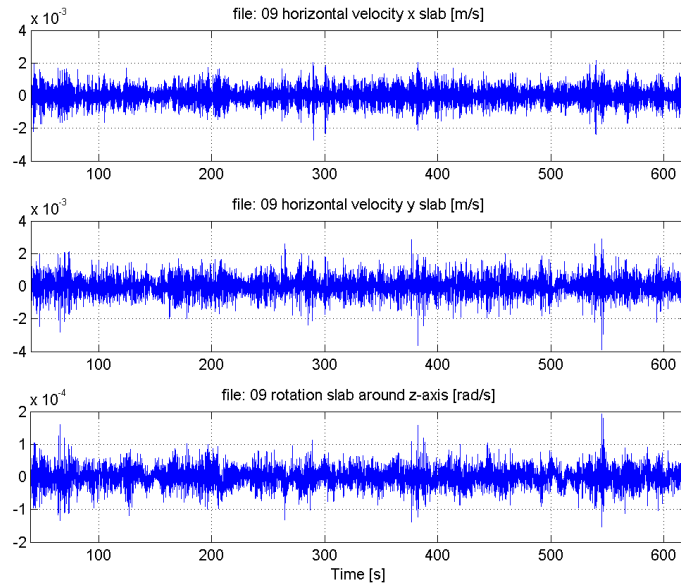
*Figure 14 Measurement 09, slab motion in time domain from the vertical vibrations*

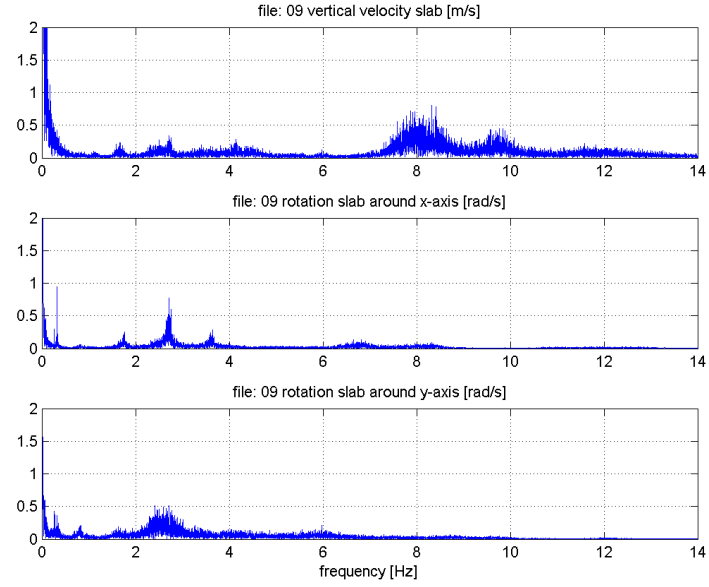
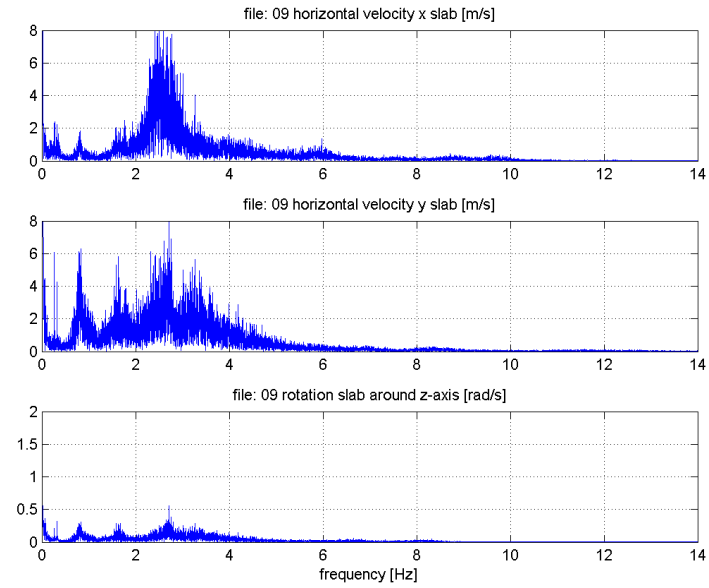
*Figure 15 Slab motion in frequency domain from the measured vibrations, measurement 09,*

In order to evaluate the difference between displacement and velocity, I study the integration to displacement further for a limited frequency band. Measurement 9 is chosen, the horizontal slab motions are studied. These signals are shown in the two upper graphs in Figure 15b.

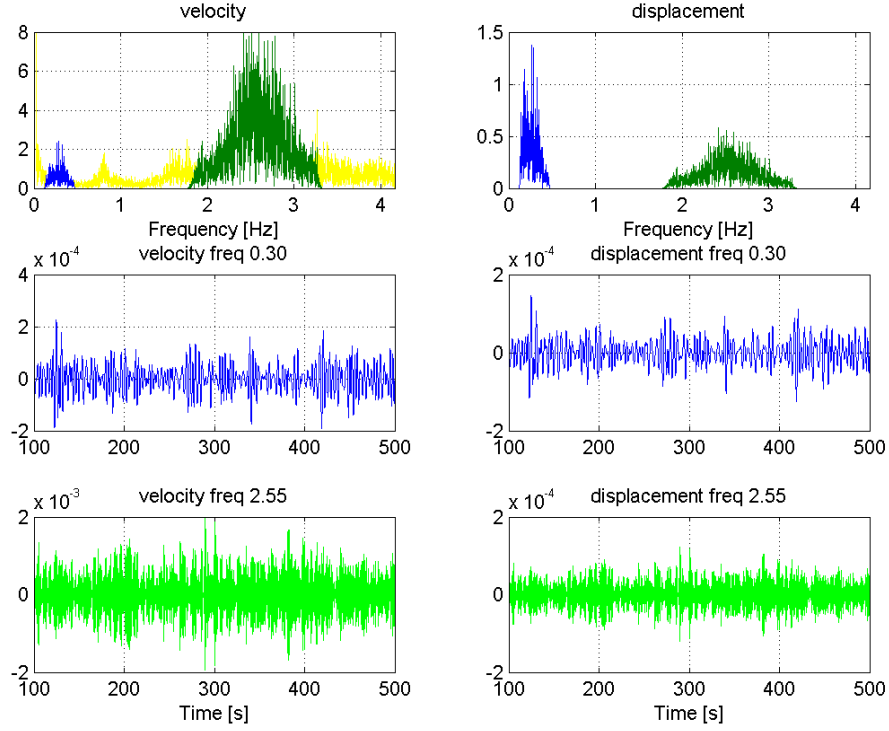
Figure 16 Measurement 9, horizontal motion of slab in  $x$ -direction, considered in limited frequency bands

Figure 16 shows the results for the two frequency bands of interest. It is interesting to note that in both frequency bands the displacement and the velocity are more or less equal. The calculated forces in these two bands are quite different. This means at least that the response at the low frequency is determined by stiffness

and the response at the high frequency is determined by impedance, or the system behavior is strongly frequency dependent.
