Effect of plastic deformation on the hydrogen embrittlement of ferritic high strength steel

npj Materials Degradation

The effect of hydrogen charging during plastic deformation was investigated on a ferritic steel containing TiC nano-precipitates. Specimens were subjected to a slow strain rate tensile test (SSRT) up to 0, 1, or 3% plastic engineering strain, held until a total duration of 2 h to saturate with hydrogen, then fast fractured. The specimens pre-strained elastically absorbed 2.36 wppm of hydrogen, which increased to 3.69 wppm for 3% plastic strain. Only 0.72 wppm is stored in non-dislocation traps such as precipitates, grain boundaries, and lattice sites, which makes dislocations the main contributor to hydrogen trapping. The increased hydrogen uptake did not lead to a decrease in fracture strain, which remained between 6 and 10% for all pre-strains, compared to 60% for full SSRT tests that were charged for a shorter time. This research highlights the necessity of high plastic strains and the presence of hydrogen in the environment during crack growth to cause HE in ductile steels.

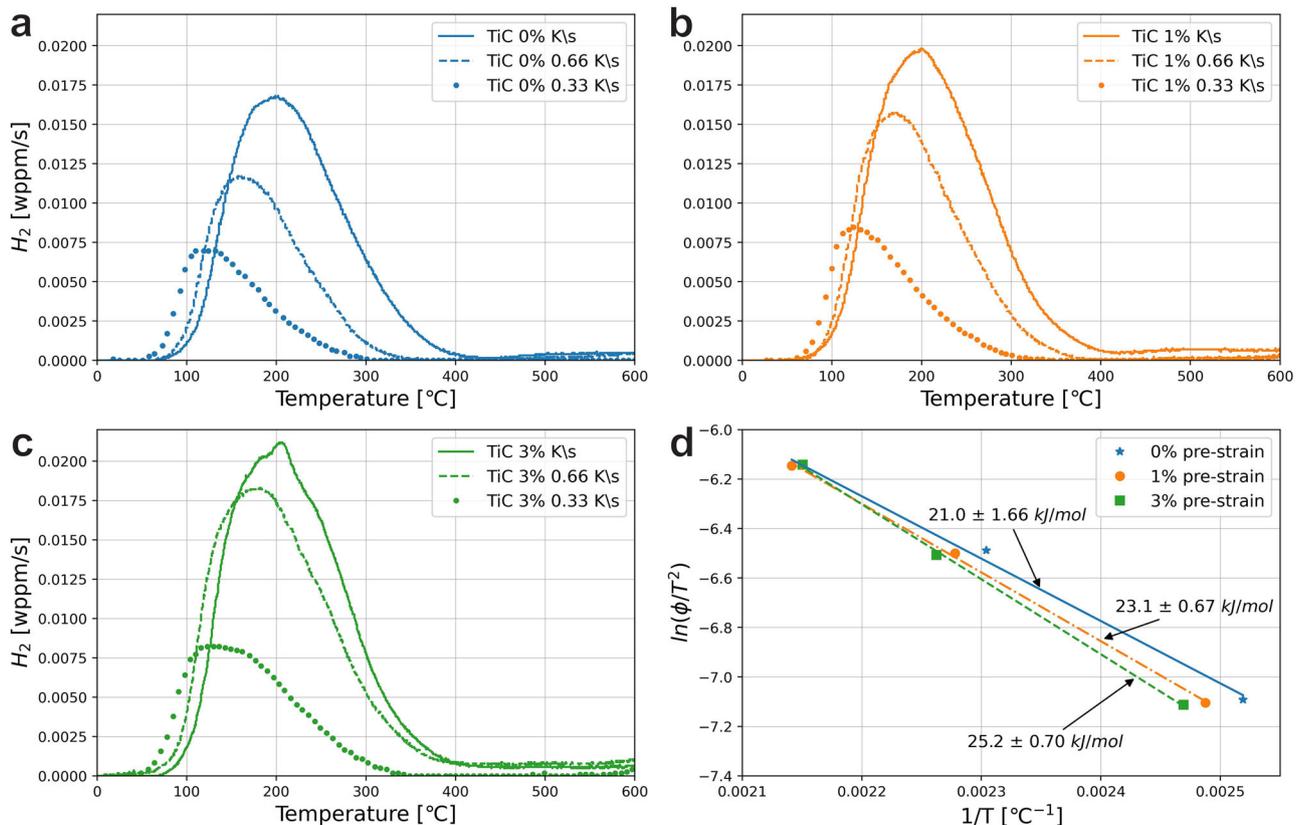
Fig. 1 | Hydrogen desorption and Kissinger curves. a 0%, **b** 1%, and **c** 3% plastic strain as well as **d** the Kissinger plot of the activation energies E_A for all pre-strains.

Table 1 contains an overview of the amount of absorbed hydrogen in each specimen after the charging and holding time of 2 h. The amount of H absorbed by the unstrained benchmark specimens was measured in our previous research under identical charging conditions and was found to be 2.18 ± 0.28 wppm³⁶. It should be noted that the incoherent precipitates that are also present in the steel trap hydrogen in stronger sites that show desorption peaks at higher temperatures. These were, however, shown not to be further charged by the method of charging in this work, and they do not influence the mechanical behaviour of the steel^{11,26}. Higher temperatures were therefore left out of the TDS measurements for this work. The hydrogen content found for the 0% pre-strained specimens is 2.36 ± 0.17 wppm, which is within the spread of that of the benchmarks. In contrast, the absorbed hydrogen content rises significantly upon the application of plastic pre-strain. The 1% and 3% plastically pre-strained specimens were found to absorb 3.00 ± 0.11 and 3.69 ± 0.26 wppm, respectively. The differences in hydrogen absorption between elastic and plastic pre-strain show the relative importance of dislocations as hydrogen trapping sites. The desorption curves for all specimens have been shown in Fig. 1. Skewed Gaussian peaks were fit to the measurement data represented in the figure, of which the maximum peak temperatures were used to calculate the activation energy of desorbed hydrogen in the peak. Table 1 shows them to be 21.0, 23.1, and 25.2 kJ/mol for increasing plastic pre-strain. The activation energy increases with plastic strain, but the extra hydrogen that is absorbed is stored in the same type of trap, namely the dislocation. Since trap occupancy in dislocations increases significantly, the increase in calculated activation energy can be understood to be an effect of re-trapping of

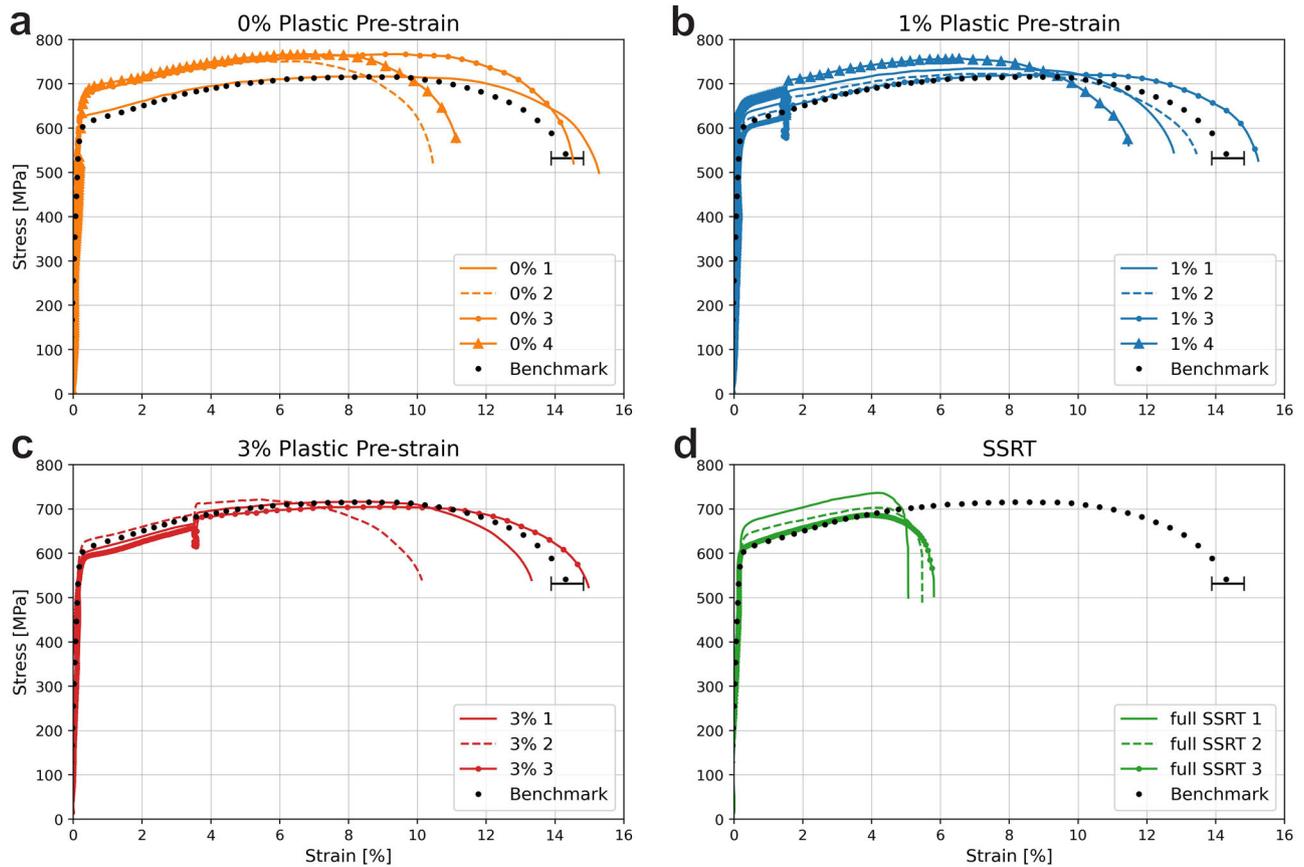
Fig. 2 | Strain curves for all specimens. a 0%, b 1%, and c 3% pre-strain, and d full SSRT curves. All tests except for benchmarks were performed during hydrogen charging. The error bar for the benchmark tests indicates the standard deviation of the final fracture strain.

Observing the mechanical behaviour in Fig. 2, it is evident that the increase in hydrogen uptake with increasing plastic pre-strain is not directly related to earlier final fracture. A trend is visible in the tensile curves, showing that, regardless of the amount of pre-strain, most tensile samples are not significantly more brittle than the uncharged benchmarks. Some individual samples are embrittled, but the degree of embrittlement is similar between specimens with different amounts of pre-strain or hydrogen uptake. The average HEI for the specimens was calculated to be 9.2%, 6.6%, and 9.5% for the 0%, 1%, and 3% pre-strained specimens, respectively. On the other hand, the SSRT specimens are consistently embrittled and fail around a strain of 5% even though they have been exposed to the charging environment for approximately 1 h, which is their time to fracture. A fractured SSRT specimen was measured in the TDS shortly after fracture and was found to have a hydrogen content of 3.48 wppm, which is within the spread of samples strained to only 3% after 2 h of charging. It therefore

seems to have absorbed hydrogen more quickly. However, the strain after fracture is not homogeneous, so hydrogen is most likely segregated to regions of high ductility. Therefore, no conclusive quantitative statements can be made about the hydrogen concentration in the fracture specimen. The SSRT specimens are severely embrittled and have an HEI of 60%.

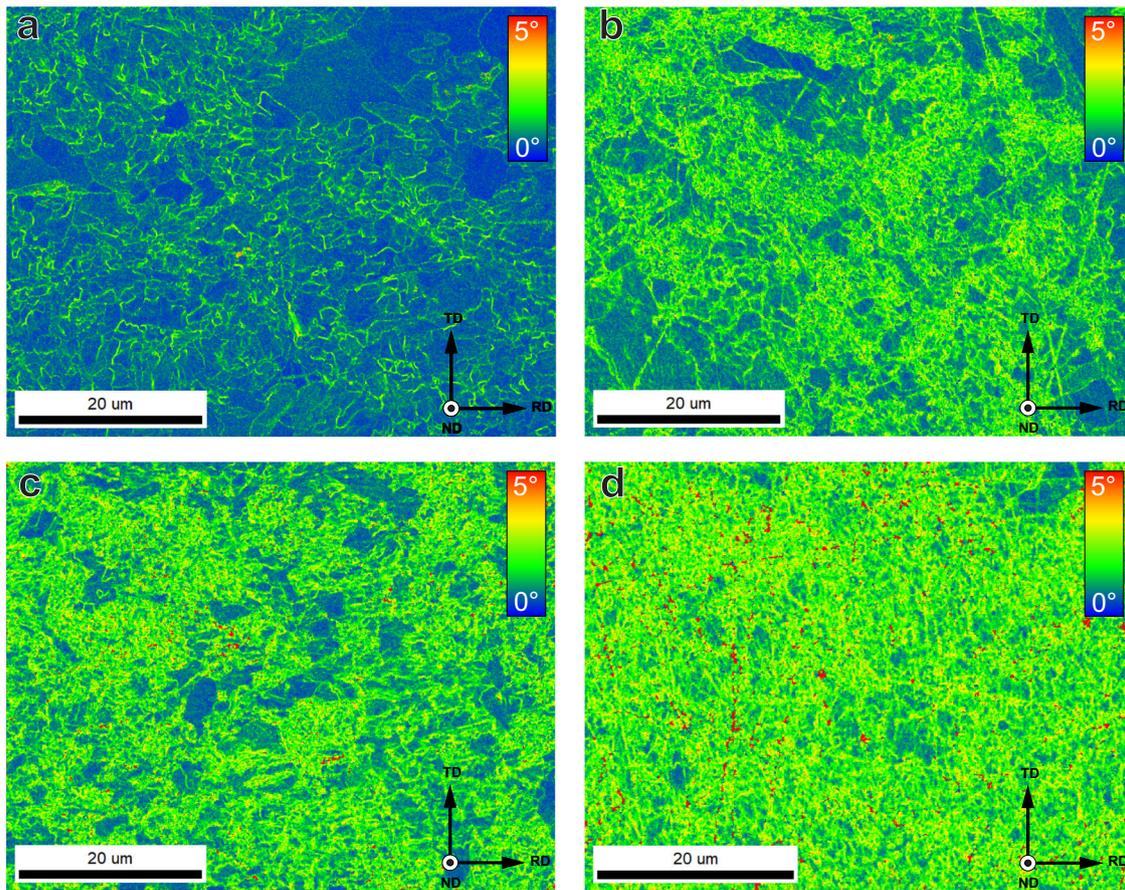
Fig. 3 | Kernel average misorientation maps. Specimens strained at **a** 0%, **b** 1%, **c** 3% plastic strain, and **d** in the necked area of a fractured SSRT sample.

Other than hydrogen content, for specimens at pre-strains of 0, 1, and 3%, the dislocation densities were determined through XRD and the KAM through EBSD. The necking area of an SSRT specimen was also characterised for both to provide data for the microstructure near the fracture in hydrogen. The results are shown in Table 2 and an overview of the KAM measurements is shown in Fig. 3. Although KAM measurements only include information on the density of Geometrically Necessary Dislocations (GNDs), and measurements from XRD also include Statistically Stored Dislocations (SSDs), the relative number of GNDs has been shown to constitute the majority of all dislocations up to the point of necking under tensile loading conditions³⁷. The two techniques can therefore be used comparatively in this strain regime. Since the dislocation density is never zero, the specimen strained below the yield point already has a dislocation density of $1.8 \pm 0.3 \cdot 10^{14}m^{-2}$, which corresponds to an average KAM of 0.6° . Both values increase with strain, where the largest relative increase is found between 0 and 1% plastic strain. The maximum is found in the necking area where the dislocation density is $4.4 \pm 0.7 \cdot 10^{14}m^{-2}$ and the average KAM is 1.4° . It should be noted that the XRD is a macroscopic characterisation technique with an analysed surface area of roughly 1 cm^2 . Since the necked region has strain heterogeneities, the measurement for the SSRT specimen therefore has a larger error than the other dislocation densities. The KAM measurement is much more localised and was therefore taken in an area close to the fracture surface. This, as such, gives a

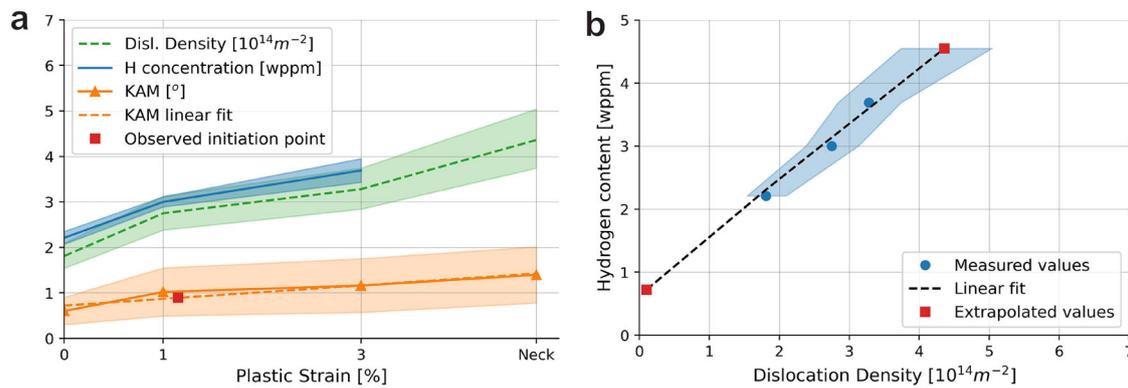
Fig. 4 | Correlations between dislocation density, hydrogen content, and kernel average misorientation. **a** The hydrogen content, dislocation density, and KAM as a function of the amount of Plastic Strain. Data for the ‘Neck’ point on the x-axis was obtained on a necked area of an SSRT specimen. The average KAM value underneath

brittle crack surfaces was indicated as the ‘Observed initiation point’. **b** The H content as a function of the Dislocation Density with extrapolated data for the ideal case of no dislocations, as well as the H content in the necked area of an SSRT specimen.

In this work, we attempt to quantify deformation of the microstructure by plotting the dislocation density, KAM values, and the hydrogen content as a function of plastic strain. Through measuring all three on specimens with known homogeneous macroscopic plastic strains for 0, 1, and 3%, a relation between them is established, and the effect of dislocations can be isolated. Figure 4a shows a graphical overview of the dislocation density, the KAM,

and the hydrogen content of the specimens as a function of the plastic strain. The amount of plastic strain for the SSRT specimen is denoted as “Neck”, for which the location on the axis was determined as 4.8% by fitting it to the KAM measurements obtained for that area. Upon plastic straining, the amount of hydrogen traps increases in the form of newly generated dislocations. Figure 4b shows the hydrogen content as a function of the dislocation density to illustrate this effect. The data closely follows a linear regression, which has been extrapolated to both the average dislocation density in the neck region as well as a theoretical density of 0 for a dislocation-free polycrystal. The hydrogen content in the most deformed

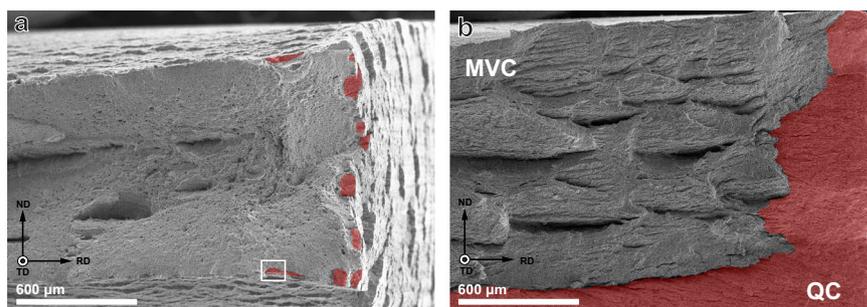
Fig. 5 | Fractographic overviews. Specimens **a** 3% and **b** SSRT, where brittle quasi-cleavage (QC) crack-initiated zones are indicated in red and microvoid coalescence (MVC) regions remain unmarked.

higher hydrogen content than what is required to cause fracture, given that the plastic deformation is kept below a certain limit, in this case approximately 5%. This raises the question, however, of what happens at this level of deformation to cause the sudden fracture of the specimen. The fracture surfaces of post-mortem specimens can indicate the progression of a crack in the specimen. Figure 5a, b shows the fracture surfaces of the 3% 2 specimen and an SSRT specimen, respectively. As is also frequently observed in literature, brittle fracture initiation zones were discovered around the edges that were exposed to the hydrogen environment^{27,28,38–40}. These zones correspond to the macroscopically brittle quasi-cleavage (QC) fracture mode and are indicated in red. The length of the brittle crack initiation zone corresponds to the width of the QC fracture zone on the fracture surface. This was measured to be between 30 and 50 μm for the pre-strained specimens, and it was found to be independent of the degree of plastic pre-straining. The SSRT specimens on the other hand, show a brittle zone of up to 500 μm, as can be seen in Fig. 5b. The fracture surface outside the brittle zones shown microvoid coalescence (MVC) type fracture that forms when the crack growth speed is too high to allow for continuous hydrogen diffusion to the crack tip. This can therefore only be formed during the fast fracture stage of the test. Since brittle fracture initiation occurs even in the 3% specimens, this is not the cause of failure that happens in the SSRT specimens. A higher magnification overview of the transition zone from QC to MVC fracture in a 3% specimen is given in Fig. 6.

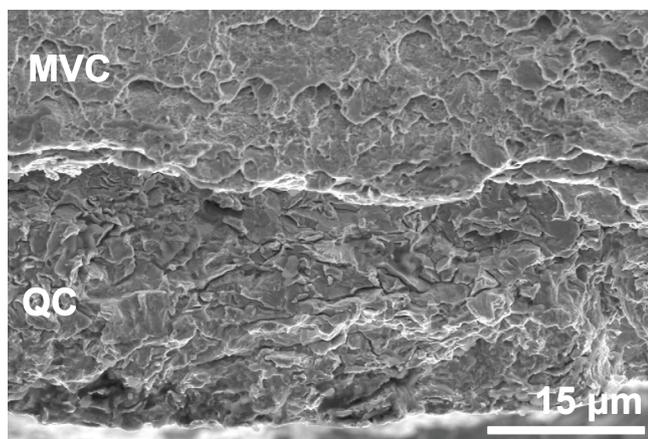
Fig. 6 | Close-up fracture surface. Transition zone from quasi-cleavage (QC) to microvoid coalescence (MVC) fracture in a 3% specimen, taken from the area indicated in Fig. 5a.

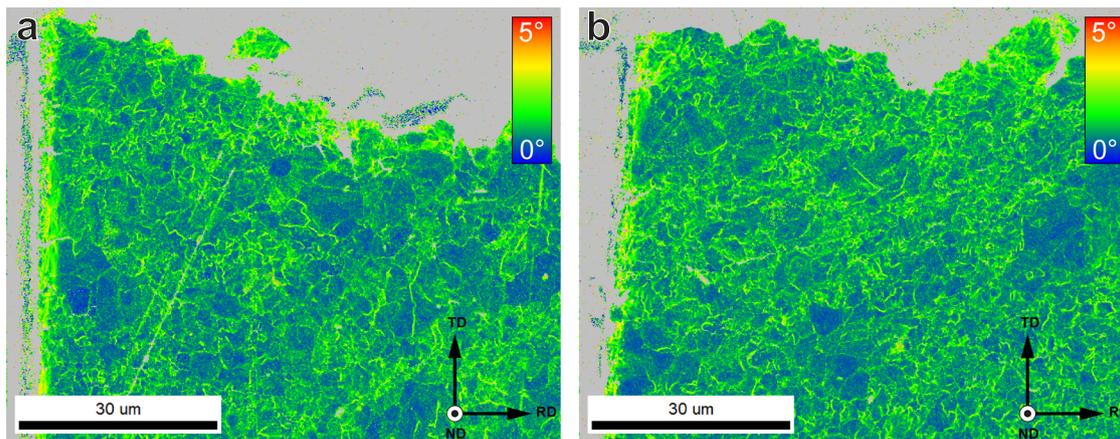
Fig. 7 | Post-mortem kernel average misorientation maps. Areas below a brittle initiation point on the fracture surface of **a** 0% and **b** SSRT specimens. Grey pixels were not included in the KAM measurement.

To find out at what point brittle initiation occurs, EBSD measurements were performed on cross-sections of selected specimens post-mortem. KAM maps of the sub-fracture surface microstructure beneath the brittle initiation zone were obtained. Figure 7a, b show two examples of these KAM maps. Figure 7b corresponds to the same sample shown in Fig. 5b, while 7a was taken from a 0% specimen exhibiting clear crack initiation on one side, providing a good study case to observe the amount of deformation required for brittle crack initiation. The average KAM values calculated beneath the crack surface are $0.89 \pm 0.47^\circ$. This point is indicated in Fig. 4a to belong to a plastic deformation of just over 1% if fit to the regression. This value itself, however, is markedly below that of 1.02° obtained for a homogeneous plastic strain of 1%. This indicates that first crack initiation in the tests takes place early on during the deformation, when a homogeneous strain of 1% is reached. Evidently, these cracks do not propagate in the 3% specimens, but do in the SSRT specimens, where they grow large enough to cause macroscopic fracture.

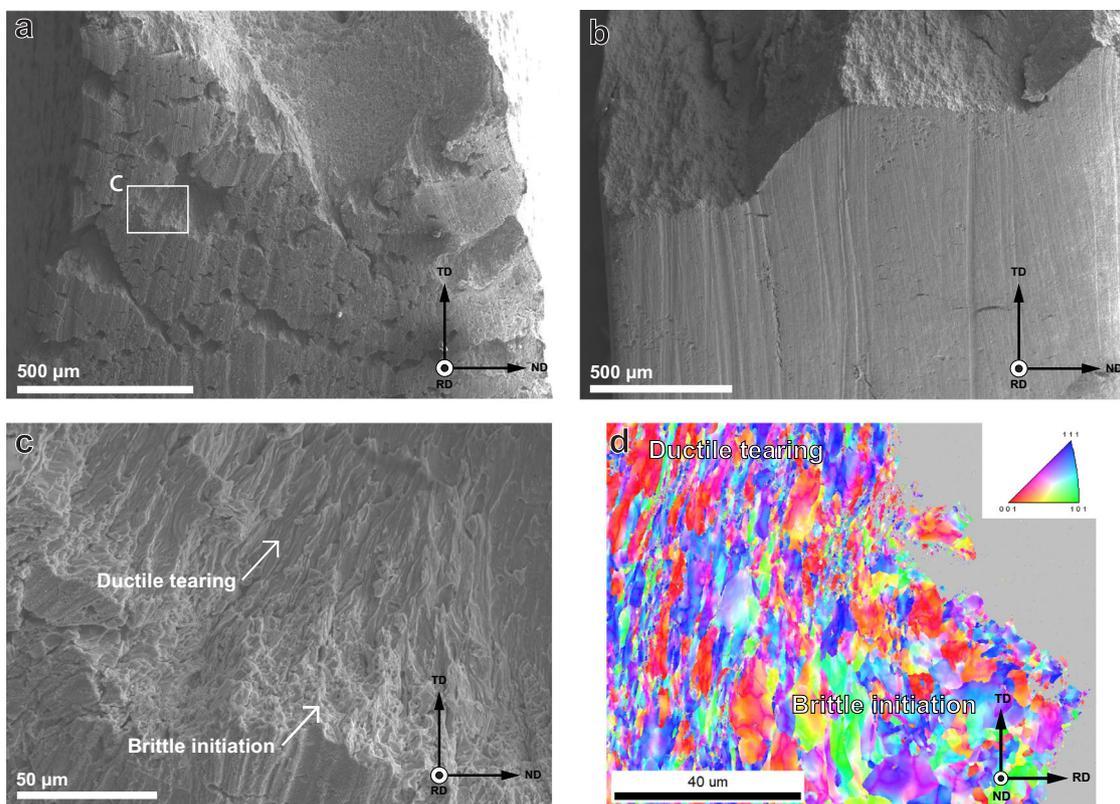
Fig. 8 | Tilted side views of post-mortem specimens. 45° tilted specimens **a** 3% and **b** SSRT. **c** shows a zoomed-in section of a crack in **(a)** to highlight the transition from brittle to ductile fracture. An Inverted Pole Figure (IPF) map of the cross-section of a similar transition is shown in **(d)**, where the start of plastic deformation can be observed.

This finding is supported by Fig. 8a, b, which show the sides of the 3% 2 specimen and a SSRT specimen, respectively. The 3% pre-strained specimen shows a high amount of secondary cracks on the side surface, with significant crack mouth opening. In the SSRT specimen, on the other hand, the fracture is entirely localised to a single crack. Some secondary cracks can be observed, but they have not been opened. The opening of the secondary cracks in the 3% specimen is shown at a higher magnification in Fig. 8c. Here, the crack clearly displays a brittle fracture initiation zone that transitions into a region of ductile tearing. This is supported by an IPF map obtained from EBSD, shown in Fig. 8d, which shows the contrast between the relatively equiaxed grains beneath the brittle surface and the heavily deformed grains in the plastic region. These findings indicate that brittle cracks initiate at several locations during either the straining or hold time of the 3% specimen, but they arrest and are only opened during the further

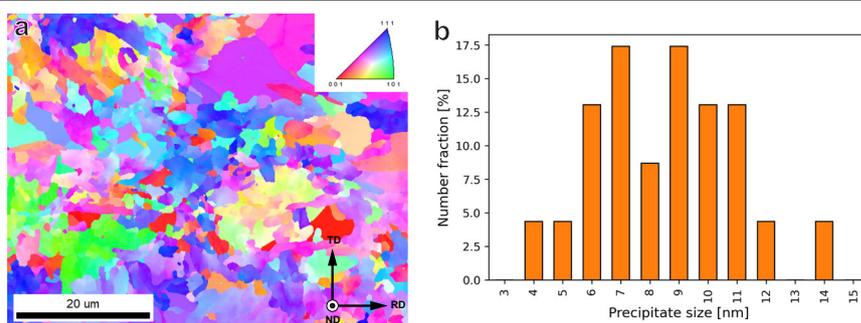
Fig. 9 | Overview of microstructure and precipitate sizes. a An IPF map of the microstructure of the undeformed steel, and b a histogram showing the distribution of semi-coherent precipitate sizes.

The steel used in this research was cast by Tata Steel in IJmuiden. The composition was measured on a PANalytical Axios Max Wavelength Dispersive X-ray fluorescence (WDXRF) instrument and is shown in Table 3. This composition was chosen to obtain a ferritic microstructure with finely dispersed TiC nano-precipitates for which the atomic ratio of Ti:C was kept as close to 1:1 as possible. The steel was heat treated by the same process as used in our previous work¹¹, which consists of a heat treatment in pure N₂ at 700 °C for 2 h. This time excludes a warm-up at 5 °C/min and a cooling-down that was furnace-limited at approximately 1 °C/min. Before the heat treatment, each specimen was sanded to a P1000 grit finish. The resulting microstructure can be observed in Fig. 9a, and b shows the histogram of precipitate sizes measured using TEM. The average grain area is $3.8 \mu\text{m}^2$, but extremes can be found on both the low and high ends. The sizes were therefore chosen to be listed in Table 4 according to the ASTM E1181 standard for randomly distributed grain sizes of a large range, the total range of observed grain areas was between 0.1 and $160 \mu\text{m}^2$.

Precipitate sizes ($\sqrt{\text{length} \cdot \text{width}}$) and spacings were obtained using transmission electron microscopy (TEM)¹¹, and are also listed in Table 4 by the same standard. Over 100 precipitates were measured manually on a Thermo Fisher Scientific™ Cs corrected cubed Titan™ TEM. The critical size for TiC precipitates to lose coherency with the iron matrix is 4.2 nm, which means that with an average size of 8.6 nm and an average spacing of 44 nm, virtually all precipitates in the steel are semi-coherent with the matrix²⁴. Larger precipitates with sizes of >100 nm were also observed, but they are much more sparse, with an average spacing of $3 \pm 2 \mu\text{m}$. These were previously shown not to have any effect on fracture, even when charged with hydrogen¹¹. The largest precipitate observed was 290 nm in size.

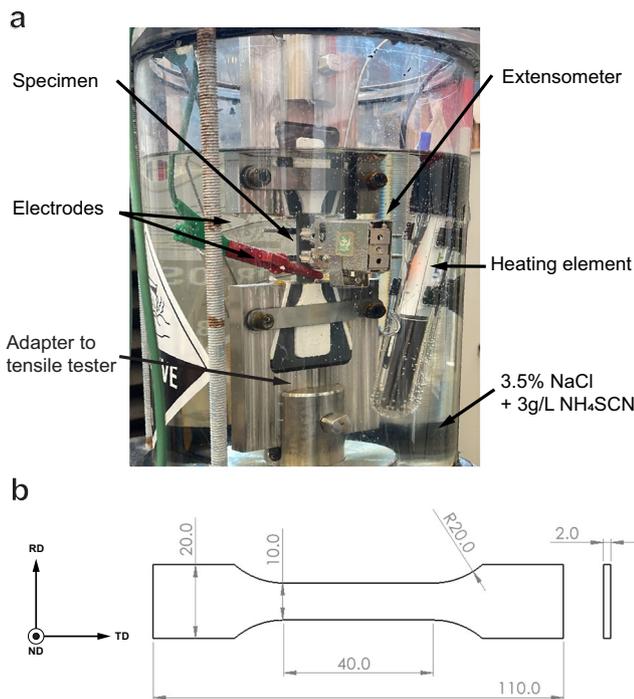
Fig. 10 | Overview of test equipment. **a** Overview of the in-situ hydrogen setup used for tensile testing and **b** the dimensions (in mm) of the tensile specimen geometry used in this study. Adapted from ref. 26.

All tests performed for this research were conducted in a custom-designed setup to allow for in-situ hydrogen charging during tensile loading. The setup and specimen geometry are shown in Fig. 10. The specimens are submerged in a 3.5% NaCl + 3 g/L ammonium thiocyanate (NH₄SCN) solution for the duration of the test to allow for hydrogen charging. The charging is

performed galvanostatically with a current density of 1 mA/cm² for the entire duration of the test. A heating element is used to keep the basin at a constant temperature of 25 °C. Before testing, each specimen is sanded up to P1200 grit for a repeatable surface finish. The test itself consists of three steps, which are displayed in Fig. 11. The first step is a slow strain rate tensile (SSRT) test at a rate of $4 \cdot 10^{-5} \text{ s}^{-1}$ up to a pre-determined level of either stress or strain. The crosshead position is then put on hold while charging is continued until the total test duration reaches 2 h, which was calculated as the saturation time for hydrogen charging of this steel in our previous work²⁶. Finally, the specimen is subjected to a faster crosshead displacement of 10 mm/min until fracture, which corresponds to a strain rate of $4.2 \cdot 10^{-3} \text{ s}^{-1}$. This is done to avoid additional hydrogen entry into the steel during the fracture phase of the tests, as well as to minimise the role of hydrogen diffusion during the fracture step. Any influence of hydrogen is thereby isolated to hydrogen absorbed during the first two steps of the test. The three threshold levels chosen were 0%, 1%, and 3% plastic strain, where 0% was set to 80% of the 0.2% proof yield strength of the uncharged specimens taken from previous research²⁶. Some specimens were subjected to a one step SSRT tests which consisted of a strain rate of $4 \cdot 10^{-5} \text{ s}^{-1}$ until fracture, which have been designated as SSRT. Other than that, benchmark specimens were tested at a similar strain rate without any hydrogen charging. The extent of HE was calculated using the fracture strains as per Equation (1) and listed as the Hydrogen Embrittlement Index (HEI). Here ϵ_f^{Air} and $\epsilon_f^{\text{H}_2}$ designate the fracture strains of uncharged benchmark SSRT specimens and hydrogen-charged specimens, respectively. Immediately after fracture of each specimen, both fractured halves were removed, rinsed with demineralised water, dried with compressed air, and cleaned in the ultrasonic bath in isopropanol for 5 min. All tests were performed using a Zwick Z-100 universal tensile tester, and hydrogen charging was performed using a Bio-Logic VSP-300 potentiostat. Strain was measured using a submersible Epsilon 4030 extensometer.

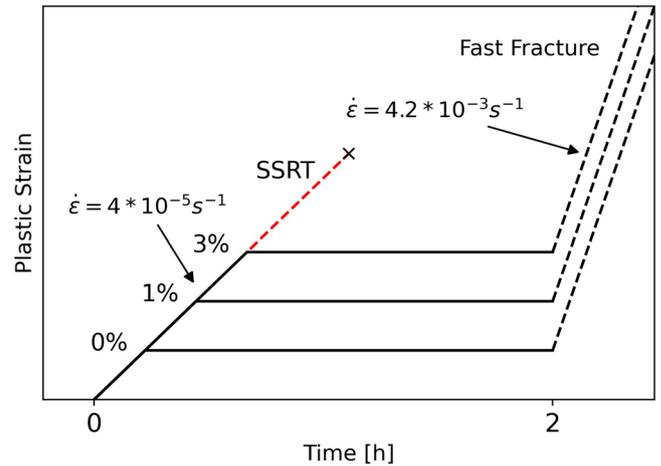
Fig. 11 | Overview of the test procedure. The entire test is performed during hydrogen charging, axes are not to scale.
