## **Recommendation of RILEM TC 243-SGM: Functional Requirements for Surface Repair Mortars for Historic Buildings**

Surface repair mortars are used for the compensation, or repair, of lost portions of surface materials in historic masonry buildings. It is recommended that their design and application should be performed in a wider context of conservation values related decision making, to prioritise preservation of original fabric, authenticity of approach and maintenance of integrity, and not just on technical principles alone. However, a technical context for their design does exist, that requires understanding of the properties of the substrate that they will be applied onto, and adherence to minimum aesthetic (colour and texture) requirements. The principles of physical, mechanical and chemical compatibility of repair apply and the attributes of the repair mortar should be carefully matched to the substrate alongside a sacrificial behaviour (not more durable than the material being replaced). Guidance is given on the design, application and the functional requirements that must be met when using surface repair mortars.

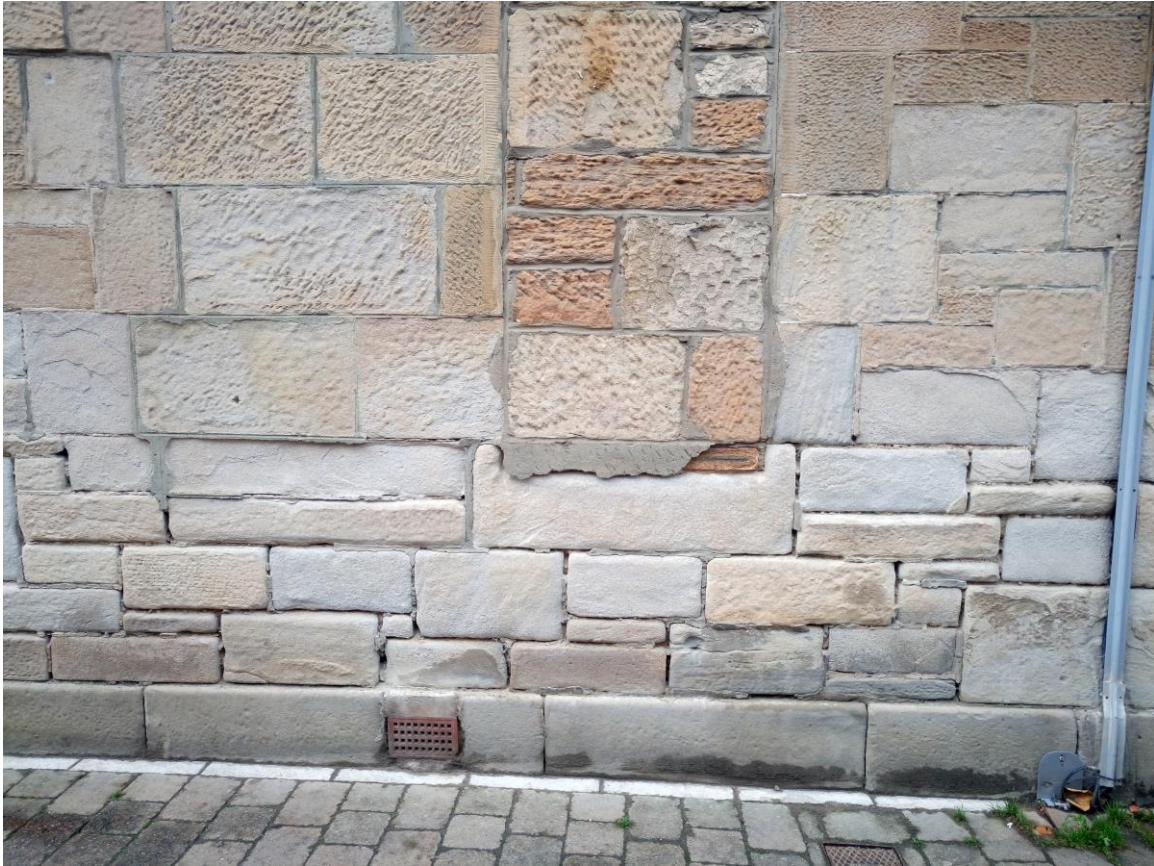
Figure 1: Advanced deterioration of a 19<sup>th</sup> century sandstone ashlar masonry façade in Bearsden, Scotland.

[10]. Fig. 1 shows the deterioration of an exposed sandstone façade; Fig. 2 shows an application of mortar to repair individual stone surfaces on a building in Glasgow.

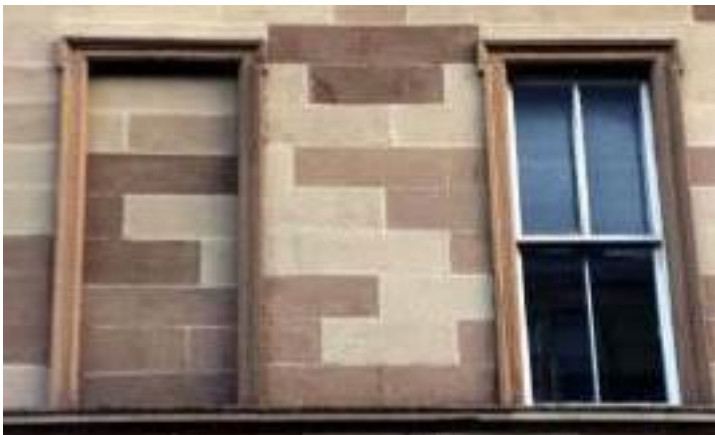
Figure 2: Example of mortar application (light parts) as a mortar repair of deteriorated stone units in Glasgow, Scotland.
