Section at middle of the 400 meter ice rink building. 1:50

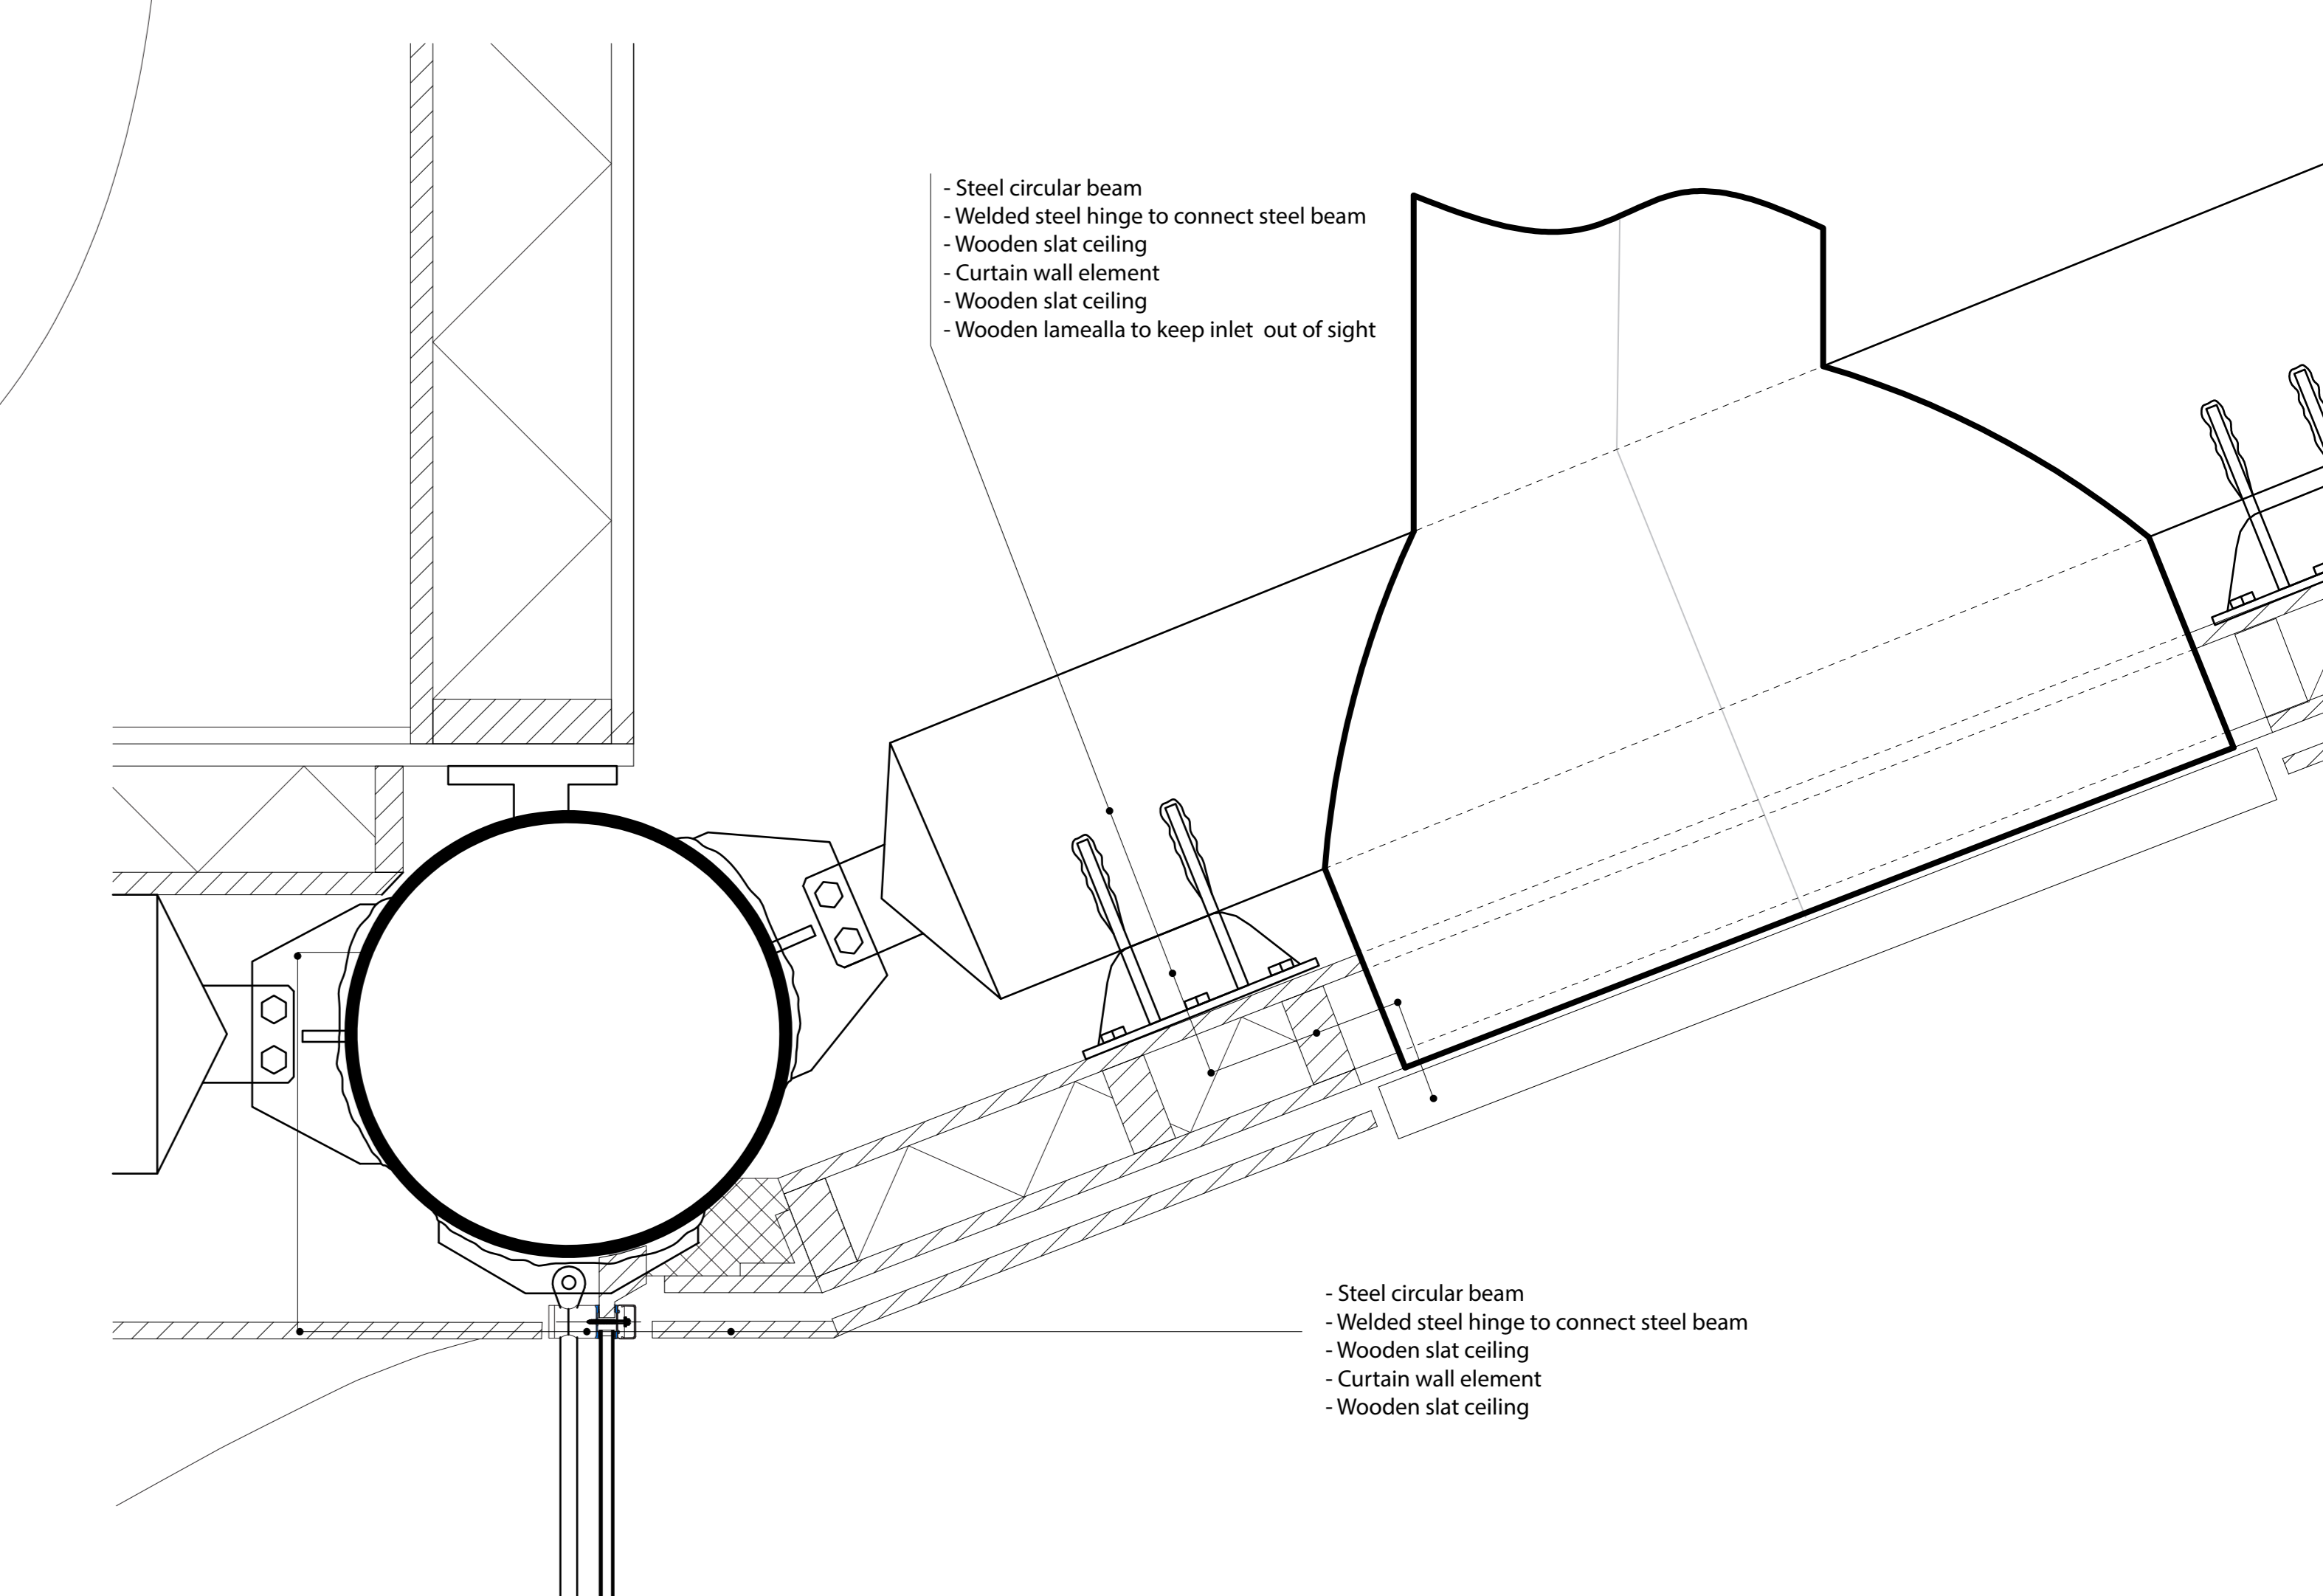
Detail 4: The tension rod meeting the circular steel beam, including a ventilation shaft, which is going to the airconditioning unit. 1:10
