## Investigation of the remaining life of an immersed tube tunnel in The Netherlands

**ABSTRACT:** In this paper we present issues related to the performance of immersed tube tunnels in the Netherlands. A range of issues are experienced for the ageing structures including long-term settlement at tunnel joints and consequent leakage. Because of the age of these structures some important aspects are often unknown thus creating uncertainty regarding remediation measures. Having discussed general issues the paper presents a case study of the Kil Tunnel which has experienced relatively large settlements over the past 40 years. In this case a lack of geotechnical engineering information for the soils below the tunnel was identified. A geophysical survey was undertaken and this provided key insights into the ground conditions at the tunnel site.

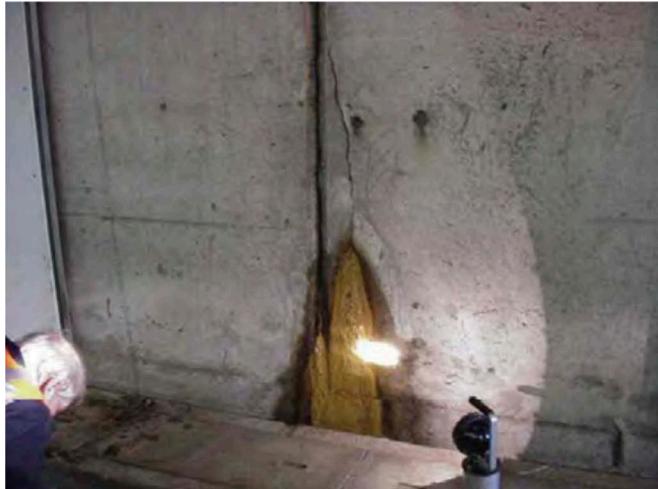
Figure 3. Cracking at segment joint.

Due to the age and total design life of the tunnel a major remediation programme is imminent. Given the significant and ongoing settlement it is important for the tunnel owner to understand the mechanism driving this behaviour and, having established this, to determine if remedial action should be undertaken as part of the tunnel refurbishment. The Geo-Engineering Section at TU Delft and Rijkswaterstaat are lead partners in the EU Horizon 2020 SAFE-10-T investigating ongoing settlements at the nearby Heineoord tunnel. The Dutch knowledge institute for underground space, Centrum Ondergronds Bouwen (COB) and the owners of the Kil Tunnel requested that this tunnel be included as an additional case study location in the project. Whilst a reasonably comprehensive ground investigation (in terms of number of locations) was conducted for the original construction, a review of the available data that comprised Cone Penetration (CPT) testing revealed that for the immersed tube section of the tunnel (Elements 1 to 3), very limited data was available for the soil immediately below the base of the tunnel. As a result, a geophysical investigation was planned in conjunction with SAFE-10-T partner the University of Zagreb to provide insight into the mechanisms controlling the settlement of Kil Tunnel.

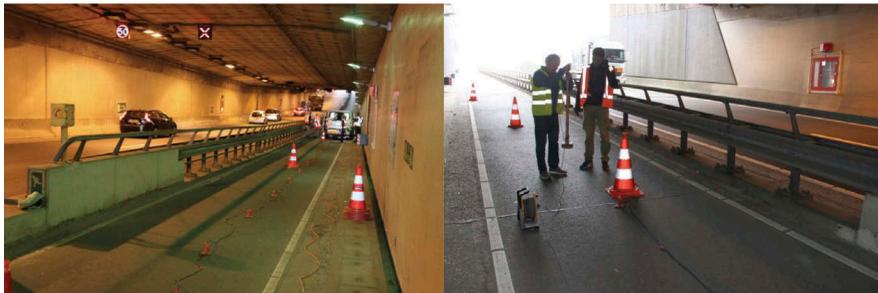
Whilst some embedment of the geophone in soils is necessary to ensure good contact, on road and concrete surfaces this is not possible and contact was ensured using a steel plates as shown in Figure 4a. A 6 kg sledgehammer was used to generate the surface waves which were in turn detected by 40 No. 10 Hz geophones placed at 2.5m centres, See Figure 4a. The source was located at the mid-point of the geophones, See Figure 4b. Data was recorded with a Smartsystem data logger at a sampling rate of 0.5 msec.

Figure 4. (a) Site test set-up (b) Test underway.
