## Morphodynamic trends of the Ribb River, Ethiopia, prior to dam construction

Geosciences (Switzerland)

# Morphodynamic Trends of the Ribb River, Ethiopia, Prior to Dam Construction

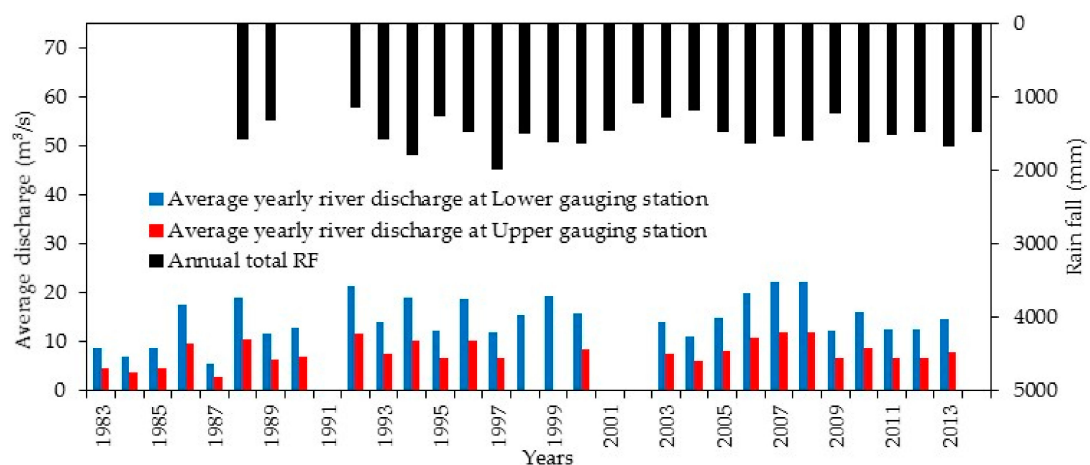
**Figure 2.** Yearly rainfall from the year 1988 to 2014 and average Ribb River discharges from the year 1983 to 2013 for the Lower and Upper gauging stations. The graph does not show any increasing or decreasing trends. Data source: National Meteorological Agency and Ministry of Water, Irrigation and Energy, Ethiopia.

The average annual maximum temperature in the upper part of the Ribb River basin is 27 °C, while the minimum falls below 0 °C in December (Debre Tabor meteorological station). The temperature increases near Lake Tana, where the average annual maximum and minimum values become 35 and 11 °C, respectively (Addis Zemen meteorological station). The Ribb River flow depends mainly on rainfall. The catchment receives a yearly rainfall of 1300 mm (data from the period 1988–2015), of which 80% occurs between the months of June and September. The annual rainfall at Debre Tabor meteorological station, assumed here representative for the Ribb basin, does not show any increasing or decreasing trends in the last three decades (Figure 2), although there are considerable

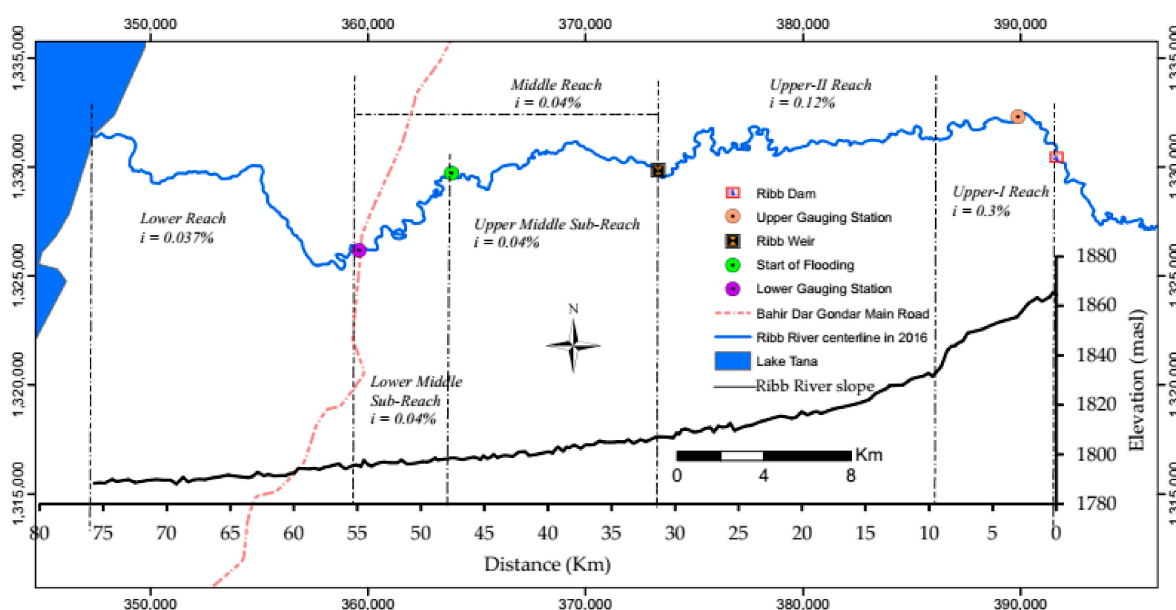
**Figure 3.** Ribb River study reach, sub-reaches and riverbed profile from the dam site to Lake Tana. The river alignment is derived from Google Earth images of 2016. The slope is obtained from 30 m resolution Digital Elevation Models (DEM) of Advanced Spaceborne Thermal Emission and Reflection Radiometer (ASTER) satellite images of 2014.

The study river reach has a length of 77 km, starting at the Ribb Dam site to Lake Tana. This reach is here sub-divided into four parts: Upper-I, Upper-II, Middle and Lower reaches (Figure 3). The presence of riverbed fixation (rock outcrops and weir), the junction of major tributaries, the longitudinal slope, the channel width and the presence of anthropogenic interventions (sand mining, embankment construction and water extraction) are the basis of this sub-division.

The Middle reach (sub-divided in Upper Middle and Lower Middle) is 25 km long, from the weir site to the Ribb Bridge (Figure 3). The reach is sub-divided based on the existence of embankments for flood protection. The Upper Middle sub-reach is 15 km long and extends from the weir site to the start of the embankment, while the Lower Middle sub-reach forms the remaining 10 km where embankments are present. This part of the reach experiences flooding due to reduced channel conveyance capacity [23]. The Middle reaches have a relatively gentle slope of 0.04% and a sandy bed.

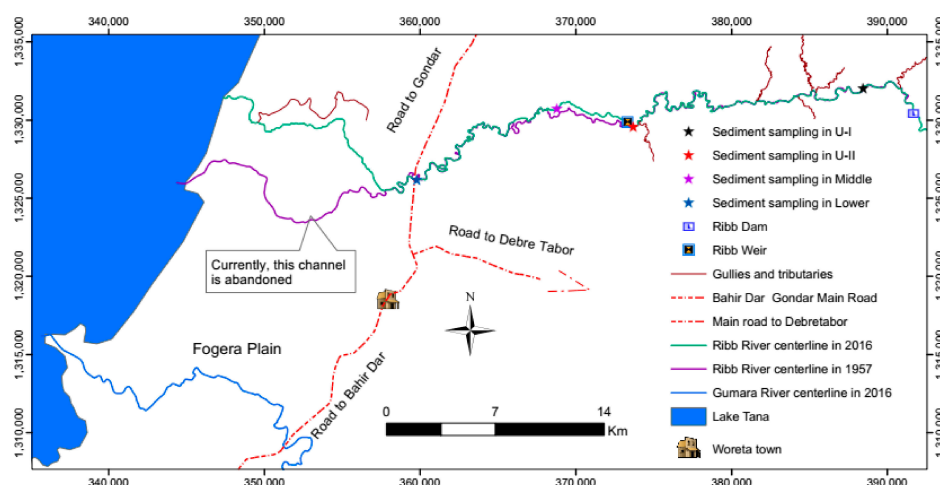
**Figure 4.** Ribb River alignments in 1957 and 2016 including gullies and tributaries and sediment sampling locations. The area between Lake Tana and the road to Gondar and Bahir Dar is part of the Fogera Plain, which is shared by the Ribb and the Gumara rivers.

The Lower reach is 20 km long, from the Ribb Bridge to Lake Tana. In the past, the river used to bifurcate 4 km downstream of the bridge (Figure 4). Since 2008, the old left channel has been completely silted up and serves as a dry-weather road. During flow peaks, however, the silted channel still conveys a small part of the flow to Lake Tana. Further downstream, the river loses its channel for a distance of 3.5 km (i.e., from 70.2 to 73.7 km from the Ribb Dam). Here, high-flow water spreads over the floodplain until it finds a well-defined channel again near a locality called Boled Gote. Farmers plant maize in the shallow river channel during the dry season, taking advantage of residual moisture (Figure 5). The river banks in the Middle and Lower reaches are made of compacted clay and silt materials.

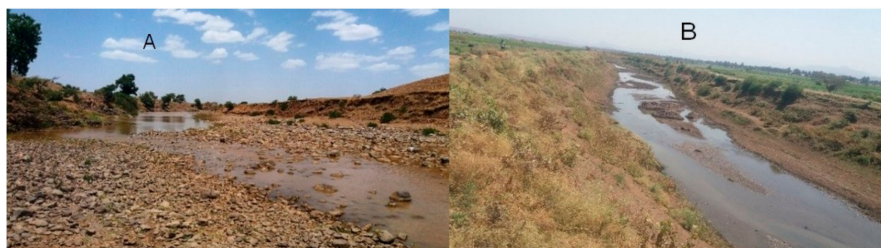
**Figure 6.** River bed and bank material in the Upper-I (A) and the Lower Middle (B) River reaches (March 2016).

The Ribb River channel has a meandering planform with sporadic central bars in the Upper-I reach where the channel is wider. Point bars inside river bends and alternate bars are observed in the Upper-II, Middle and Lower River reaches. Figure 6 shows the riverbed and banks in the Upper-I reach and Lower Middle sub-reach.

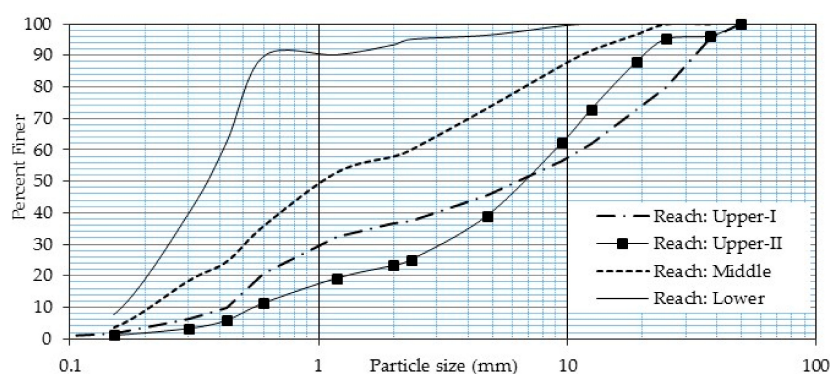
**Figure 7.** Grain size distribution of Ribb River bed material downstream of the Ribb Dam site, upstream and downstream of the weir site and upstream of the Ribb Bridge, at Universal Transverse Mercator (UTM) coordinates 37P 0388475, 1332080, 1872 m a.s.l.; 37P 0373692, 1329576, 1819 m a.s.l.; 37P 0368803, 1330762, 1804 m a.s.l. and 37P 0359808, 1326196, 1795 m a.s.l., respectively (Samples were collected in March 2016).

The granulometric curves of the bed material (Figure 7) show that the Ribb River sediment becomes finer in the downstream direction [13,24].

The riverbed near the dam site is dominated by a mixture of gravel (65%) and sand (35%). The bed material gradually changes to sand near the weir site (60% sand and 40% gravel). Further downstream, the riverbed is composed of 90% sand. The median grain size,  $D_{50}$ , is 7 mm in the Upper I and Upper II reaches and decreases to 0.65 mm in the Middle (the Upper and the Lower) reaches and 0.35 mm in the Lower reaches. Historical data on sediment grain size are lacking and this does not allow for assessing their temporal evolution.

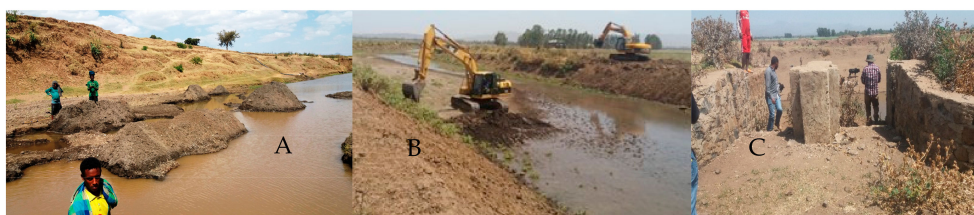
**Figure 8.** (A) excavated sand accumulation by sand miners in the Middle River reach; (B) river channel enlargement and deepening to increase flow conveyance. The contractor used the material for embankment construction at the Lower reach; (C) flood outlet structure to the farmlands as low height weir (April 2016).

The Ribb River has been subject to long years of sand mining (Figure 8A) and water extraction for irrigation during the dry season (Figure 9A). The prolonged sand mining activity in the Middle and Lower River reaches has clearly affected the natural riverbed topography. Sand miners extract sand from bar tops during low flow conditions, altering the shape and height of sand bars, as well as the sediment balance of the river. This activity has steadily increased in the last 30 years.

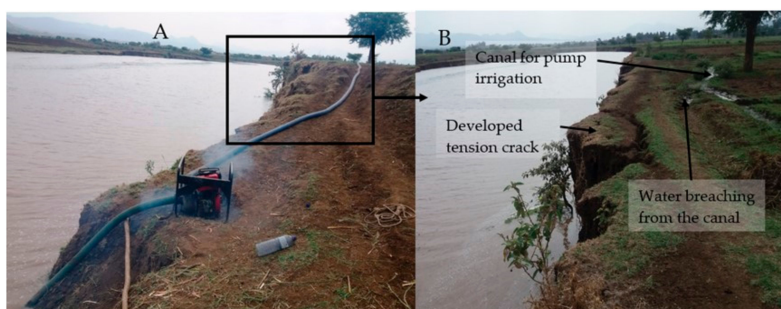
**Figure 9.** (A) water extraction with a diesel pump for irrigation; (B) irrigation canal to transport extracted water, which has been breached, and adjacent failing banks. The photos were taken immediately upstream of the under-construction Ribb weir in April 2017.

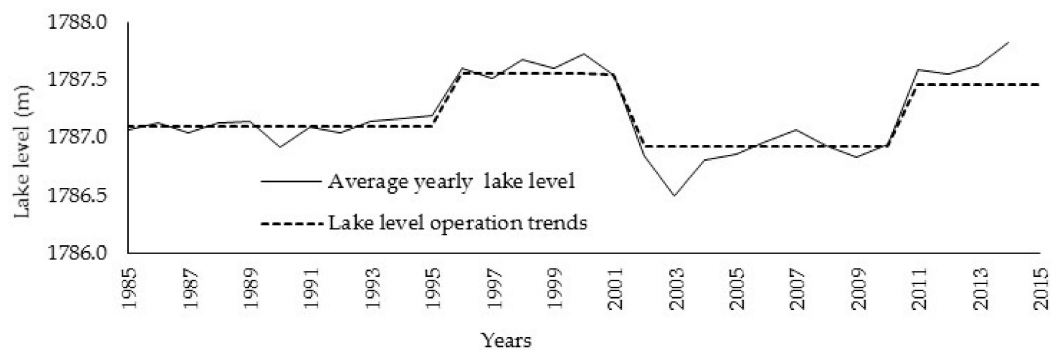
**Figure 10.** Mean annual Lake Tana level since 1985 (data source: Ministry of Water, Irrigation and Energy, Ethiopia).

The Ribb River debouches in Lake Tana, which had a regulated level for hydropower production since 1995. It shows three distinct operation periods: (1) a rise by 45 cm in the period 1995–2001, (2) a drop by 53 cm in the period 2001–2010, and (3) a rise by 62 cm in the period 2010–2015 (Figure 10). Increased flooding and the recent channel avulsion of 2008 have been often attributed to past lake level regulation.

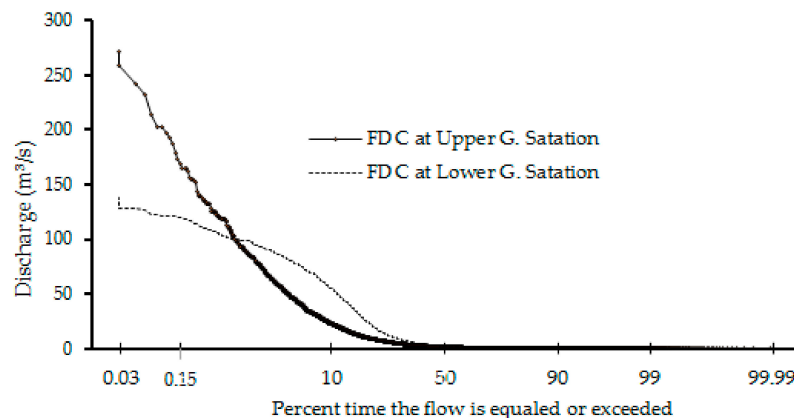
**Figure 11.** Flow duration curves at the Lower and Upper gauging stations (data source: Ministry of Water, Irrigation and Energy).

The FDCs derived for the gauging stations are shown in Figure 11. It is evident that the peak discharge at the Upper gauging station is substantially greater than the one at the Lower gauging station. This is likely due to overbank flow reducing the discharge exceeding the bankfull by as much as 71% at the Lower gauging station [21].

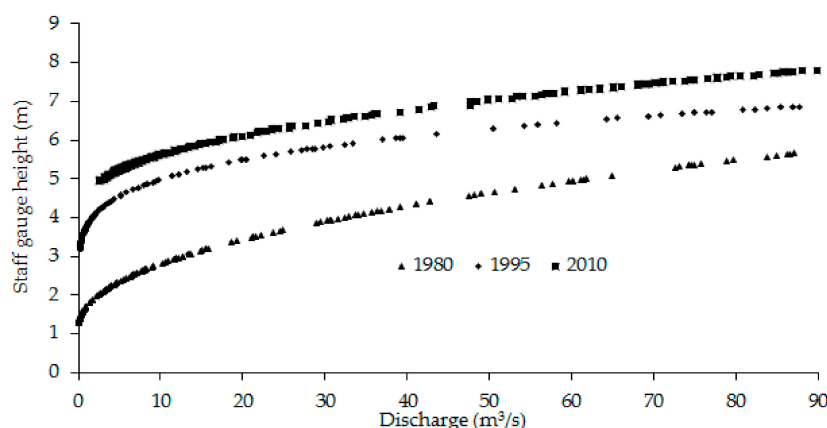
**Figure 12.** Ribb River staff level at the Lower gauging station with corresponding discharges (Data source: Ministry of Water, Irrigation and Energy, Ethiopia).

The time-series of daily water levels at the Lower gauging station shows that the riverbed rose by 2.2 m (14.7 cm/year) and 0.7 m (4.4 cm/year) between 1980 and 1995 and between 1995 and 2010, respectively, which is 2.9 m in 30 years (1980 to 2010) (Figure 12). Similarly, the nearby Gumara River bed rose by 2.91 m (6.3 cm/year) between 1963 and 2009 [18]. The adjacent Megech River to the north has similarly experienced sedimentation of the old channel downstream of a bifurcation since 1998 [23]. This means that sedimentation is observed in practically all rivers debouching in the Lake Tana from the Fogera plain.

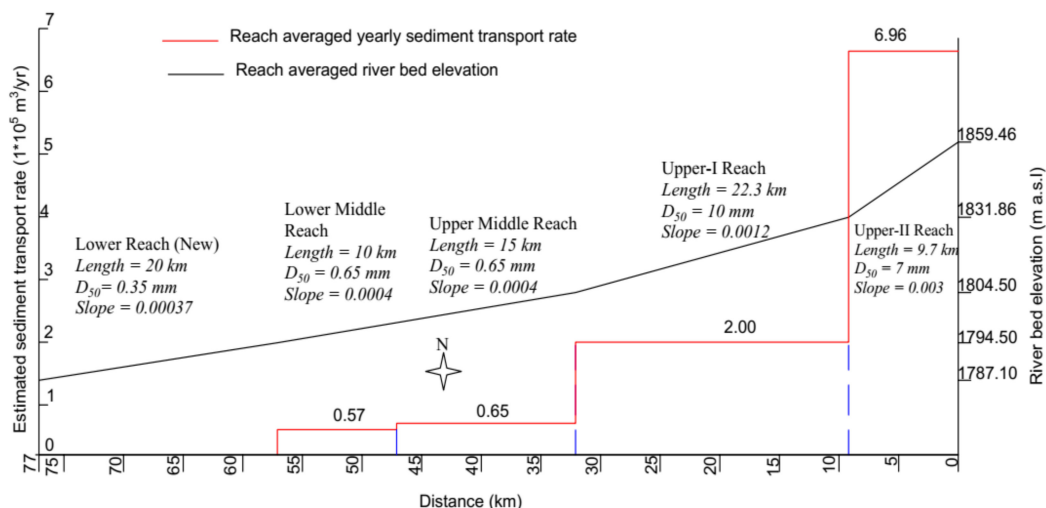
**Figure 13.** Sedimentation trend along the Ribb River based on estimated sediment transport rates. Distance of 0 km corresponds for dam site while 77 km is Lake Tana.

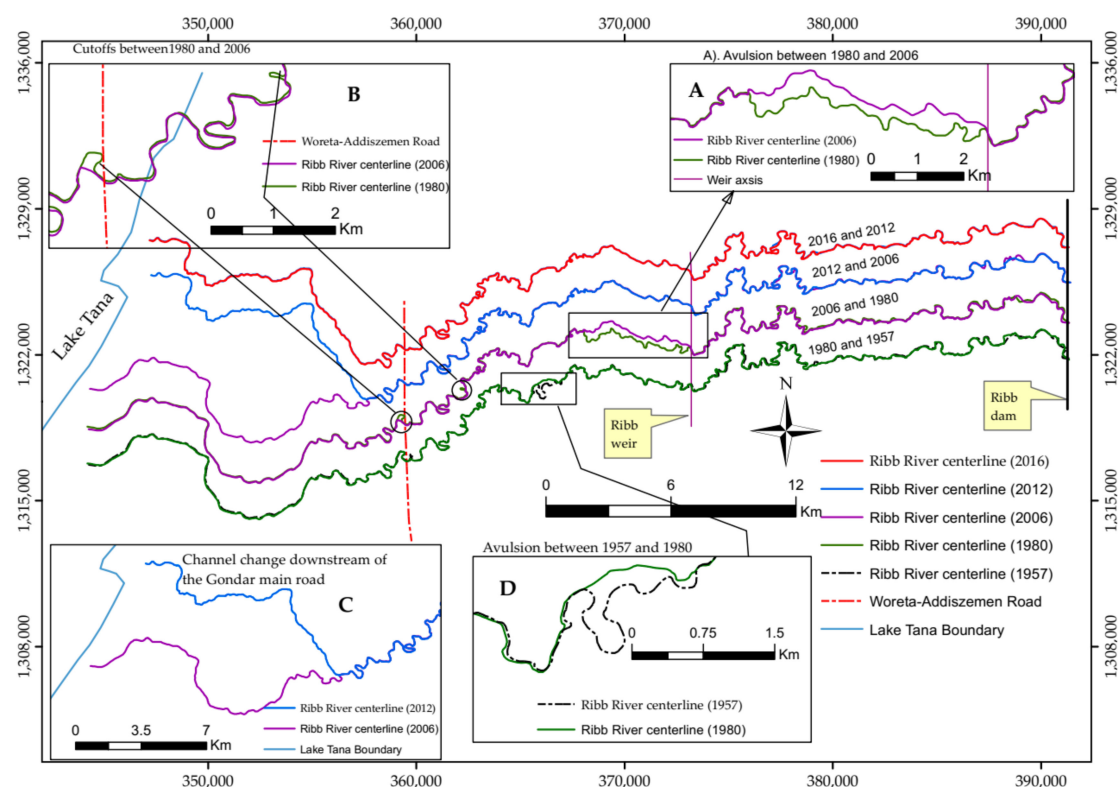
**Figure 14.** Successive Ribb River centerlines. (A) avulsion developed between the years 1980 and 2006; (B) cut-off developed between the years 1980 and 2006; (C) complete channel change between the years 2006 and 2012; (D) cut-off developed between the years 1957 and 1980.

The river reach-scale characteristics in 1957, 1980, 2006, 2012 and 2016 are presented in Table 2, where negative values for sinuosity changes indicate length reduction. The river planform changes caused by bank retreat, cut-off formation, channel avulsion, and complete channel blockage between 1957 and 2016 are shown in Figure 14.

The analysis of aerial photographs and satellite images shows that the study reach of the Ribb River reduced its length from 81 to 77 km since 1957. In the Upper-I and Upper-II reaches, the river has experienced only little planform changes, with  $-4.08\%$  and  $11.28\%$  sinuosity changes resulting in 0.2 km length reduction and 1.5 km length increment between 1957 and 2016, respectively. The rocky nature of the channel bed and banks in the Upper-I reach controls channel shape and width. The Middle reach reduced in length by 2.4 km, resulting in a sinuosity reduction of 16.9%. This was due to a channel avulsion event (Figure 14A) and a cut-off (Figure 14B), which occurred in the period 1980–2006. Another cut-off event (Figure 14D) occurred in the period 1957–1980. The small avulsion in Figure 14A reduced

the channel length from 7.4 to 6.3 km and the sinuosity from 1.41 to 1.20, while the cut-off in Figure 14D reduced the river channel length from 3.0 to 1.4 km and the local sinuosity from 2.51 to 1.11. Generally, channel cut-offs and avulsions immediately increase the energy slope and the bed shear stress and may coarsen the riverbed materials [42]. However, in the absence of further changes, the channel tends to restore its characteristics (slope, width, etc.) as before the shortening, with channel incision as a result. Embankments have been built in the Lower Middle sub-reach to reduce flooding. These embankments have also drastically reduced local channel migration. In the Lower reach, the channel experienced sedimentation, which resulted in complete river channel blockage starting 4 km downstream of the bridge in 2008 followed by channel avulsion (Figure 14C). The length of the new river channel is 2.6 km larger than that of the old river reach, but has similar sinuosity (Table 2).
