# Assessment of the effect of embedded RFID tag on a composite laminate strength

Daniele Ambrosini<sup>d</sup>, Dimitrios Zarouchas<sup>b</sup>, Alessandro Pirondi<sup>a,\*</sup>, Luca Vescovi<sup>c</sup>

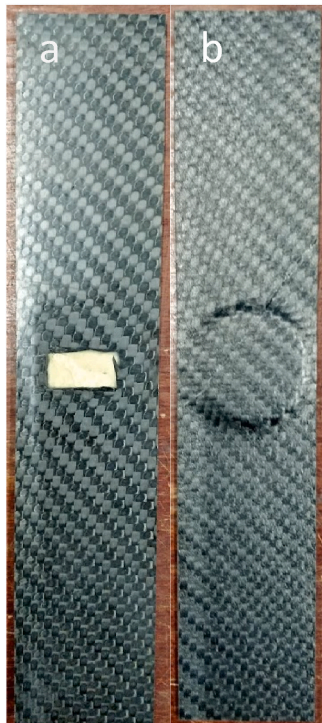
**Fig. 5.** Image of tensile composite specimens a) front and, b) back.

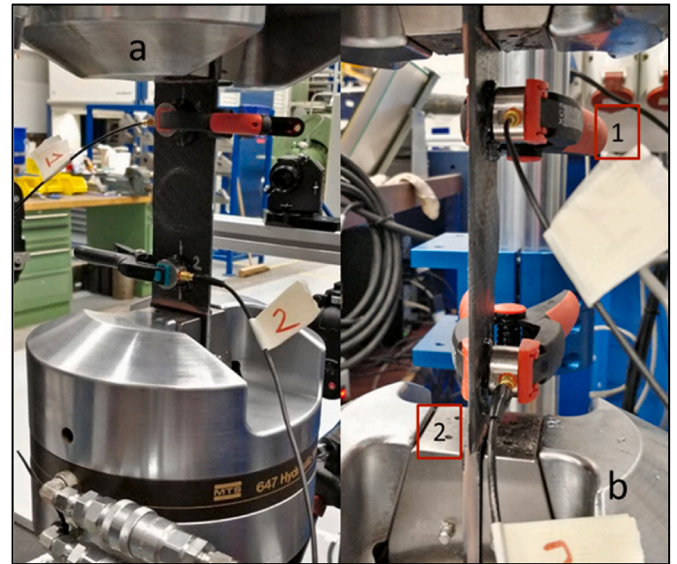
Fig. 10. Acoustic emission sensors positioned during the Tensile tests a) back view b) side view.
