RILEM TC 243-SGM report: grouting for historic architectural surfaces

Abstract Historic Structures are commonly coated with mortar layers (plasters, renders, flooring) for protection and decoration. These well finished architectural stratigraphic surfaces often suffer from deterioration, such as lack of adhesion or detachment between support and mortar layers and even between mortar layers. Grouting and filling voids between delaminated layers can be an effective intervention if the layers are compact. This paper deals with aspects pertinent to the selection, design and implementation

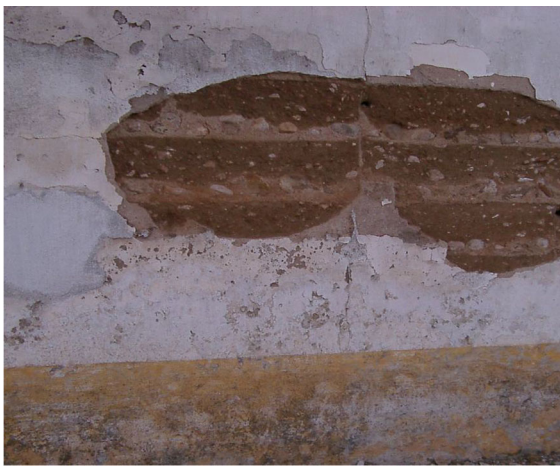
Fig. 2 Delaminated lime-based render with loss of plaster on earth-block masonry in Santarem Building, Portugal. Photo by A. Velosa

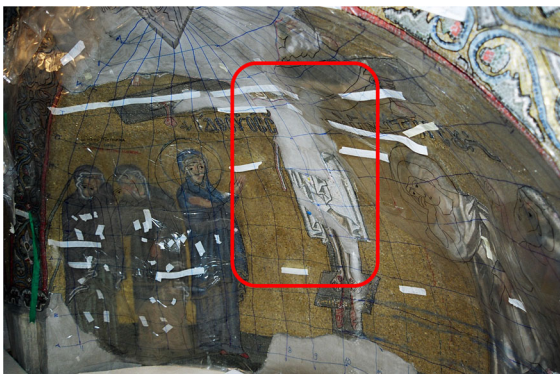
Fig. 3 Detachment of wall-mosaics from a masonry wall due to bulging of the mortar layer because of compression forces within the layers, Monastery of Chios (1045–1056 A.D.), Greece. Photo archive: Lab of Building Materials AUTH

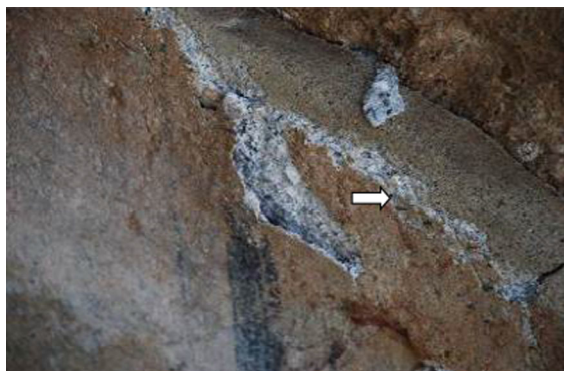
Fig. 5 Detachment of a lime-based plaster from an internal plaster layer. Archaeological site of Dion, Greece (Roman period): Plaster consisting of two layers of a total thickness of 2.5 cm (external: 0.5 cm, internal: 2 cm) with the external layer decorated with wall paintings (Photo archive: Lab of Building Materials AUTH)

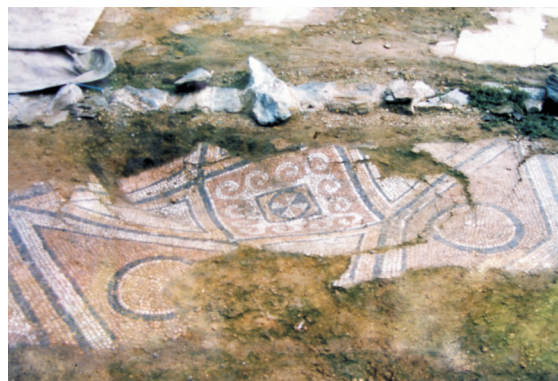
Fig. 6 Detachment due to deformation of substrate of floor mosaic layer (one part of the mosaic was detached due to subsidence another part was detached after cracking) (Galerius Palace, Greece, Roman period, photo archive: Ephorate of Classic Antiquities)

Injection grouting aims to stabilize architectural surfaces by introducing a bulked fluid adhesive material (i.e. grout) into the delaminated area (Fig. 4). Grout is a mixture of binding material(s) with an adequate dispersing medium, that may or may not have fine aggregate and/or filler and admixtures, forming a fluid but stable injectable mixture. The layers which need re-adhesion may be very thin (some millimeters), as in the case of Hellenistic colored renders and plasters (Fig. 5), or may be of considerable thickness, usually one or two centimeters, such as in mosaics (Fig. 6).

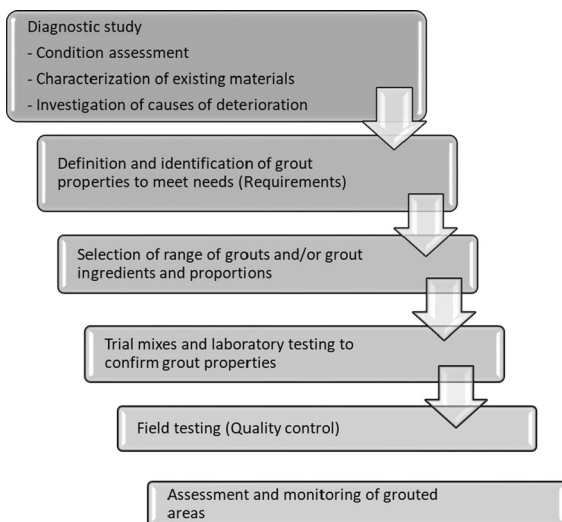
Fig. 7 Methodological approach for grouting historic architectural surfaces

The development of a grouting operation requires a methodological approach. This approach should begin with a diagnostic investigation, including a thorough condition assessment, the characterization of the original and the added materials, and the development

of an understanding of the deterioration causes and mechanisms (Fig. 7). This systematic planning is necessary to determine the compatibility criteria and the performance requirements for grouts, leading to the selection of the properties of an appropriate grout and to the overall development, implementation and control of the grouting intervention. Grout trial mixtures should be tested in the laboratory in fresh and hardened state. In situ applications and field tests will provide further guidance for selection. Furthermore, grout performance must be controlled and recorded, and its effectiveness should be monitored periodically after intervention.

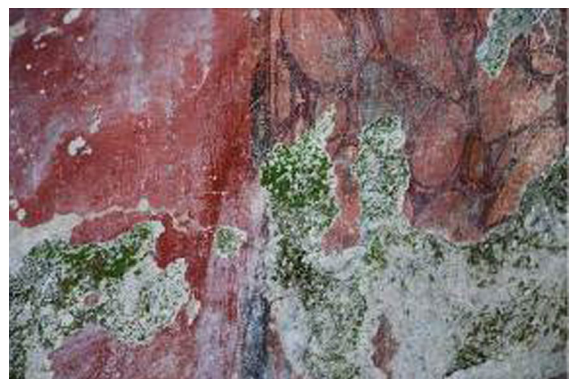
Fig. 8 Detachment and loss of a lime-based plaster from the masonry support. Archaeological site of Dion, Greece (Roman period): Plaster consisted of two layers of a total thickness of 2.5 cm (external: 0.5 cm, internal: 2 cm), decorated with wall paintings. (Photo archive: Lab. of Building Materials AUTH)

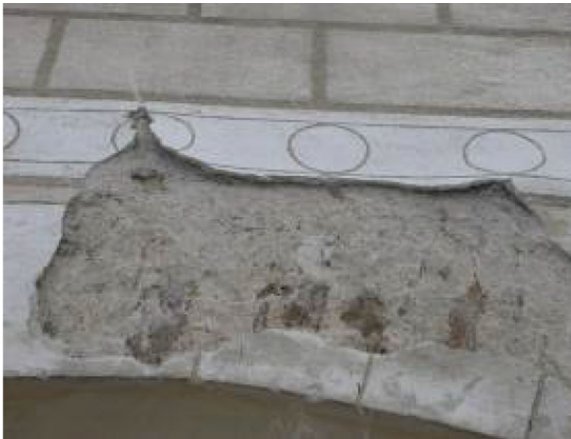
Fig. 9 Examples of delamination due to **a** Degradation and internal loss of cohesion, **b** Structural movements, **c** Differential thermal properties (as a result top plaster layer is completely

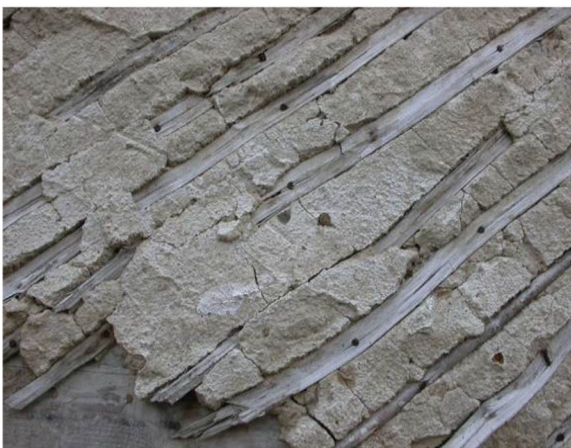
c

missing), **(d)** insufficient bonding and construction related problems (photo archive: A. Velosa)

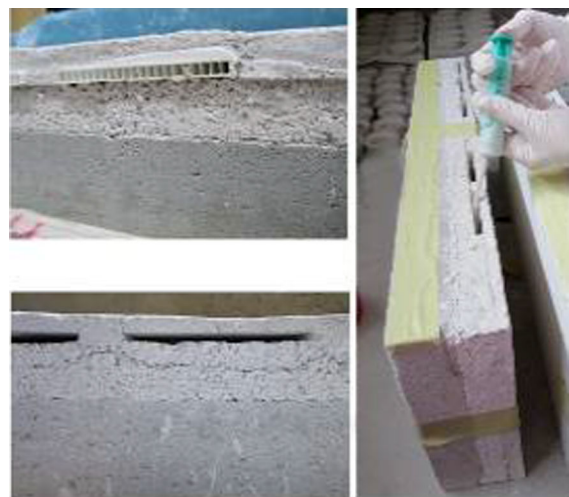
Fig. 10 Testing adhesion of grouts SIST EN 1015–12 (photo archive: A. Padovnik)

The adhesion test EN 1015–12 (2000) described in the literature [32, 33] (see Fig. 10), seems adequate for grouts used for reattachment, although the repeatability of the measured values is low. However, minimum required adhesion values, such as $> 0.1 \text{ MPa}$, given in ref. [34], are achieved only in the case of grouts with hydraulic binders, while hydrated lime grouts usually exhibit lower values (0.01–0.08 MPa).
