**Root causes of failures in sustainable urban drainage systems (SUDS)
an exploratory study in 11 municipalities in the Netherlands**

Blue-Green Systems

Root causes of failures in sustainable urban drainage systems (SUDS): an exploratory study in 11 municipalities in the Netherlands

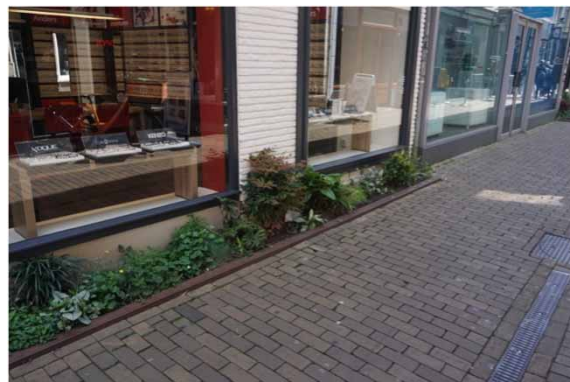
Figure 3 | Case #30: a facade garden, which has been assigned the root cause embedded practices of involved actors. A facade garden is typically constructed surrounded by raised borders. Preventing runoff to be drained into the garden, this reduces the effectiveness of the SUDS.

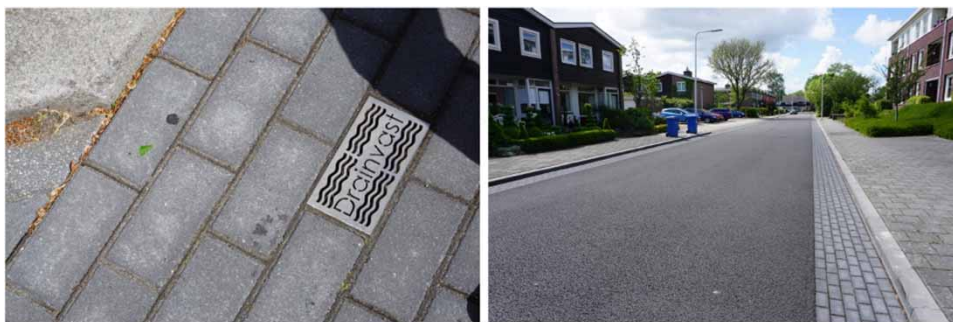
Figure 6 | Case #33 has been assigned the root cause *Incomplete knowledge* about the internal technical processes. The pavers were separated by joints filled with a permeable material, allowing water to infiltrate. Even after a small rainfall event, however, water remained ponding for at least 1 h. As such, it was thought that the permeable material had become clogged, leading to a malfunction of the SUDS.

explained that this incomplete knowledge typically stems from the limited monitoring that is carried out in SUDS. They argued this prevents learning and results in unnecessary failures. In addition, one interviewee reported that in some cases, designers do not have the knowledge and/or experience to properly understand the internal processes occurring in SUDS. This relates, for example, to incomplete knowledge about the subsoil. As compared with sewers, the subsoil forms an important part of SUDS, particularly in the case of infiltration facilities. The design is then often based on the very limited information available about the subsoil, if at all. When SUDS are then constructed in practice, the subsoil sometimes has other characteristics than expected, resulting in malfunctions. For instance, the soil contains more clay, or groundwater levels are higher than expected, decreasing the permeability of the soil, or reducing the subsurface storage capacity, respectively. An example is provided in [Figure 6](#).

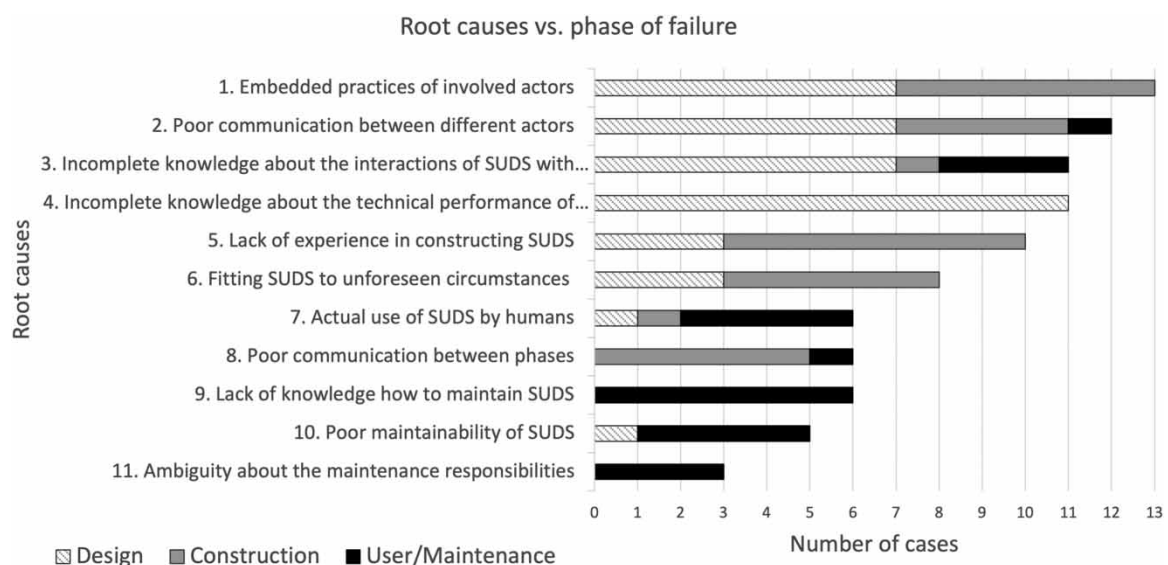
Figure 9 | Number of failures that origin from each of the project phases, per root cause.

With respect to the failures originating from the user and maintenance phase, Figure 9 reveals that the most dominant root causes are 7, 9, and 10: *Actual use of SUDS*, *lack of knowledge how to maintain SUDS*, and *poor maintainability of SUDS*, respectively. All these root causes relate to a certain lack of knowledge from users and operators on how to handle SUDS. Actors in charge of maintenance have to be well involved such
