## Field Measurements of Very Oblique Wave Run-up and Overtopping with Laser Scanners

Oosterlo, P., Hofland, B., van der Meer, J. W., Overduin, M., & Steendam, G. J. (2020). *Field Measurements of Very Oblique Wave Run-up and Overtopping with Laser Scanners*. 1-2. Abstract from ICCE 2020: International Conference on Coastal Engineering (Virtual). <https://doi.org/10.9753/icce.v36v.waves.20>

# FIELD MEASUREMENTS OF VERY OBLIQUE WAVE RUN-UP AND OVERTOPPING WITH LASER SCANNERS

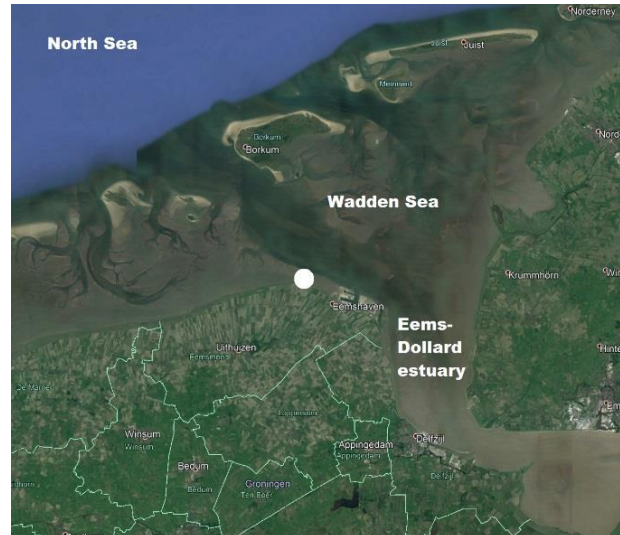
Figure 1 - The Eems-Dollard estuary in the Netherlands, area of interest of the field measurement project. Laser scanner system location indicated by white dot.

An extensive field measurement project is being performed in the Eems-Dollard estuary in the north of the Netherlands for a period of 12 years. The measurements started in 2018, measuring wind, water levels, waves and wave run-up and overtopping. The estuary consists of deep channels and shallow tidal flats and is part of the Wadden Sea, a shallow shelf sea, see Figure 1. A particular aspect for this area is that the dike design conditions are characterized by very obliquely incident waves, up to  $80^\circ$  relative to the dike normal. As the reliability of the models as used for the Dutch dike safety assessment has not been sufficiently validated for such conditions, the aim of the measurements is twofold. First, to better understand the processes yielding nearshore wave conditions, ultimately leading to improved numerical prediction models. Second, to better understand the processes related to oblique wave run-up and overtopping, leading to improved prediction methods. In the project, the wave overtopping is measured with four wave overtopping tanks built into dikes at two locations. The laser scanner system of Oosterlo et al. (2019) has since been upgraded and has now been placed next to two of the overtopping tanks on the dike in the Eems-Dollard estuary to measure during actual severe winter storms, see Figure 2.

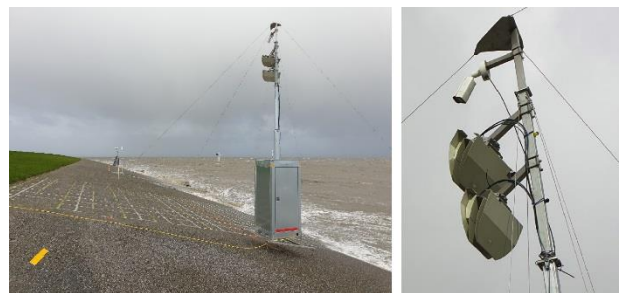
Figure 2 - Left: New laser scanner system next to the overtopping tanks on the dike in the Eems-Dollard estuary. Right: from the bottom to the top: Laser scanner 1, laser scanner 2, video camera.
