# Eemdijk full-scale field test programme: sheet pile pullover tests

## TProgramme d'essai terrain à taille réelle Eemdijk : essais de déformation et de rupture de murs palplanches

**ABSTRACT:** Dikes in the Netherlands have traditionally been constructed with soil. Climate change and subsidence requires heightening and or reinforcing of these existing ground dikes. Traditional reinforcements demand additional space, which in some cases conflicts with existing buildings. Applying sheet pile walls in dikes allows for strengthening while minimizing the increase in footprint. However, a validated design approach that complies with relevant regulations lacks. To enable the validation of a proposed design approach, a full-scale field test programme (Eemdijkproef) was performed near the town of Eemdijk, The Netherlands. It consisted of a step wise approach: 1) sheet pile pullover tests, 2) ground dike stability test, 3) sheet pile dike stability test. All tests were loaded until failure occurred. The full-scale pullover tests (POT) consisted of 4 sheet pile configurations. The length of the sheet piles varies between 13 and 16m and the width of the panel varies between 1.8 and 4.2m. Bo

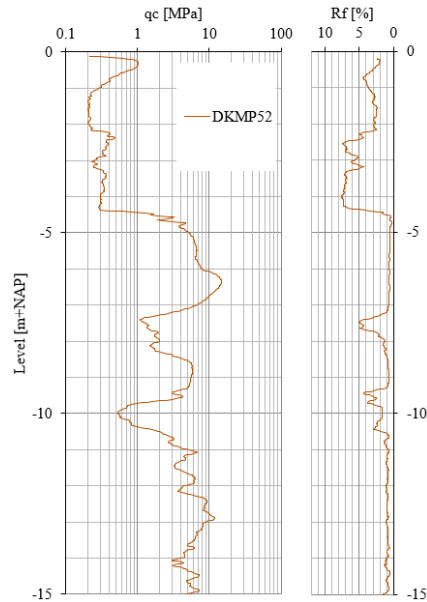
Figure 1. Representative CPT at POT site

The ground conditions at the test site are homogeneous, consisting of peat and clay layers on top of a sand layer. In Figure 1 a representative CPT is presented and Table 1 presents the stratification. The “Eemdijkproef” comprised an extensive field and laboratory testing programme. A more detailed description of the geotechnical conditions is presented in (Lengkeek, 2019b). During

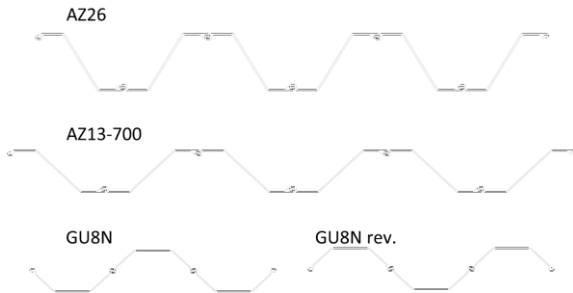
Figure 2. Sheet pile profiles

Four sheet pile configurations are tested in the POT (see figure 2):

- GU8N triple is a class 3 profile according to the (EN 1993-5, 2007) and the same type as used in the FST sheet pile dike. To assess the influence of the loading direction, this profile is also tested in the reversed direction (GU8N-rev).

- AZ26 profile is tested to validate the plastic bending capacity since this profile is a class 2

profile according to the (EN 1993-5, 2007) and therefore is expected to reach the full plastic bending capacity with additional plastic rotation capacity.

- AZ13-700 is a class 3 profile according to the (EN 1993-5, 2007) and is tested for comparison with the AZ26 profile. It is expected to reach the expected elastic bending capacity (plastic resistance in term of Eurocode) but not the full plastic bending capacity.

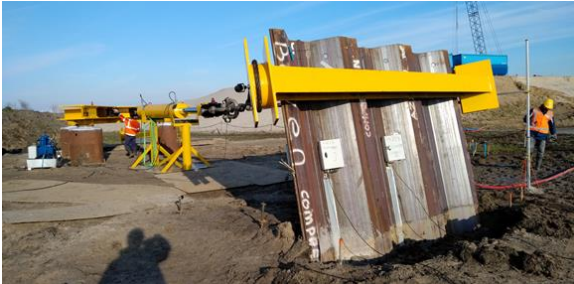
Figure 4. Photo of AZ13-700 during the test

Between the reaction frame and the sheet piles a hydraulic jack is placed 2m above surface level, see Figure 4. This jack can generate a pull-force of 1200kN and has a stroke of 2m. This jack is placed on a sliding table to support the jack and prevent the self-weight of the system to influence the behavior of the sheet pile. The jack is connected to a steel cable to both sides of a waling on the sheet pile. This connection is such that the pull-force is evenly distributed over both sides of the waling and the pull force remains centric on the waling even for large rotations of the sheet pile wall.

The AZ13-700 three double-Z is a relative wide panel in respect to the GU8N triple-U profiles, see Figure 4. Since the wall is wider and has a higher bending moment capacity than the GU8N

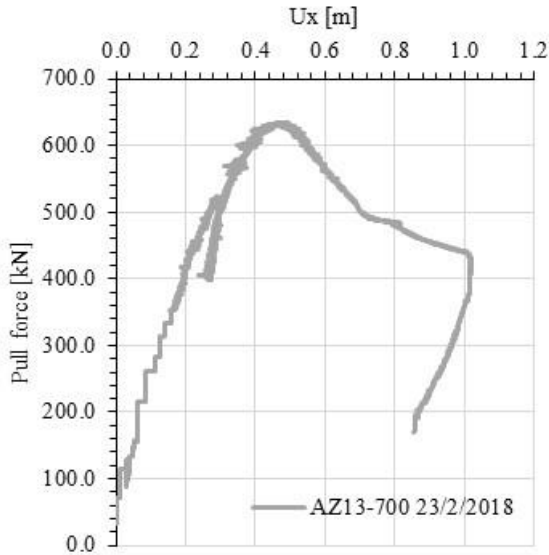
Figure 10. Force-displacement diagram AZ13-700  
AZ13-700 2018-02-23 14:04:00

triple-U, the maximum pulling force is also higher at 634kN (figure 10). The AZ13-700 three double-Z profile is stiffer than the GU8N profile. This is also reflected in horizontal displacements (figure 11). The fixation level where rotation starts is about -4.0m NAP due to the higher stiffness.

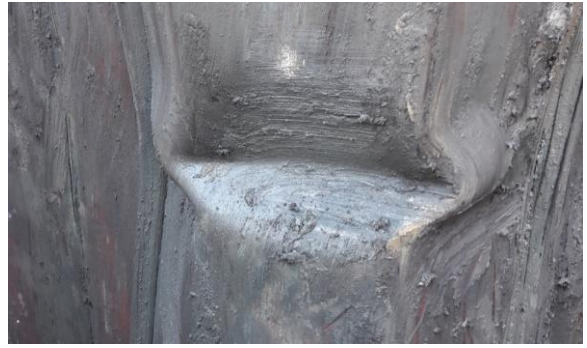
Figure 14. Excavated GU8N-rev with local buckling

After performing the pullover tests the sheet piles have been excavated to investigate the failure mechanism. Figure 14 shows as example the buckled compression flange of the GU8N-rev triple-U.

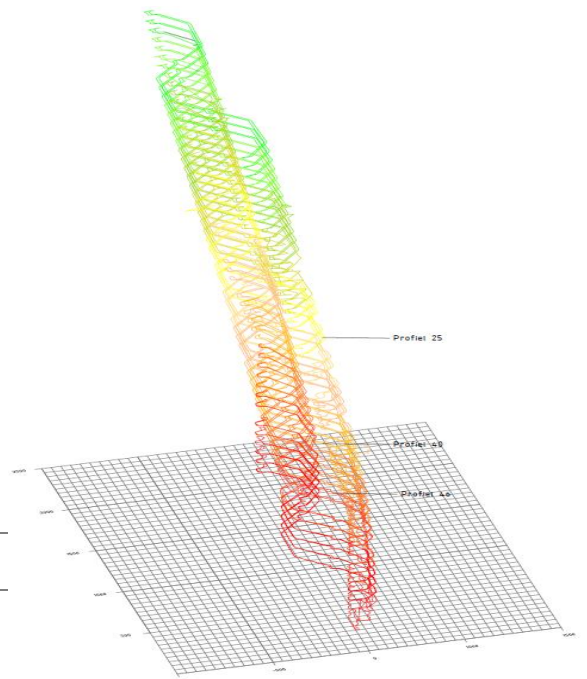
Figure 15. 3D scan of deformed GU8N-rev

In addition to the visual inspection of the excavated sheet piles 3D scans have been made to record the deformed shape of the entire profile, see Figure 15. Based on the 3D-scans it is observed that the buckling and plasticity is limited to approximately 0.5m height. The shape of the rest of the profile did not change significantly.

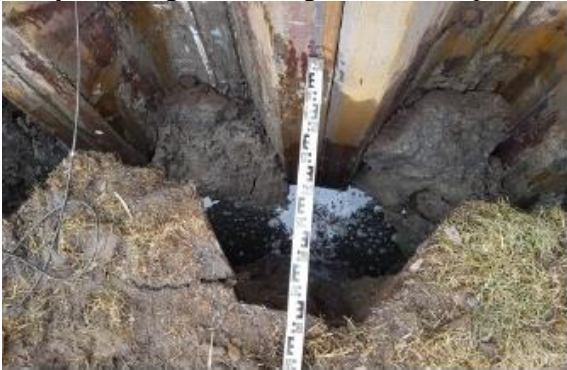
Figure 16. Gapping behind sheet pile wall AZ26

During the pullover test the sheet piles are pulled forward resulting in a gap at the back of the sheet pile wall. Due to the undrained behavior of the cohesive soil the soil remains almost perfectly vertical and the water level in this gap drops significantly below the original water table effectively reducing the loading on the sheet pile.
