## Deliverable D.T. 4.1.1

### Data collection, modelling and prediction

# Data collection, modelling and prediction

EMfloodResilience

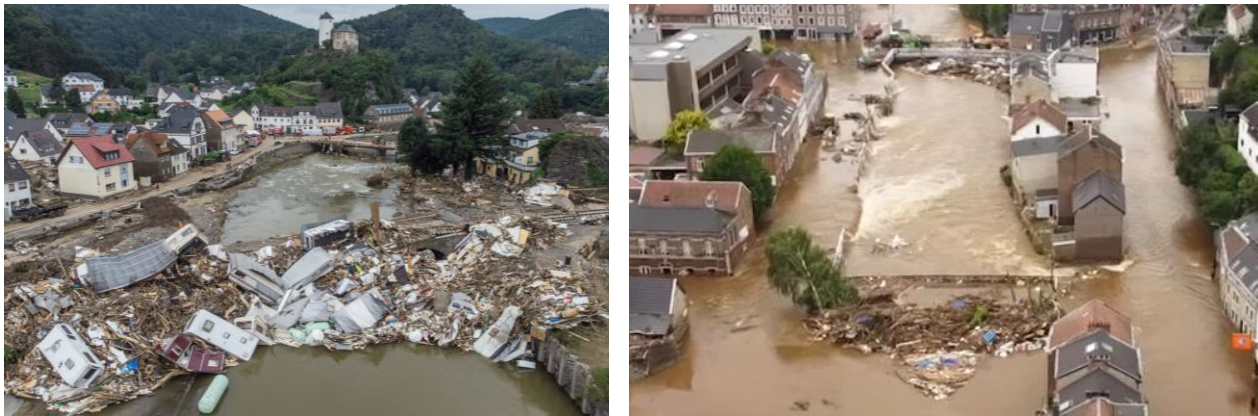
*Figure 4: Two extreme examples of debris accumulation, with trees, building rubble, caravans, tanks and other materials show the backwater rise caused by accumulations. Location: Kreuzberg, Germany and Pepinster, Belgium.*

With the help of the data collection on debris accumulation, the total volumes as well as the different debris compositions were determined, and characteristic bridge designs established. The observed debris accumulations at the bridges in Belgium and Germany ranged in size from a few m<sup>3</sup> to more than 4000 m<sup>3</sup>, i.e. up to 88 m<sup>3</sup> per meter of bridge length. Especially large accumulations were able to disrupt the normal flow of the river and cause substantial backwater rise (Figure 4). Moreover, debris accumulation and flooding caused widespread bridge damage. Of the 71 bridges with debris accumulation, 13 were structurally severely damaged and a further 19 too damaged to be kept in service. In the Netherlands, no significant bridge clogging was identified. Clogging did occur at one submerged culvert, near Bunde. Although the accumulation was relatively limited compared to those in Belgium and Germany, the resulting reduction of the already insufficient culvert discharge capacity means the debris intensified local flooding.
