Proceedings of the Institution of Mechanical Engineers, Part C: Journal of Mechanical Engineering Science

# Cutting fluid role in the machinability of AZ91/SiC composite: Tool wear and surface roughness

Ali Asgari<sup>1</sup> , Amin Sousanabadi<sup>2</sup> and Mohammad Sedighi<sup>2</sup>

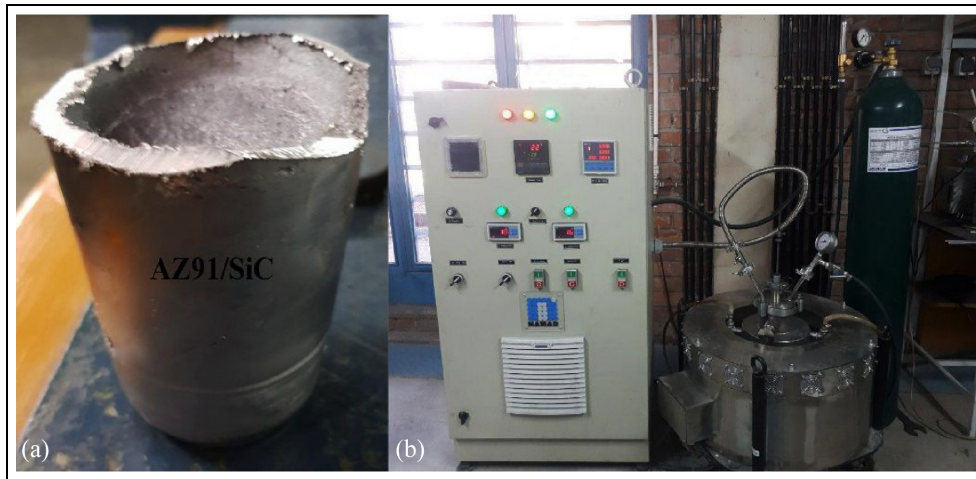
**Figure 1.** AZ91/SiC composites fabrication through stir casting: (a) AZ91/SiC composites and (b) stir casting set-up.

Samples are made of AZ91 composites considering magnesium alloy AZ91 was the matrix material and SiC particles were reinforcements, volume fraction 5%. This volume fraction is chosen since more clusters of SiC particles are seen in high fractions and 5% has been mentioned in different references.<sup>14,17,41</sup> Composites were fabricated by stir casting process because of simplicity and lower costs.<sup>42</sup> Chemical composition of AZ91 material is shown in Table 1. In order to fabricate the metal matrix composites, some pieces of magnesium alloy AZ91 are put into the crucible and is melted while argon gas is continuously blowing into the furnace. At temperature about 776°C, SiC particles with mesh size 320, meaning average particle size 45 µm, are added to the molten materials. Then, the mechanical stirrer is applied to blend it for nearly 10 min, with rotational speed 2600 rpm, and then magnet stirrer is turned on and works for 3 min. Afterward, composite materials are cooled down to reach the ambient temperature.<sup>41</sup> Composites are machined to reach a cylindrical shape 50 mm in diameter and 60 mm in length. Fabricated composites and the used set-up are illustrated in Figure 1.
